B-052 April 15, 2003

SAFETY RECALL CODE 0826 - SIDESTAND LEG FOR 2003 LIGHTNING XB9SL

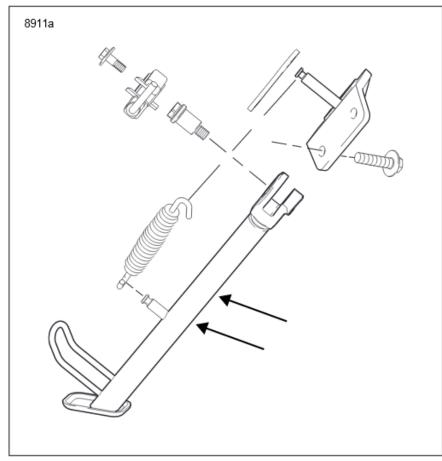
Figure 1. Sidestand Assembly with Sidestand Leg (Part No. 94218Y)

As recently advised, Buell Motorcycle Company has decided that there is a safety defect with the sidestand legs on certain 2003 XB9SL motorcycles which causes them to have the potential to bend or break without notice, thereby allowing the motorcycle to fall and potentially cause an injury.

See Figure 1. The correct replacement sidestand for the purpose of this bulletin is Part No. 94218Y.
