Recall Code 0828 - Horn Wire Routing for 2004 XB9S, XB9SL and XB12S

Purpose

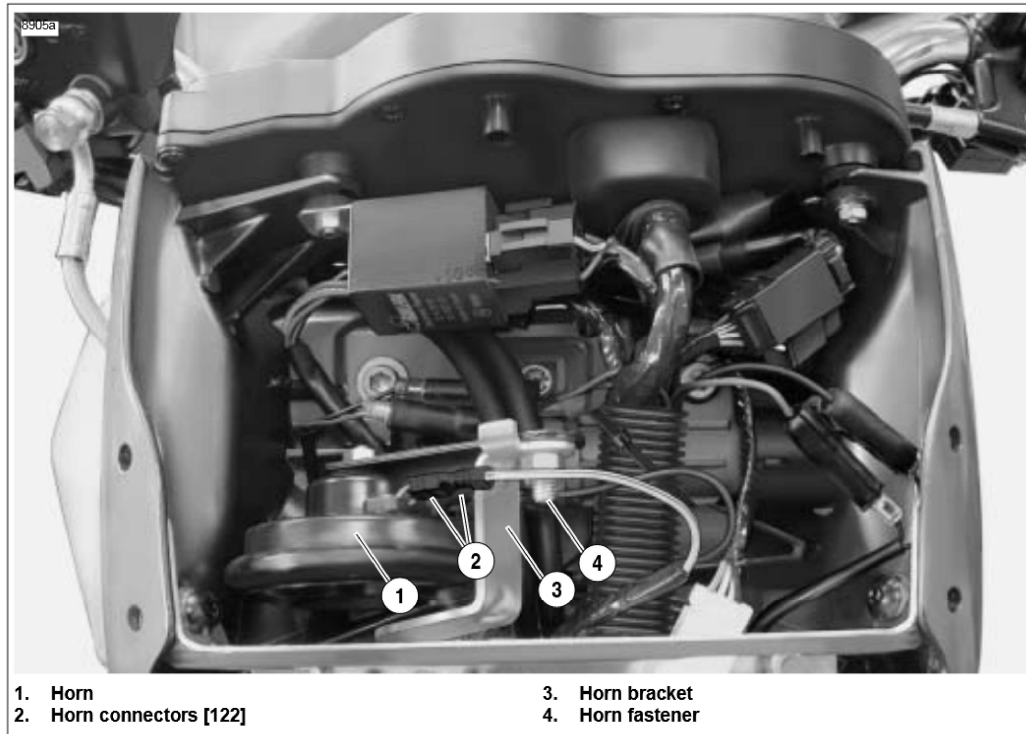
Figure 1-1. Horn Assembly Behind Windscreen

Buell Motorcycle Company has determined that a condition, relating to motorcycle safety, exists involving 2004 model year motorcycles built between June 23, 2003 and August 27, 2003. This condition involves the wire that provides power to the horn, which due to mis-routing, can become frayed from contact with the horn bracket mounting bolt. The result is that the horn wire becomes exposed, and when the horn button is pushed, either the horn circuit fuse or the key switch fuse can blow. If the horn fuse blows, the horn and rear brake light will no longer function. If the key switch fuse blows, in addition to the horn and rear brake light not functioning, the vehicle can lose ignition and create a "quit while riding" situation. A "quit while riding" situation could result in an accident.

2. Disconnect battery by unthreading fastener and removing negative cable (black) from battery first.
3. Remove windscreen.
4. See Figure 1-1. Disconnect horn connectors [122] (2) and remove horn fastener (4) and horn (1).

Horn bracket (3) should remain attached to headlight support bracket.

5. Install horn (1) using new fastener from kit and tighten fastener (4) to 72-96 in-lbs (8.1-10.8 Nm).
6. Inspect horn wire for damage. If damaged, see WIRE REPAIR SECTION next page.
7. Connect horn connectors [122] (2).

8. Inspect horn wire routing to ensure there is no contact. Correct as necessary.
9. Install windscreen and tighten fasteners to 10-12 in-lbs (1.1-1.4 Nm).
