#### SAFETY RECALL CODE 0830 - SIDESTAND PIVOT BOLT FOR 2005 FIREBOLT XB12R AND LIGHTNING XB12S, XB9SX

B-060

Buell Motorcycle Company has decided that there is a potential safety defect with the sidestand bracket assemblies on certain 2005 XB12R, XB12S, XB9SX model motorcycles.

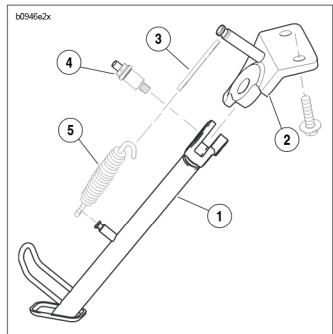
Figure 2. Sidestand Assembly

- 1. Sidestand leg
- 2. Sidestand bracket
- Spring extension plate
- 4. Sidestand pivot bolt
- 5. Spring

- Vehicle should be placed onto the lift with front or rear tire placed in the wheel vise in order to successfully perform this procedure.
- Sidestand assembly does not have to be removed from motorcycle in order to remove sidestand pivot bolt.
- Remove two fasteners from left side of chin fairing.
- See Figure 2. Remove sidestand pivot bolt (4).
  - a. Retract sidestand leg.
  - Remove sidestand spring (5) and spring extension plate (3) using SNAP-ON SPRING TOOL (Part No. HE-52B).
  - c. Remove sidestand pivot bolt (4).

- See Figure 2. Install sidestand pivot bolt (4) tightening to 18-20 ft-lbs (24-27 Nm).
- Retract sidestand leg.
- e. Install spring extension plate (3) and sidestand spring (5) using SNAP-ON SPRING TOOL (Part No. HE-52B).
- Apply LOCTITE 272 (Red) and install the two left side chin fairing fasteners and tighten to 36-48 in. lbs (Nm).
