SERVICE BULLETIN

B-064 Safety Recall Code 0831

August 16, 2006

P&A Accessory Tall Windscreen Part Nos. 58214-06Y and 58214-06YA

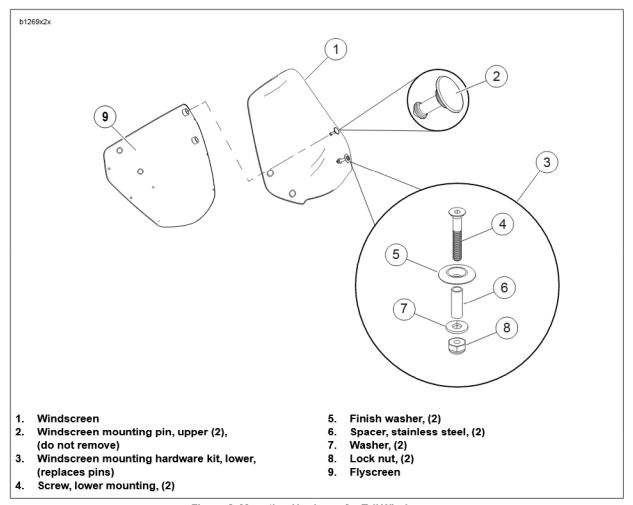
Figure 2. Mounting Hardware for Tall Windscreen

See Figure 2. The windscreen (1) upper mounting locations use mounting pins (2) (Factory installed in windscreen) and the lower two mounting locations use fasteners (3) supplied in the 94485Y recall kit. It will be necessary to remove the flyscreen in order to properly install the new windscreen lower fasteners.

- See Figure 2. Install the windscreen (1) by pushing the upper mounting pins (2) into place. Ensure upper mounting pins on windscreen locate properly into upper mounting grommets of the flyscreen.
- 4. Align the lower flyscreen and windscreen mounting holes. For the left and right side lower mounting holes, insert finish washer (5) and spacer (6) onto the screw (4) and place through the windscreen holes and flyscreen grommets.

- 5. From the inside of the flyscreen place washer (7) onto the screw (4) and thread lock nut (8) onto screw. Tighten screw to 50-60 **in-lbs** (5.6-6.8 Nm).
- Install flyscreen (with windscreen attached) using 6 screws removed earlier. Tighten screws to 10-12 in-lbs (1.1-1.4 Nm).
