Loss of control and collision with terrain involving de Havilland Canada DHC-1 Chipmunk, VH-UPD

Coffs Harbour, New South Wales | 29 June 2014

ATSB Transport Safety Report
Aviation Occurrence Investigation
AO-2014-114
Final – 4 February 2016

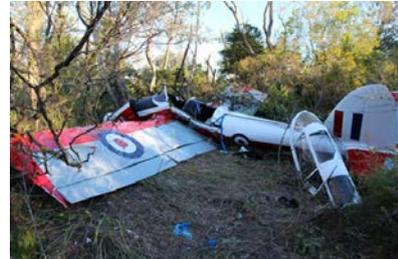
VH-UPD accident site

At the top of the loop, the aircraft stalled while inverted, most likely as the result of excessive elevator input. The aircraft rolled and entered an upright spin, which became flatter as it developed. Later, the pilot reported that attempts to recover were unsuccessful. The spin continued until the aircraft impacted terrain. The pilot and passenger sustained serious injuries and the aircraft was seriously damaged. There was no fire.

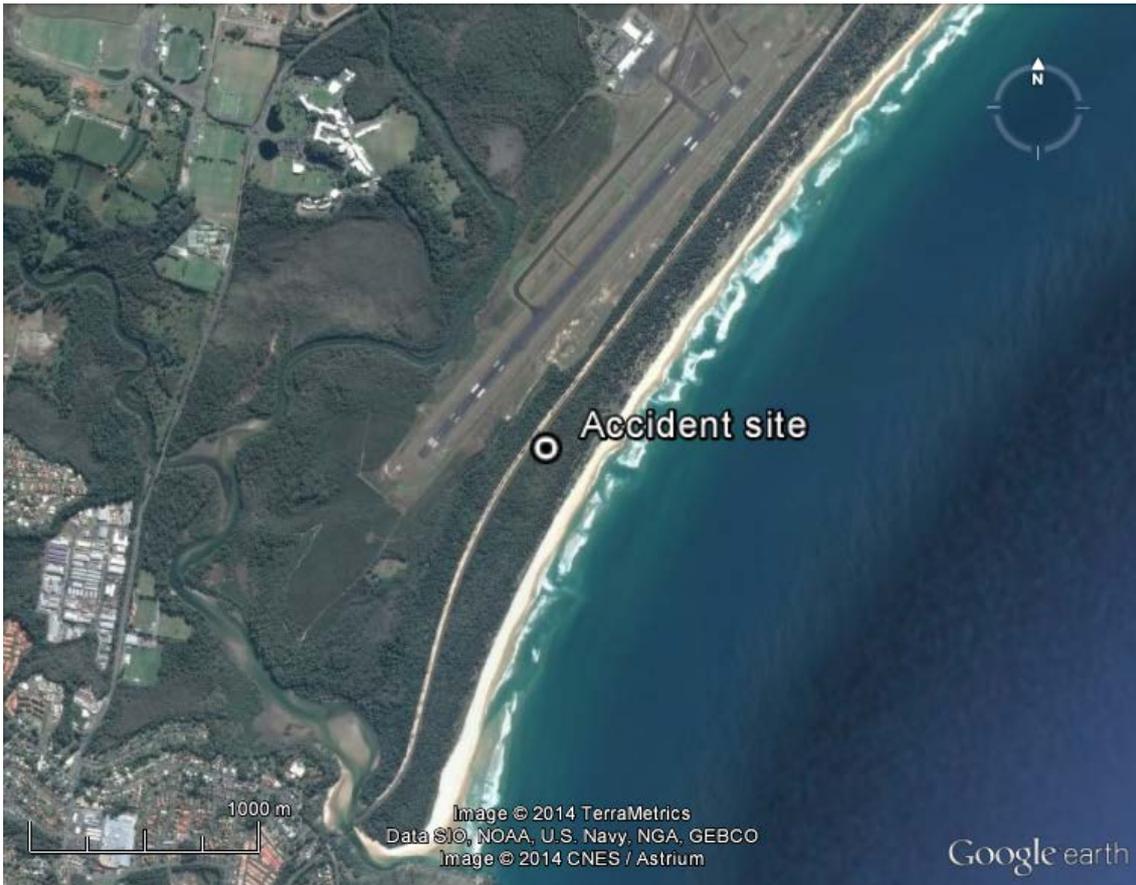
Figure 2: VH-UPD accident site location

The accident site was located about 400 m east of the Coffs Harbour Regional Airport runway 03³ threshold (Figure 2).

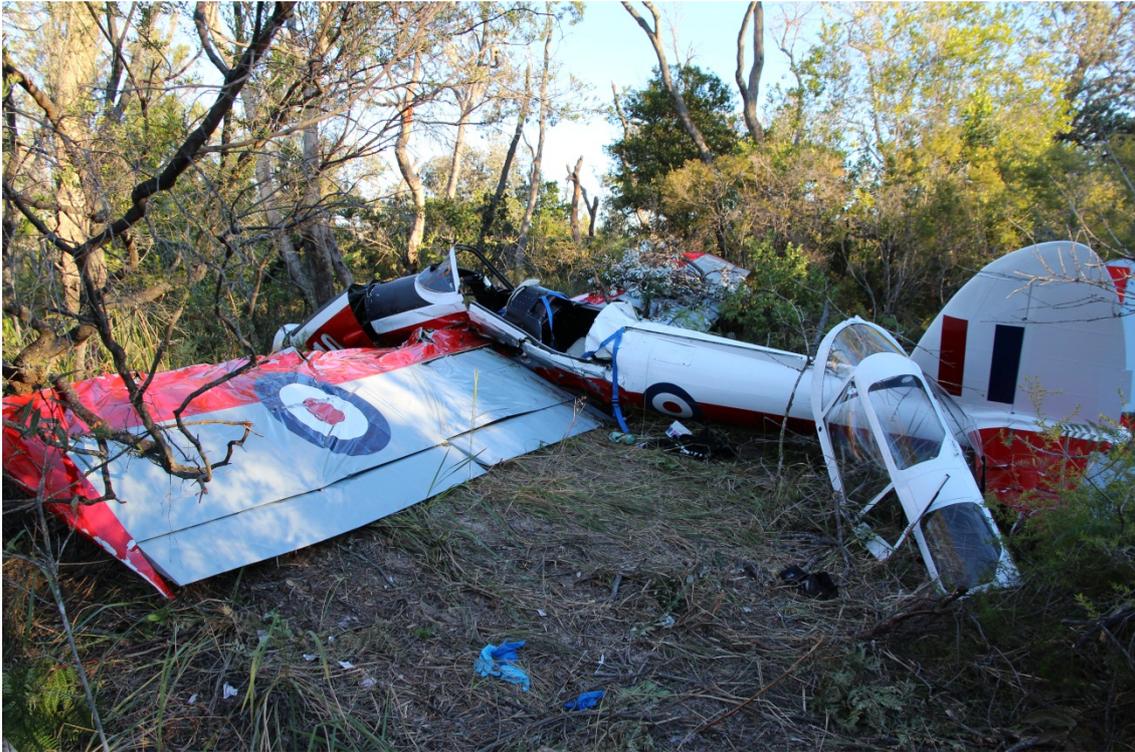
Figure 3: VH-UPD accident site

The main wreckage was in an upright position, oriented towards the east (Figure 3). The damage to the aircraft and impact marks on the surrounding foliage and the ground indicated that the aircraft impacted terrain in a near vertical descent while yawing from left to right and in a slightly nose-low attitude. The fuselage and undercarriage absorbed much of the ground impact forces, as did the foliage and relatively soft, sandy ground.

All of the aircraft components were accounted for in the immediate area of the accident site. There was no evidence of any pre-impact failure.

Flight control continuity was established. The flaps appeared to be retracted at the time of impact. The elevator trim position could not be accurately determined due to the structural deformation of the fuselage.

A loose washer was found in an area behind the rear control box. Visual examination of the washer revealed no damage that would indicate that it had been jammed in the controls.
