How do ingested Foreign Objects damage turbos?

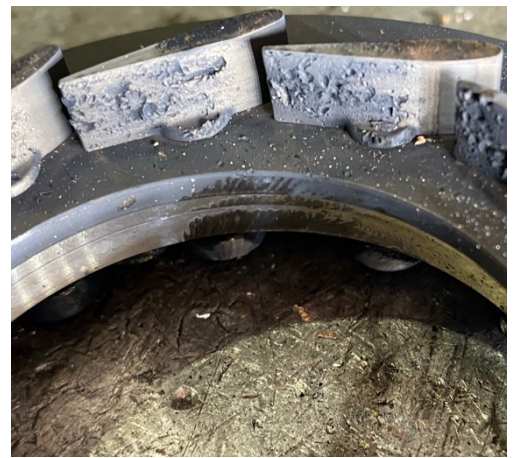
Compressor wheel ("cold side") damage is caused by small particles entering the compressor inlet port of the turbo.

- Most commonly, these are small pieces of dust/dirt entering via a damaged air filter element and/or air cleaner housing to turbo, connection hose.
- Catastrophic damage will occur if even a small nut / washer, cleaning rag, or gasket remnant, is accidentally left anywhere in the induction tract during turbo replacement.

- VERY CAREFULLY ensure that there are no fragments from the original damaged turbocharger, which is being replaced, anywhere in the intake ducting or just as importantly, in the exhaust manifold.

- VERY CAREFULLY clean the air cleaner housing and inside of the rubber connecting ducting to the compressor inlet port of the turbo. Ensure no cleaning rags are left inside either component.

- VERY CAREFULLY check the surface walls of the rubber ducting connecting the air cleaner housing to the compressor inlet port. Cracks which develop over years of service can be invisible to the eye with the engine stationary, however, open up during engine/vehicle operation, allowing dust/dirt ingress.

- Ensure a brand new, high quality air filter element is installed.
- Ensure all old gasket material is carefully and cleanly removed from all mating surfaces.

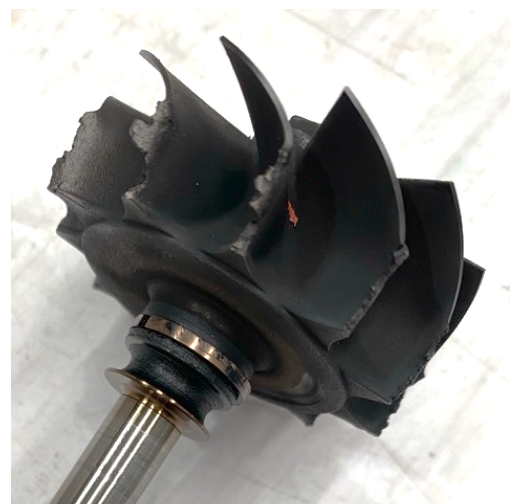
Turbine wheel ("hot side") damage is caused by either pieces of carbon and/or metal entering the exhaust entry port of the turbine.

- This usually occurs due to the lack of, or just simply poor, service of the EGR system at the time of the replacement turbo installation.

- Old gasket remnants are also a common cause of foreign object impact damage. On rare occasions, Injector or Glow Plug tips can also result in this type of damage.

- COMPLETELY AND CAREFULLY service the entire EGR system, including replacement of the EGR valve mechanism, if it is not possible to get the valve spotlessly clean. This includes all EGR exhaust gas passageways and must be done after removing the failed turbo and BEFORE installing the replacement turbo. A high-quality solvent and high pressure compressed air should be used where necessary to achieve satisfactory results.
