Why does oil contamination damage turbos?

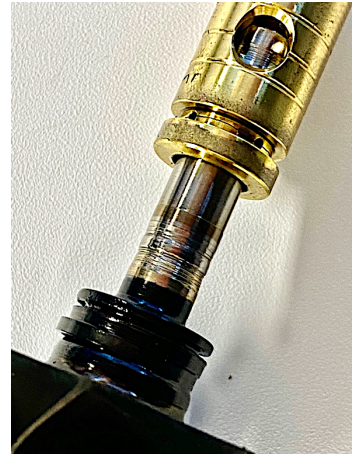
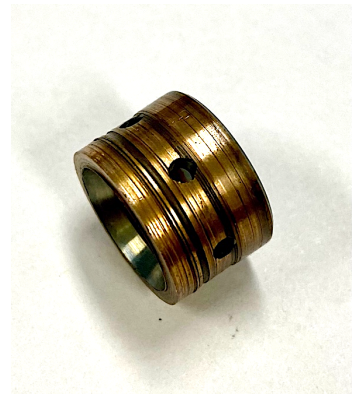
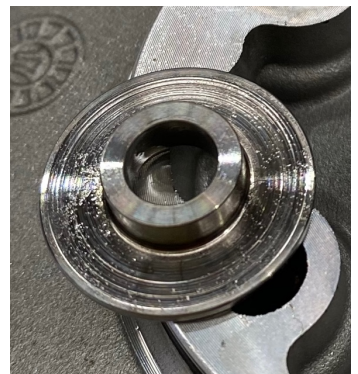
If either the internal or external hydrostatic oil film is broken by fine contaminant material in the oil supplied from the engine, the fully floating bronze bush will fail, leading to the eventual total destruction of the turbocharger.

The above situation is the reason the turbocharger's shaft support bush will fail as a consequence of oil contamination, long before the engine's main crankshaft bearings.

Before installing a new turbo, always determine and correct the issue which caused the original turbo to fail, or the replacement turbo will almost certainly fail for the same reason.

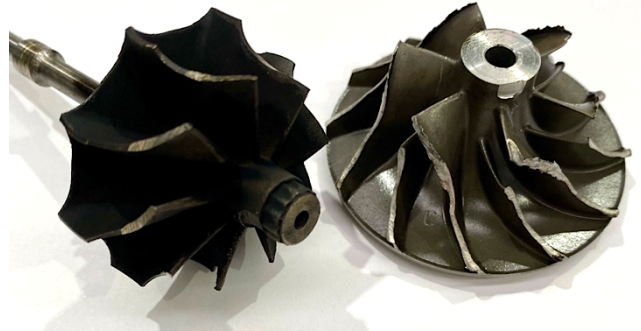
- High carbon build-up inside the engine. This **WILL** contaminate even new clean oil, changed at the time of turbo replacement. This carbon can be present in either or both of the following locations.
 - 1) Internal surface of the oil supply line from engine to turbocharger.
 - 2) Internal surfaces of the sump / main oil pickup.
- Oil degradation due to high ambient temperature operation and /or oil change intervals beyond 5,000 KMs.
- Poor quality Oil Filter
- Malfunctioning oil filter Bypass Valve
- Contamination of new oil during filling.
- Engine wear, leaving swarf deposits throughout the engine internals.

- Replace the Oil Supply Line to the turbocharger, as a used component is essentially impossible to clean. Normally the oil supply lines are 3-4 mm ID and the baked, carbonized oil attached to the internal line surfaces, (particularly around any bends), cannot be 100% successfully removed by any normal cleaning process.
- Remove the sump and main oil pickup and thoroughly clean both. Unfortunately, there is no way to reliably clean these components without removal.
- Use only the highest quality oil and filter and change both every 5,000 KM.
- Take extreme care to avoid dirt/dust contamination during the filling of the new clean oil.
