Why does oil starvation damage turbos?

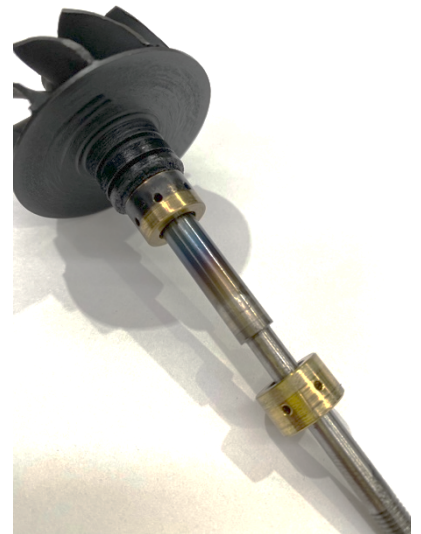
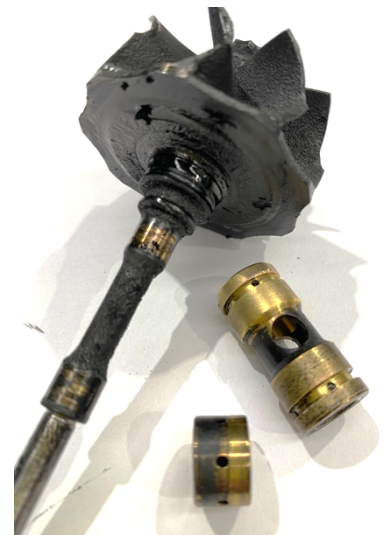
If there is either insufficient pressure and/or volume of the oil supplied from the engine, the fully floating bronze bush will fail, leading to the eventual total destruction of the turbocharger.

The above situation is the reason the turbocharger's shaft support bush will fail as a consequence of oil starvation, long before the engine's main crankshaft bearings.

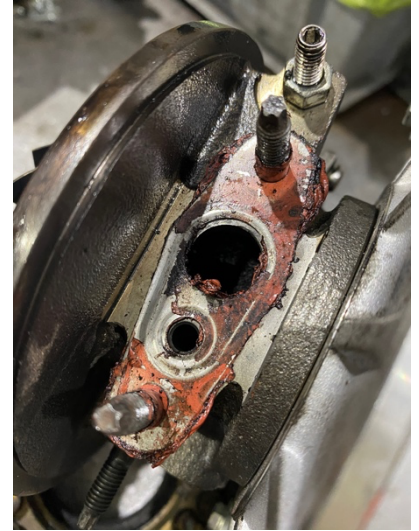
- High carbon build-up inside the internal surface of the oil supply line from engine to turbocharger.
- Bent or kinked oil supply line from engine to turbocharger.
- Failure to prime the replacement turbo with oil, prior to initial engine start.
- Failure to prime the oil supply line between the engine and turbo.
- Blockage caused by using silicone sealer on the oil inlet tube flange.
- Blocked, damaged or poor-quality oil filter
- Low engine oil level in the sump
