WHO KILLED THE COVER?

A GUIDE FOR COMMON COVER ISSUES

PLASTIPACK LIMITEDTM
© Plastipack Ltd

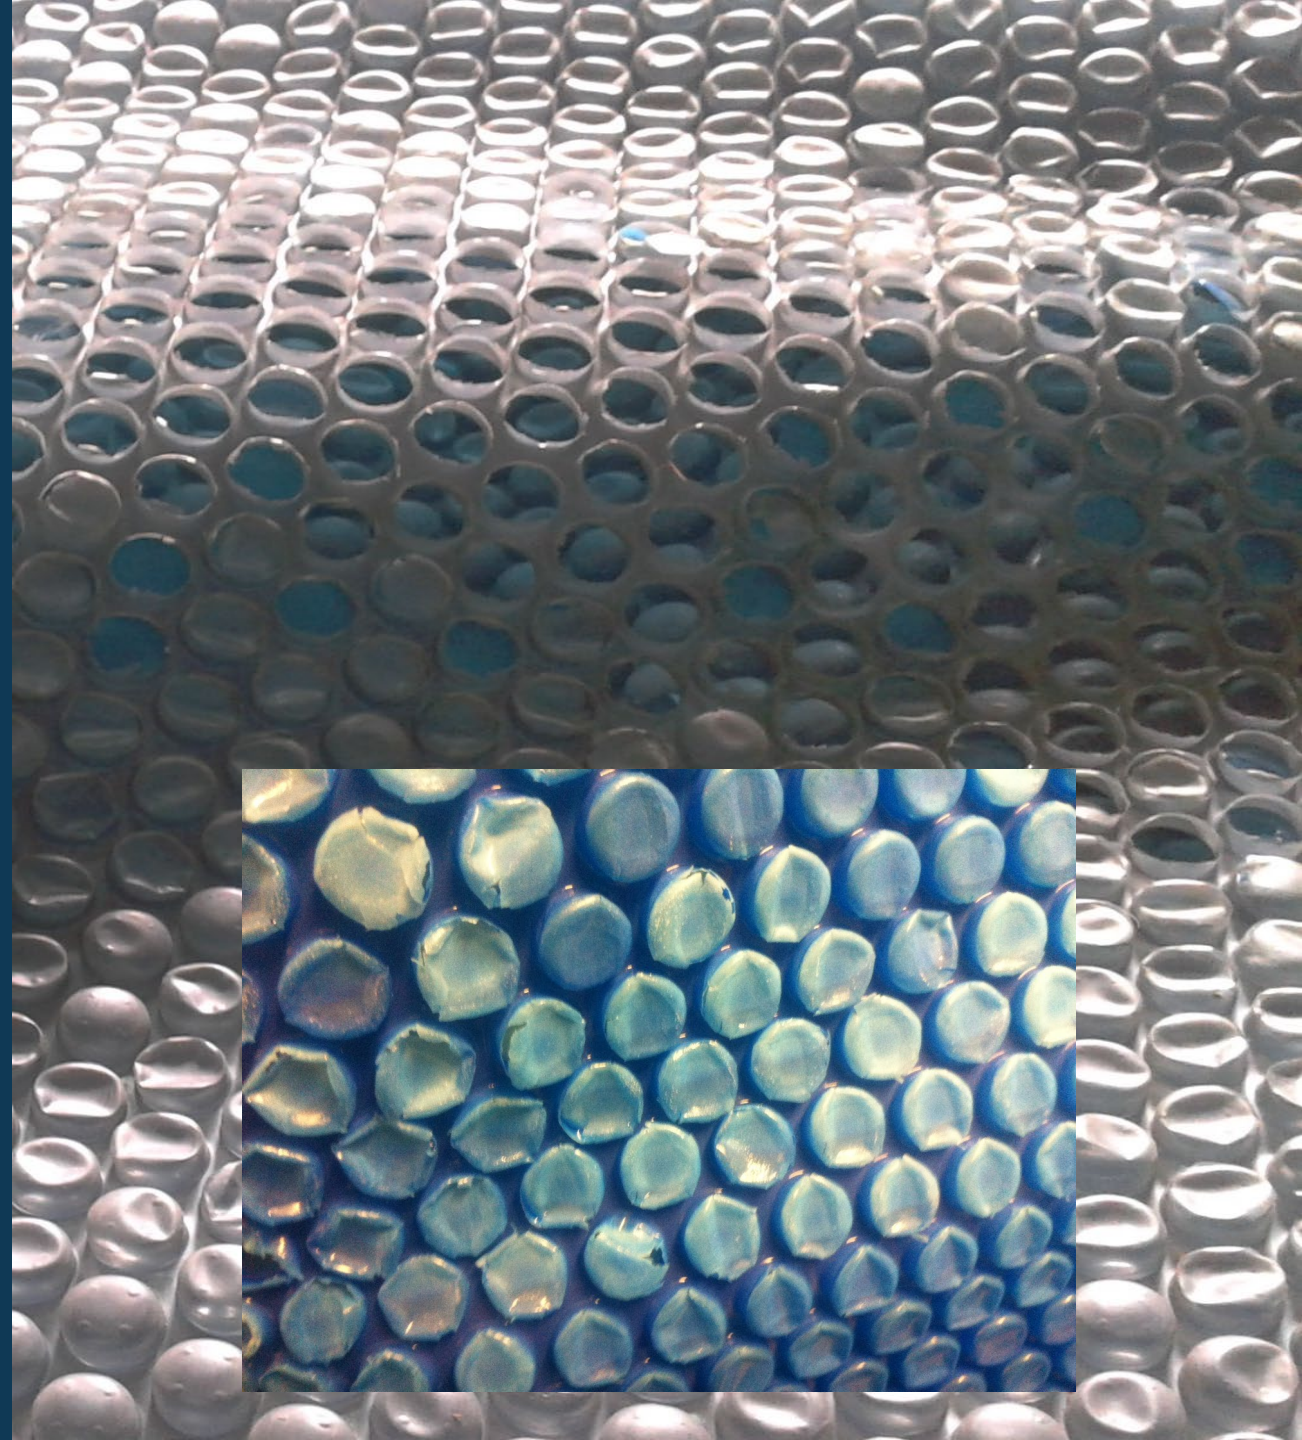
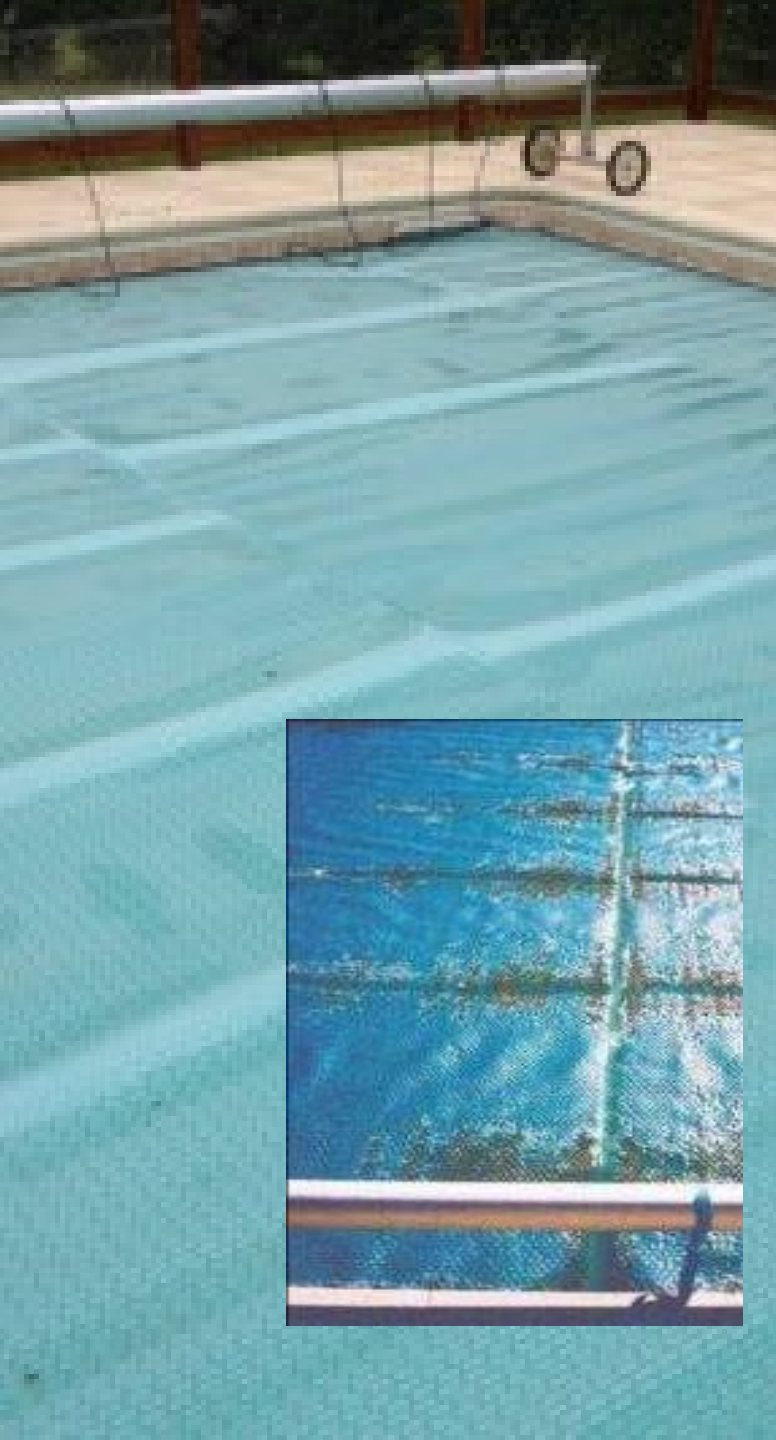
Chemical Degradation

Most issues involving premature degradation are the result of elevated chemical levels within the pool.

Frequently, a sudden deterioration of the cover can be the result of a shock treatment.

Noticeable effects:

- Bleaching of the underside of the cover.
- Bleaching of the hemming/edge.
- Material has turned brittle - in particular on the bubble layer.
- High residue amounts on the cover.
- Oxidation of eyelets.
- Strong chlorine smell

A cover should always be removed when shock dosing and when the chemicals come out of balance.

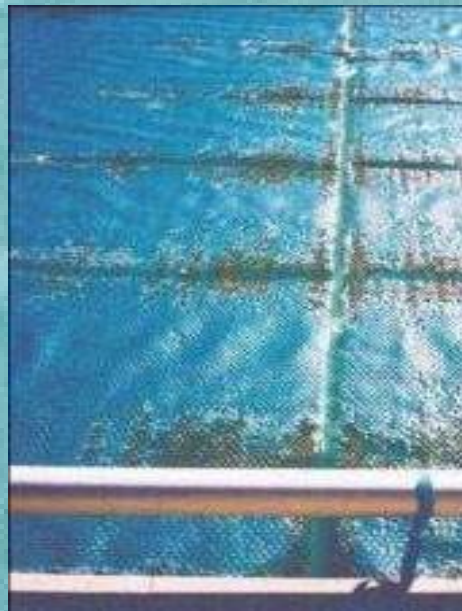
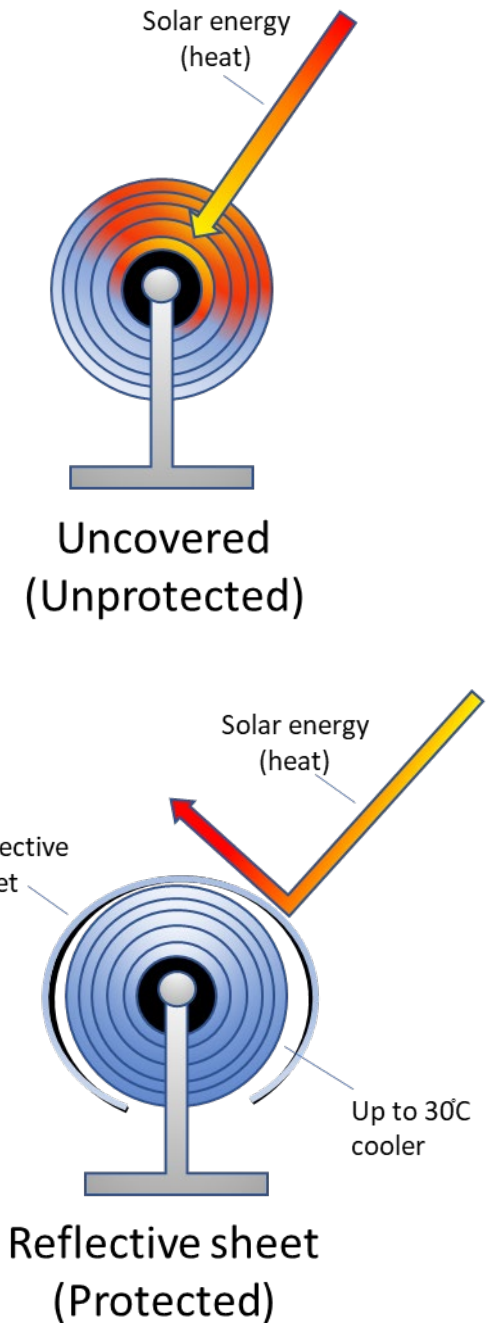
Overheating on the Reel System

A common issue of improper storage can be identified by the bands of warping occurring across the pool.

Usually, these bands increase in frequency as they get closer to the reel system, or the folding edges when fan folded. This occurs when the cover is stored in direct sunlight for a prolonged period of time.

Bubble Covers (solar Blankets) are designed to heat the water and insulate the pool to keep the heat in. When exposed on the reel system, this results in a rapid elevation in temperature at the centre of the roll. Tests conducted found temperatures of up to 175°F .

PE (polyethylene) is a thermoplastic which means it becomes malleable as the cover reaches its Vicat softening point. As the cover cools, the material sets to the shape of the reel and results in warping and doesn't lay flat.

In extreme cases the covers can even oxidise or weld the layers of material together.

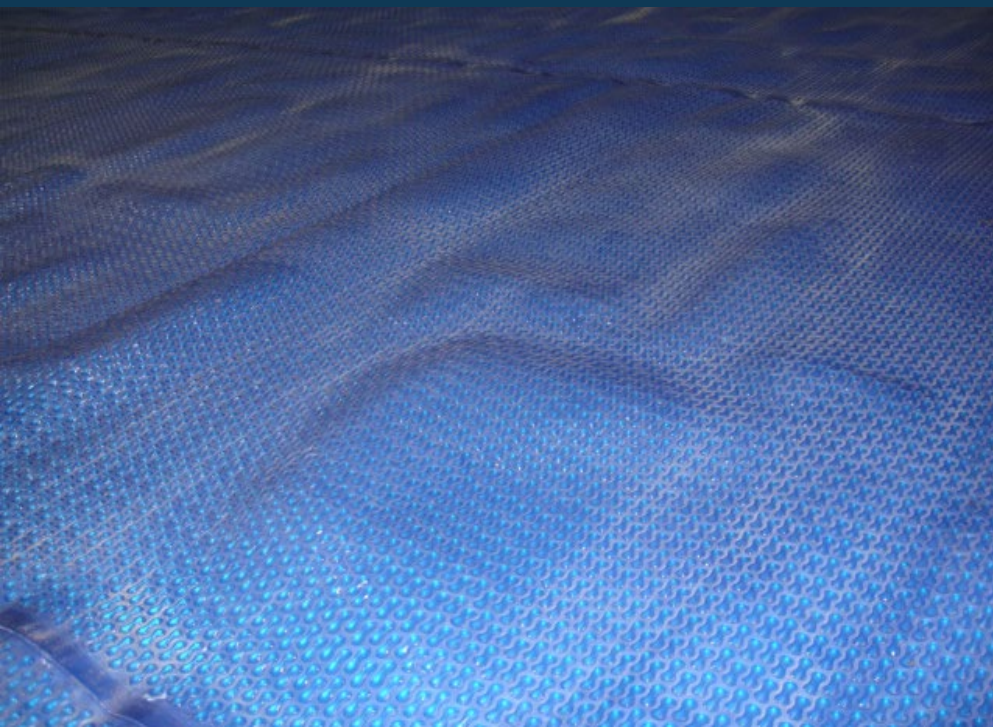
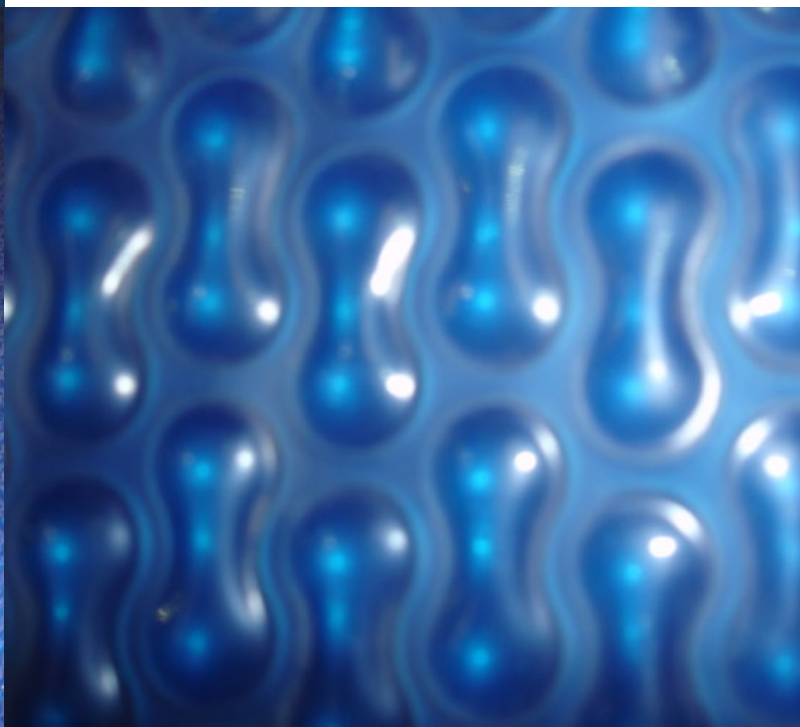
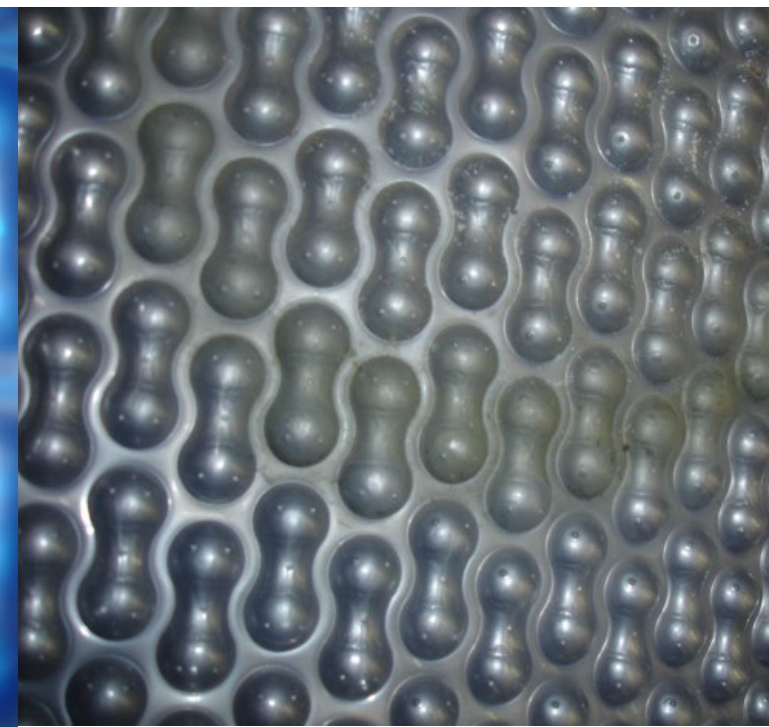
Bubble Expansion

Bubble swell is a rare cause for complaint and is often mistaken for shrinkage.

Although it is not entirely clear what exact conditions produce this effect, key factors seem to be atmospheric pressure, pool temperature and chemical levels.

Features may include:

- The bubble will resist compression.
- The cover material will have the appearance of lumps in random patches of the cover.

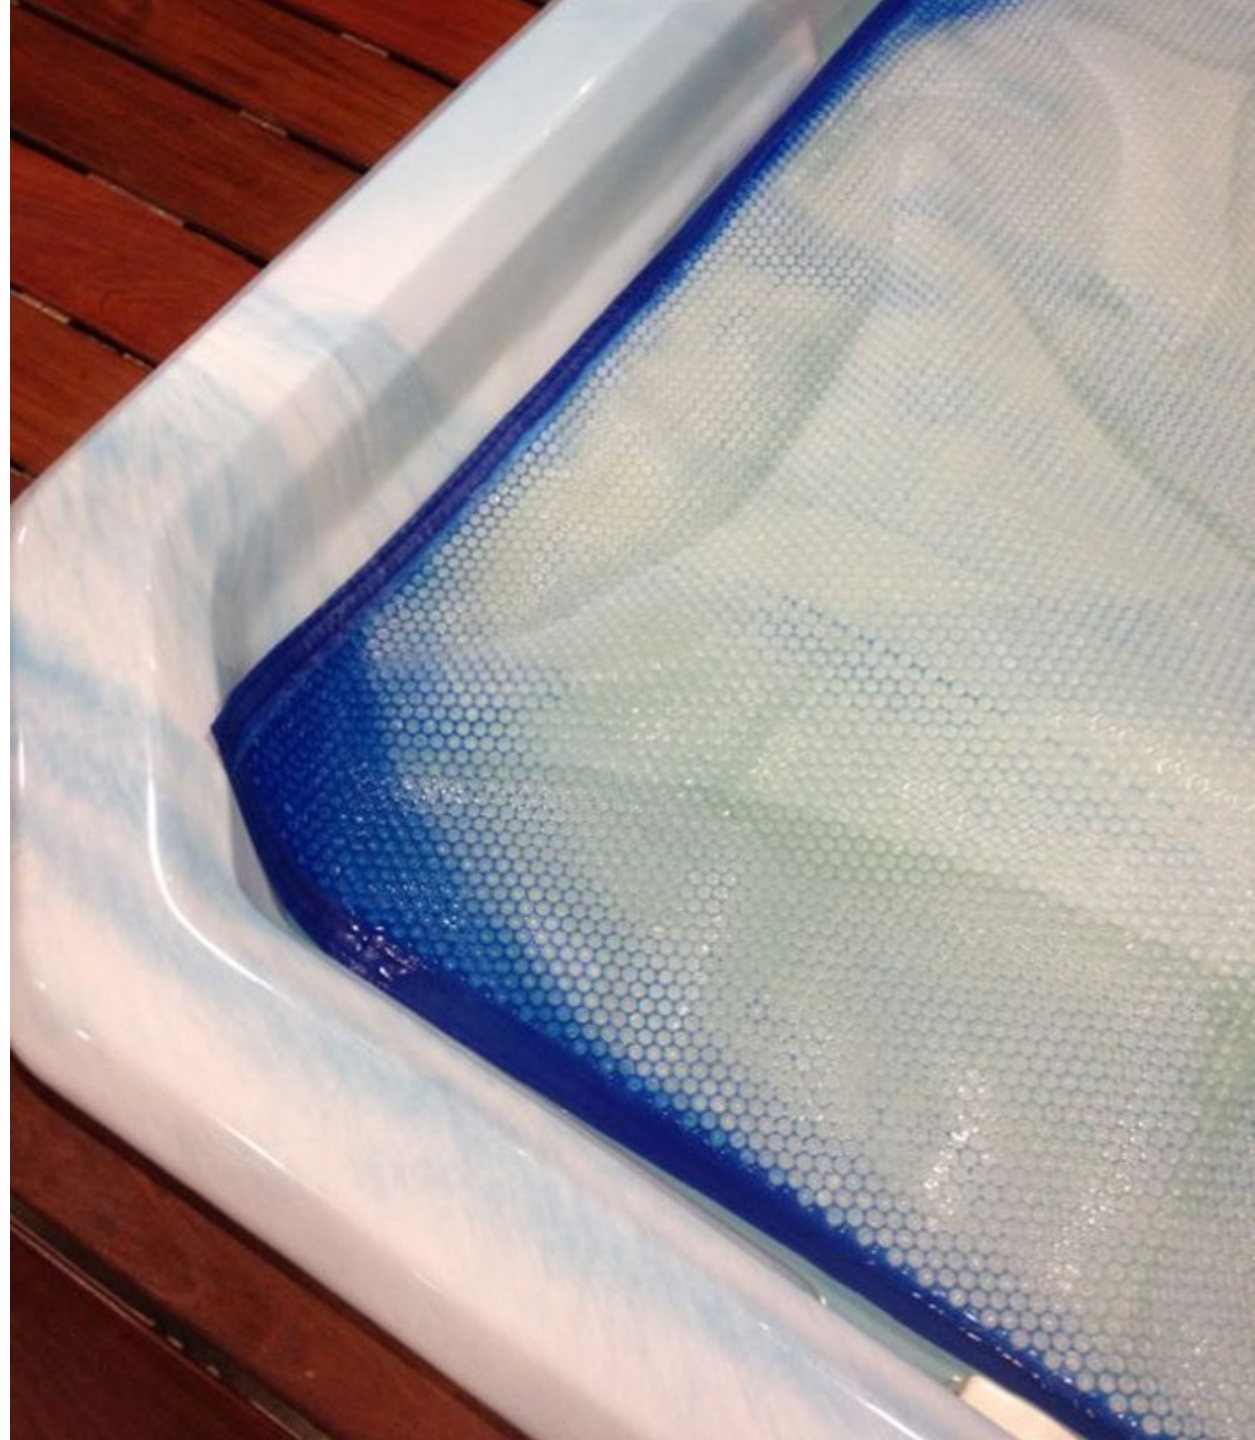
Bleached pigment

When a cover has been bleached, this is the result of high chemical level and is often associated with high temperatures such as on a hot tub.

The first indication of chemical degradation will be the bubbles on the underside of the cover.

Bleaching of the cover will normally be noticed once the bubble layer has started to become brittle and crack easily.

In extreme cases (like in the image) the cover has been used on a hot tub and the combination of high chemical levels and higher temperatures have resulted in a dramatic change in the covers appearance and properties.

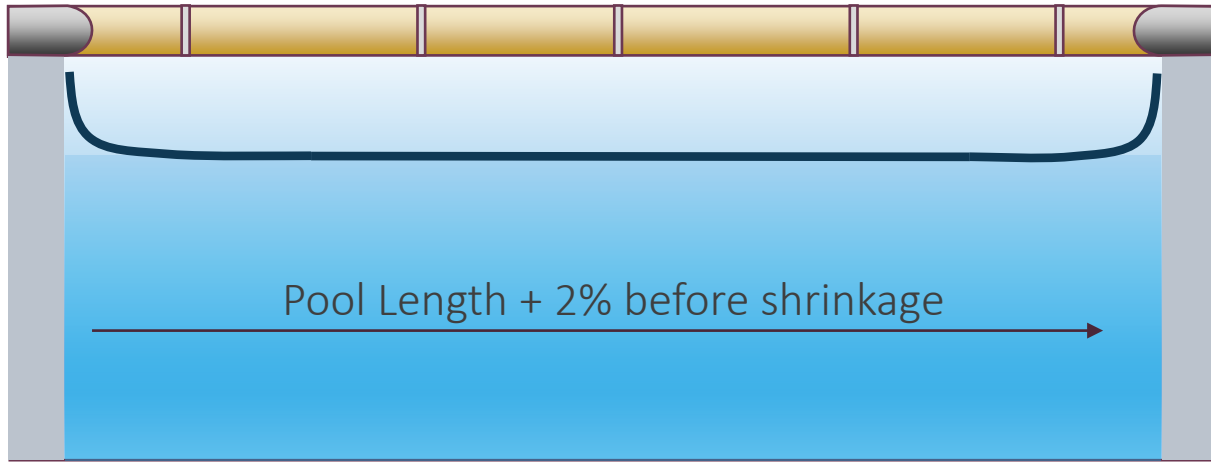
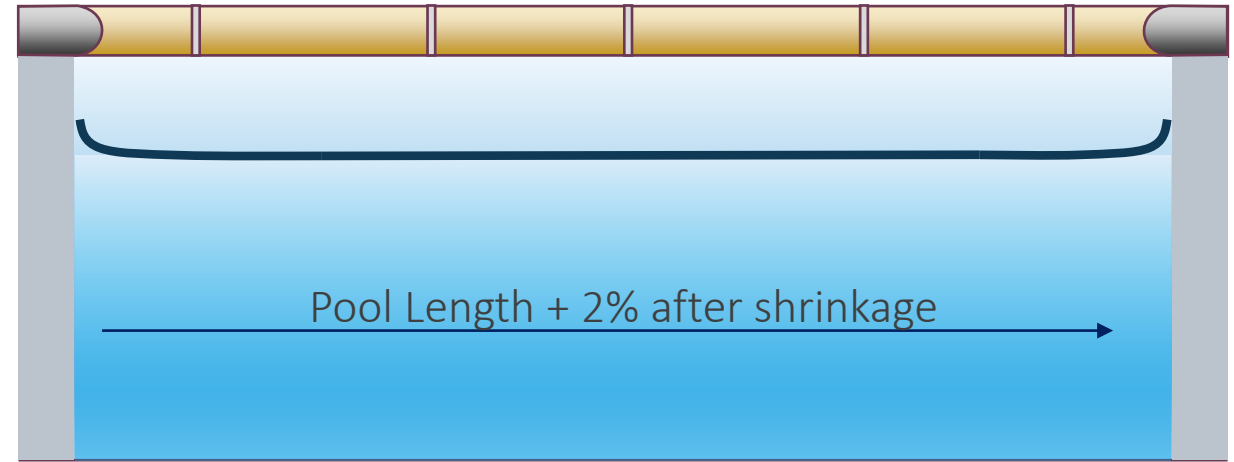
Shrinking Cover

Shrinkage of the cover can happen and is usually exaggerated by bubble swell.

Shrinkage is the result of the polymer in the material releasing stress as it gains molecular mobility.

As the material heats up the polymer gains the ability to release any stresses held within the material.

It has become a common part of industry's best practice to oversize the cover by 2% in its length to allow for a small amount of shrinkage as the cover settles on the pool.

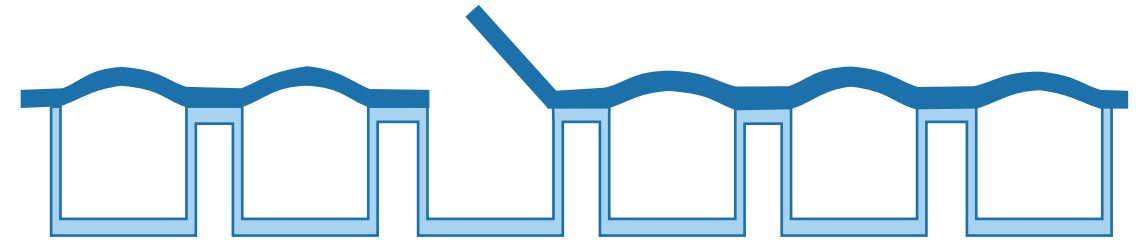
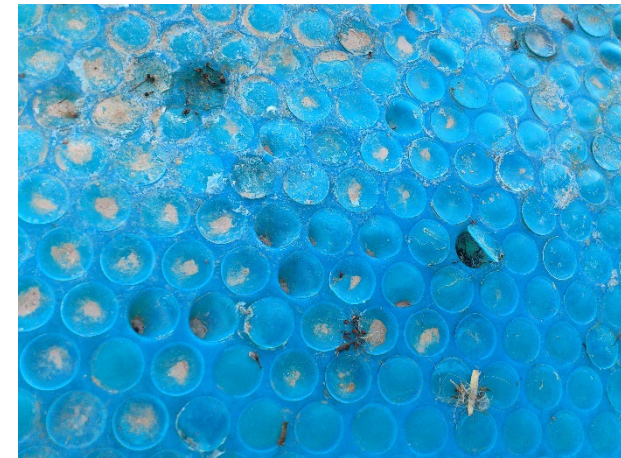
Top Hattting

Top hatting is where the flat top surface of the cover starts to come away from the material around the bubble profile.

Top hatting usually occurs as the cover starts to degrade either chemically or from UV as they reach the end of their lifespan.

However, this issue can also present itself from overheating. As discussed in the section “Overheating on the Reel System”, a cover could reach up to 175°F, which could cause permanent damage to the cover, even an issue such as top hatting.

This is most often seen in materials with a dark/opaque top surface.

With a well monitored chemical regime and appropriate storage provisions, this can be prevented.

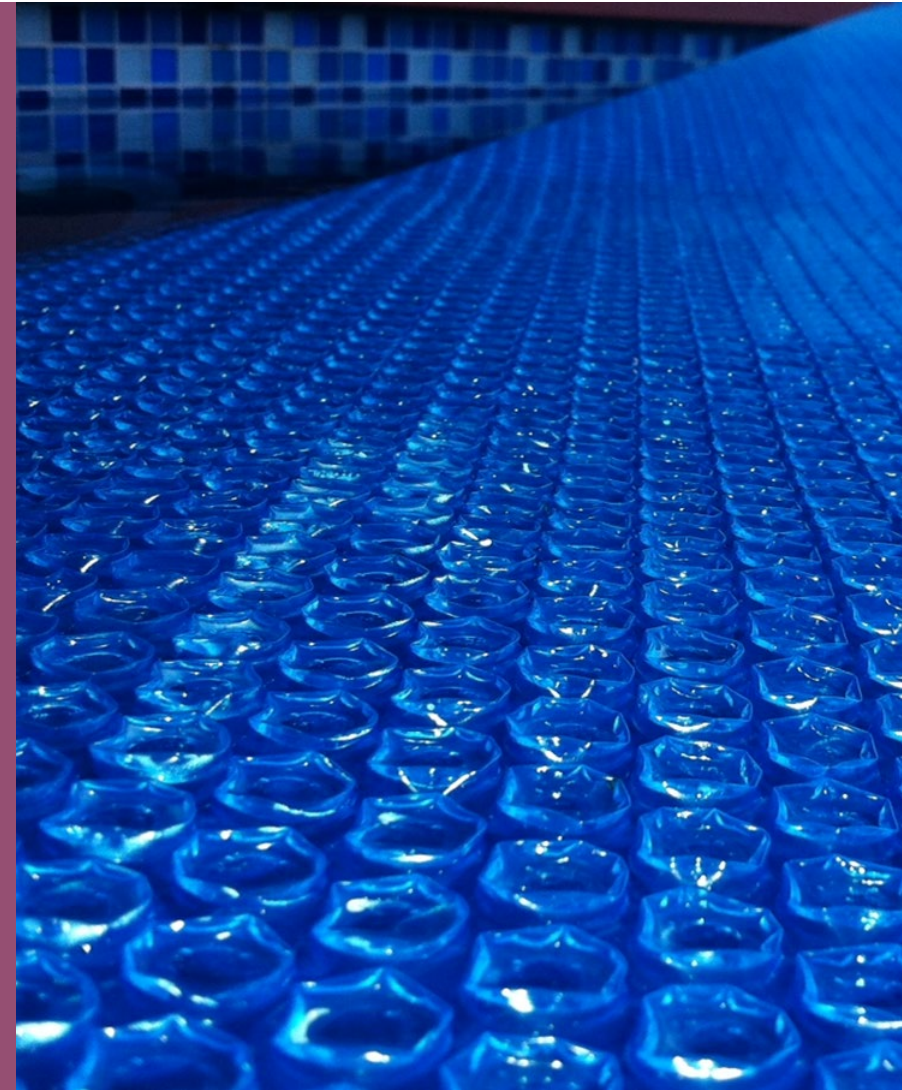
Bubble Collapse

The Bubbles on the under side of the cover deflate. Most commonly seen in 12mm materials as in the picture to the right.

This effect is very rare and can be caused by the build up of Nitrogen trichloride (NCl_3) which is one of the chloramines produced by the reaction of Hypochlorous acid (HOCl) and Ammonia (NH_3), derivatives in the warm water.

This is often an indication of a building in TDS (total dissolved solids) and CC (Combined Chlorine.)

The pool chemistry can be returned to balance by removing the cover and performing a break point chlorination or draining a portion of the loaded water with fresh.

Unfortunately, once this has occurred the bubbles will not return to their previous state, but actions taken to correct the issue will prevent this happen to a replacement cover.

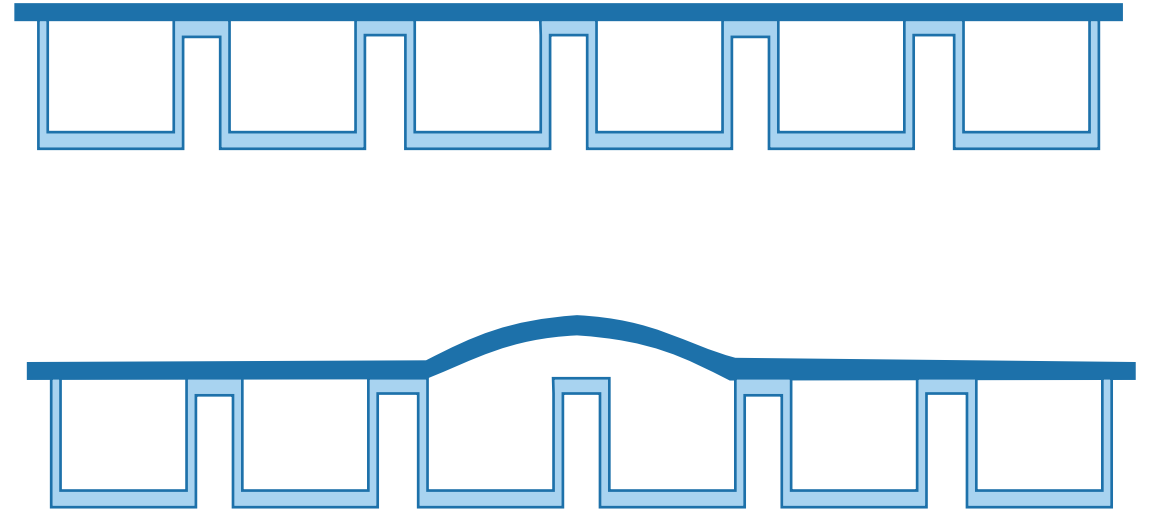
Delamination is incredibly rare and most often is the result of the cover overheating when being stored off the pool.

When folded or left on a reel system exposed, the material quickly heats up and causes the air within the bubbles to expand.

In extremely rare cases, this can result in the air expansion forcing the layers of material at the land area of the bubble separating.

This can be avoided with the implementation of a reflective storage sheet.

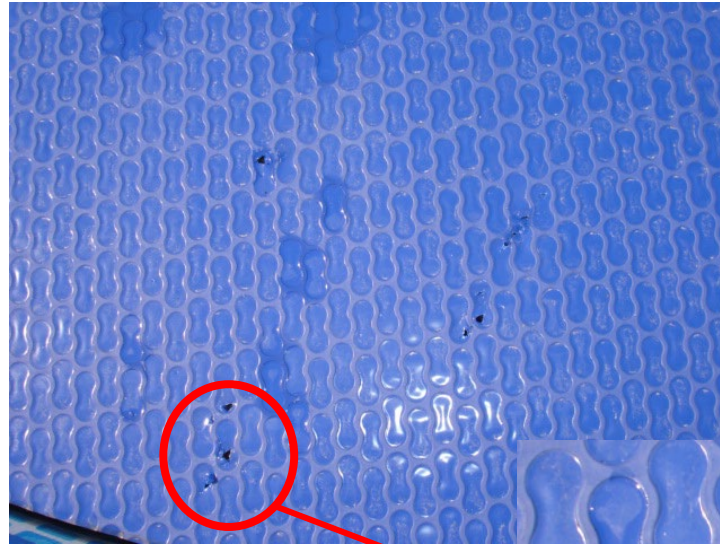
Herring Gull attack!

Bird Pecks

This is more common than would be imagined. Small groups of punctured or torn holes are often caused by birds.

We have found that a few CD's hanging from a string will cause reflections that discourage the birds from lingering around the pools.

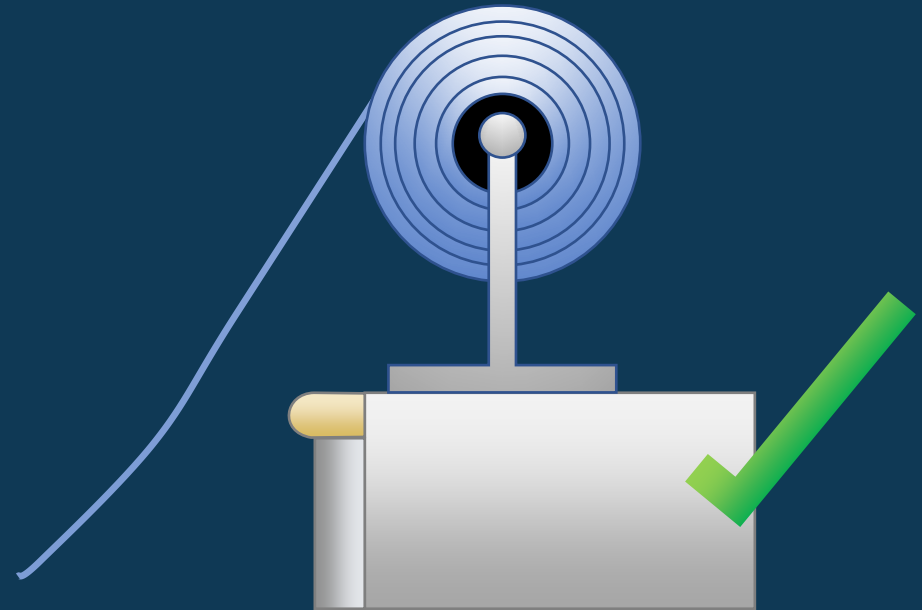
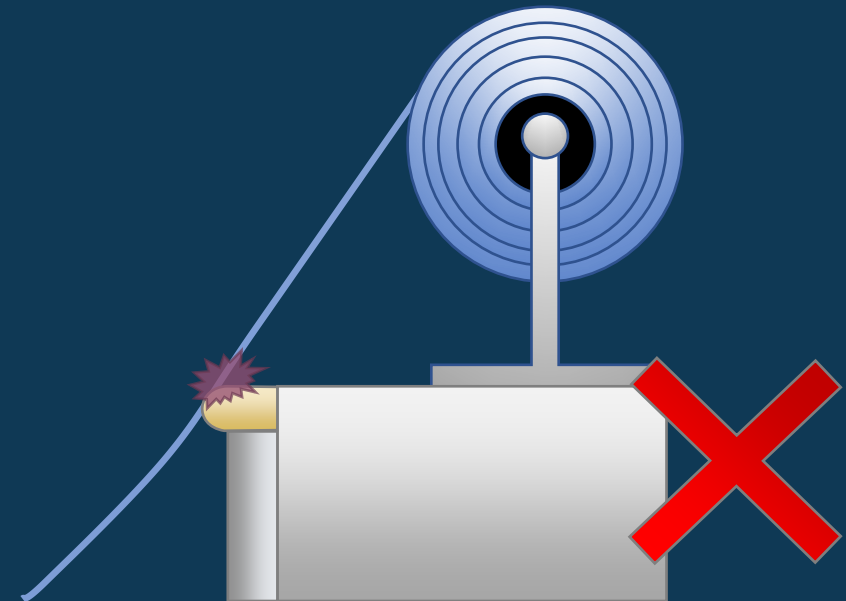
Water incursion into bubbles

Usually, the most noticeable sign that a bubble or bubbles across the cover have ruptured is the propagation of algae or the build-up of debris within the bubble.

A common cause, usually produced when a reel system is set too far back from the pool or the cover is removed by hand is a scuffing of the underside of the bubble. This causes a rupture through abrasion on rough surfaces and edges.

This is simple to identify by turning the cover over in the affected area and pressing down on the bubble. As the pressure builds, you will see bubbles or water ejecting from the affected area.

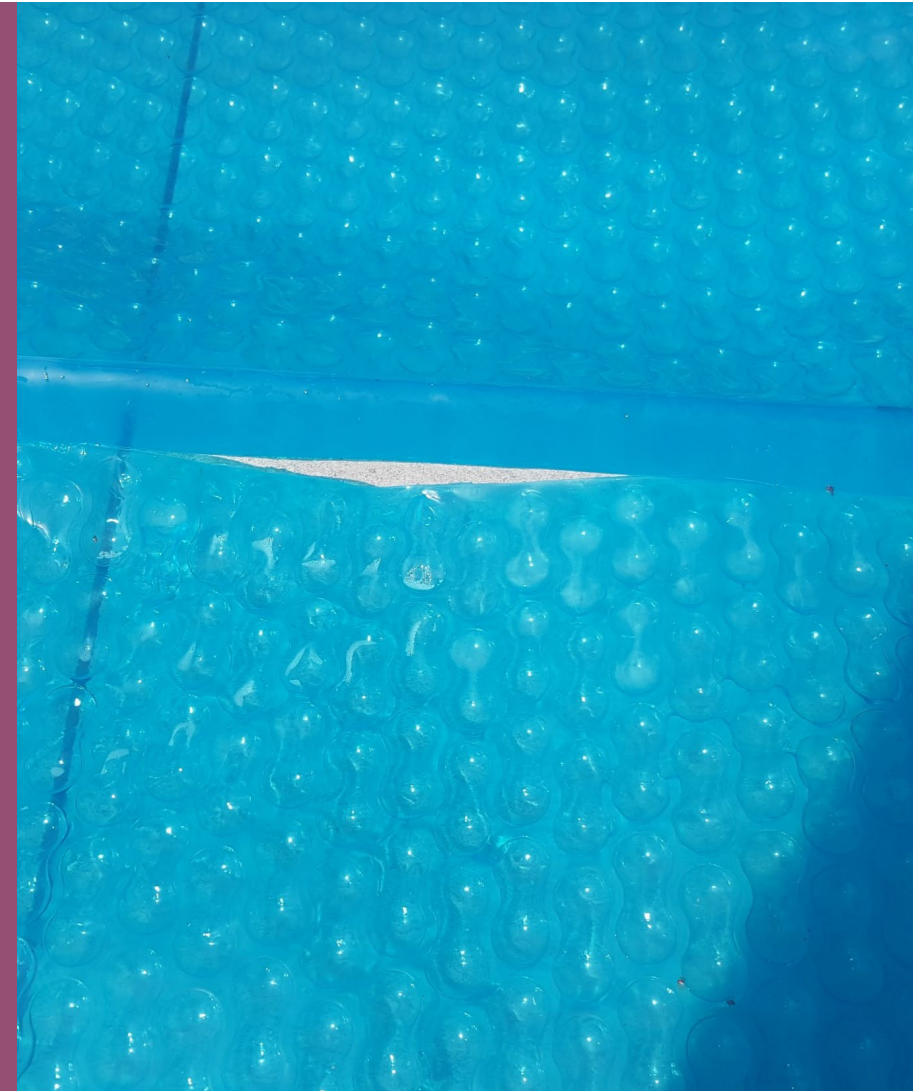
Splits at the weld edge

A score line appears as a fine split next to the weld edge that shows no sign of polymer elongation.

Score lines are caused by damage to the material during welding. This can be due to:

- Residue build-up on the wedge of the hot wedge welder.
- Dirt picked up from the floor being trapped on the wedge or misalignment of the wedge.
- Too much compression from the pinch roller.

While there are tapes that can bond the materials together. This is not a permanent solution. If this occurs in the early days of the covers working life it is better to seek a replacement from the company who supplied the cover to you then attempt a repair.

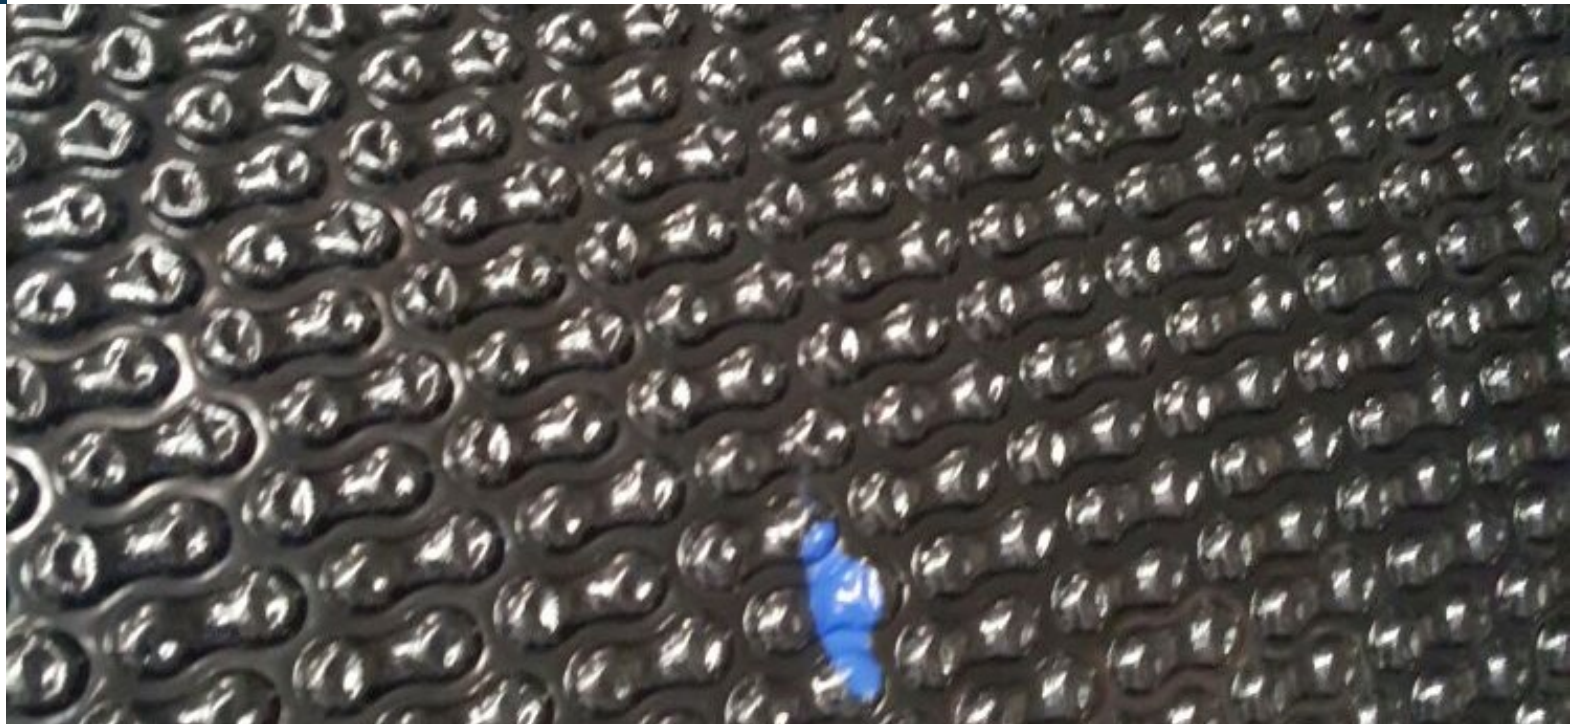
Lensing

Lensing is caused by a rupture in one of the material films during production.

This can be caused by a process known as “Gelling” from the polymers or from an un-melted or carbonized piece of polymer or debris, working its way through the production line.

This results in a tear shaped deformation in the bubble. Lensing can appear in both the top and bubble layer.

If you receive a roll with lensing that renders the material unusable, please do not hesitate to contact us.
