A Technical Review of the:
MG TC EXHAUST SYSTEM
by Doug Pelton

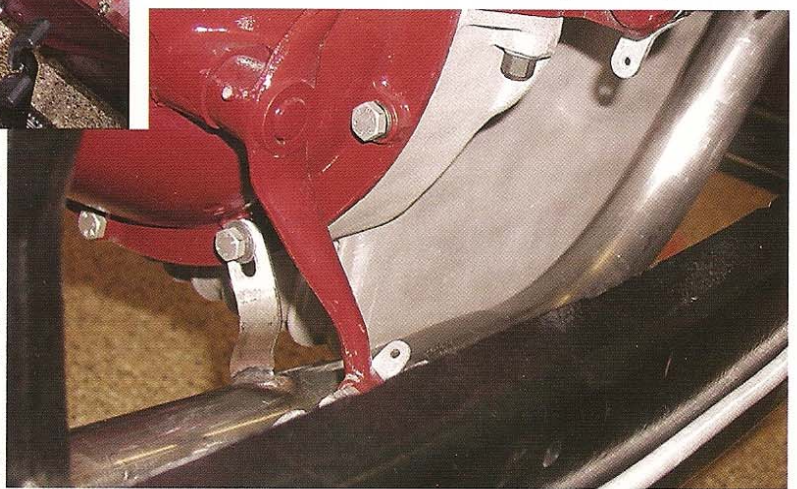
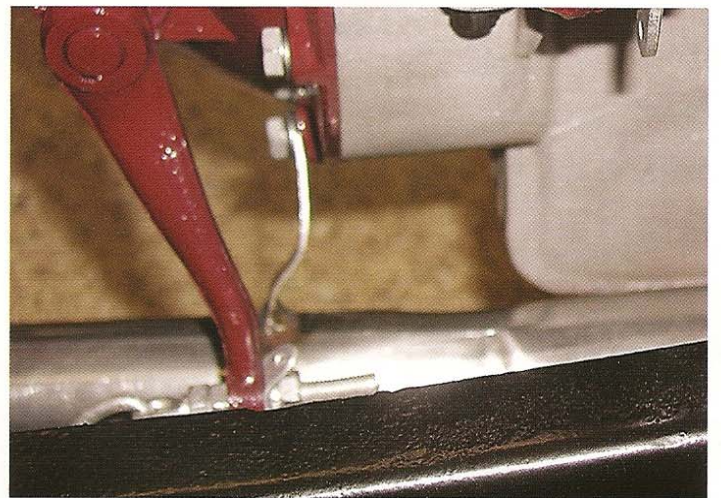
3. Bell housing bracket: The next point of attachment is the down pipe to the bell housing. This has also been a problem area in that it does not always connect to the bell housing. Originally, there was an additional bracket that has been lost, misplaced, or discarded. When the engine and gearbox was

installed at the factory, they had a metal tab bolted to 1 bolt on the bell housing (at the 5 o'clock position). It had 2 additional blank holes that were also elongated for adjustment. According to the original MG Midget Factory Specifications #259, there were 2 - 5/16 BSF x 5/8" bolts w/ flat and lock washers used to attach the welded tab on the down pipe to the bell housing bracket. Depending on the today's exhaust system manufacturer, the welded tab on the down pipe may or may not fit directly to the bell hous-

ing. If it does not, you can make a simple bell-housing bracket. Just use a piece of stock steel measuring 2 1/2" long x 3/4" wide x 1/8" thick. Drill a 5/16" hole for bell housing bolt and 1 or 2-3/8" holes for exhaust pipe bracket tab. There have been reports of some who have replaced or re-welded the down pipe tab with a longer one to get it to fit. Others have simply ignored this tab and never bolted it to anything, which has never really caused any other problems. This hand made bracket solves the bell housing connection problem.
