**TOP ASSEMBLY LEAKS (ALUMINUM SKIN) TROUBLE SHOOTING GUIDE
1968 TO PRESENT MODEL YEAR FOLDING TRAILERS**

**AMERICANA TOP ASSEMBLY
POTENTIAL LEAK LOCATIONS**

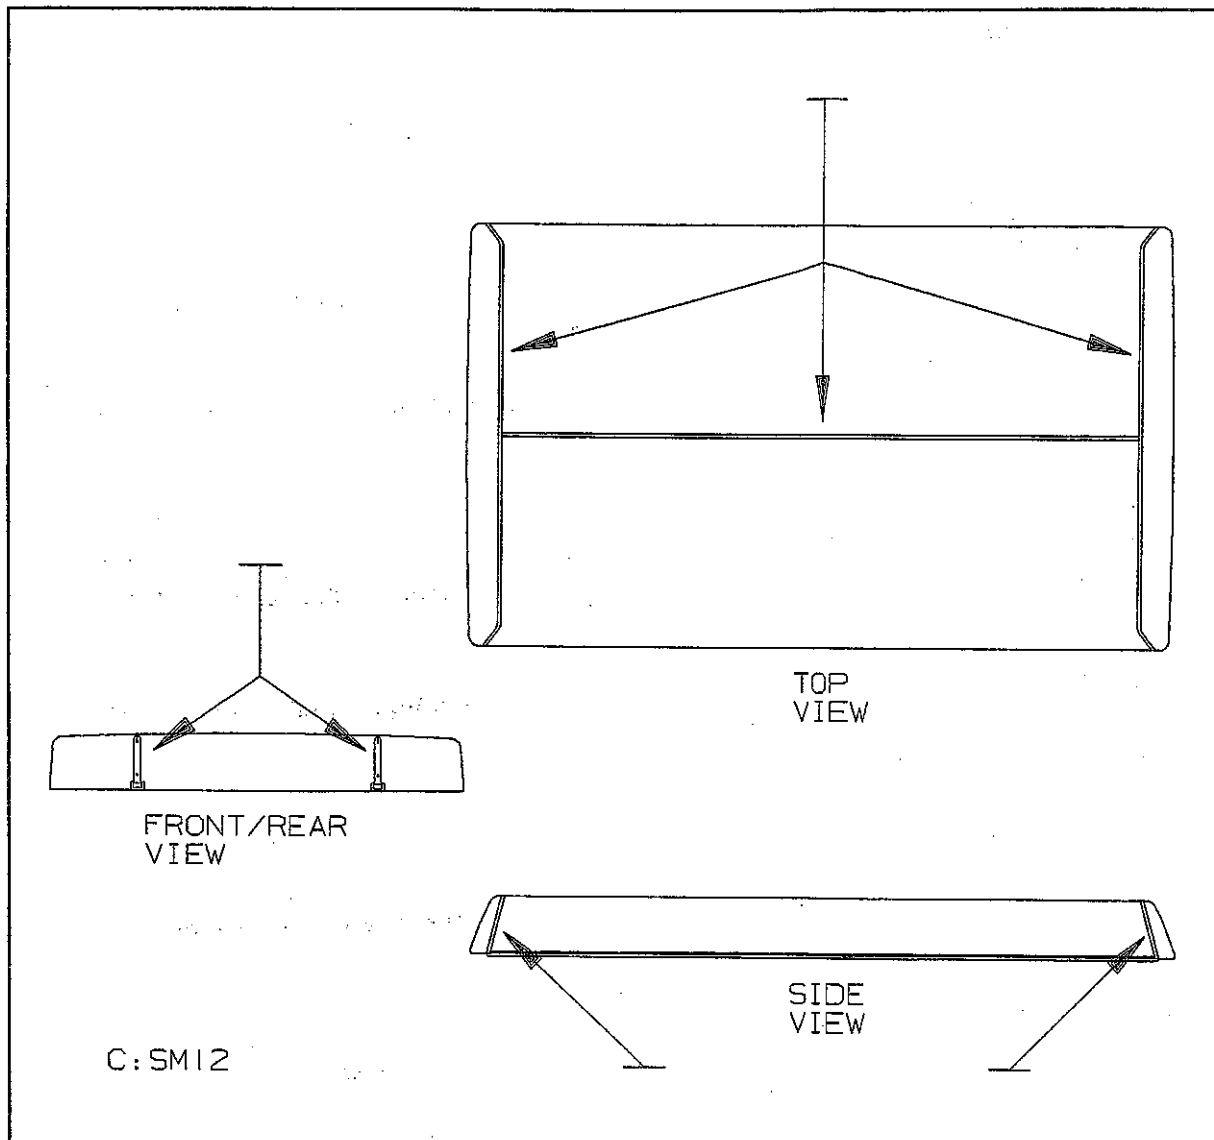
Water leaks around light fixture

Exterior center seam seal broken

Voided or cracked caulking around top corners and side rails

NOTE: When locating water leaks, it is important to isolate problem area to determine what factors (screws, seams, accessories, etc.) would contribute to top assembly developing a leak.

Remove center seam. Clean and seal top outer skin splice. Replace center seam (with new, if necessary).

Remove old caulking; recaulk damaged areas
