American Bonanza Society Air Safety Foundation

Flight Controls, Flaps and Trim System Inspection, Repair and Rigging Guide

For Beechcraft Bonanza, Debonair, Baron and Travel Air

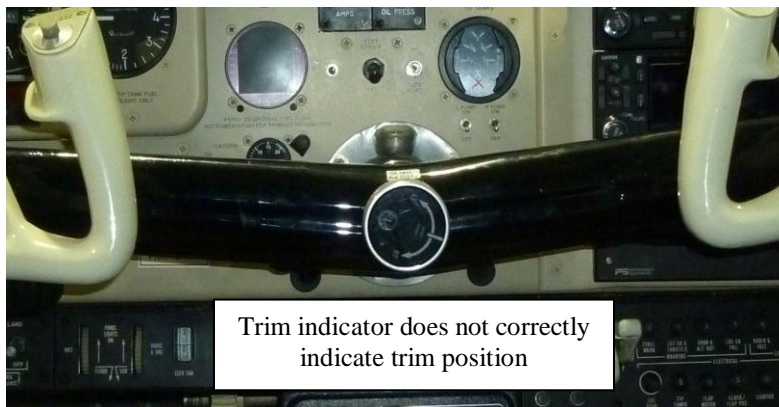
Discrepancy: Aileron trim indicates left or right when the control wheel is centered (Models 35; Be33; Be 36 except E-1946, E-2104, and E-2111 and after; Model 36TC except EA-320 and EA-389 and after).

1. Remove the indicator placard retaining ring with a scribe or “o” ring pick.
2. Reposition the indicator to 12 o’clock (trim centered) position.
3. Reinstall the retaining clip.

4. Check that the trim indicates correctly.

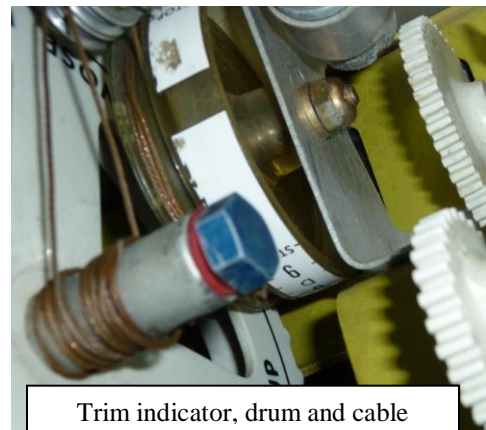
Trim indicator, drum and cable

Discrepancy: The elevator trim indicator drum cable is frayed or broken.

1. Set the elevator trim tabs to neutral.
2. Remove the trim indicator and cable.
3. Check that the indicator drum and indicator cable idler pulleys rotate freely on their shafts.
4. Apply a drop of lube on the shafts.
5. Install elevator trim indicator cables per instruction in the Beechcraft Shop and Maintenance Manual.
6. Set tension on the idler so the cable works correctly on the trim wheel.

Caution: The first sentence of the Beech Shop manual instruction on section 3 page 61 paragraph b. is incorrect. *You need to wrap cables a full turn in opposite directions.* The rest of the instructions are correct.

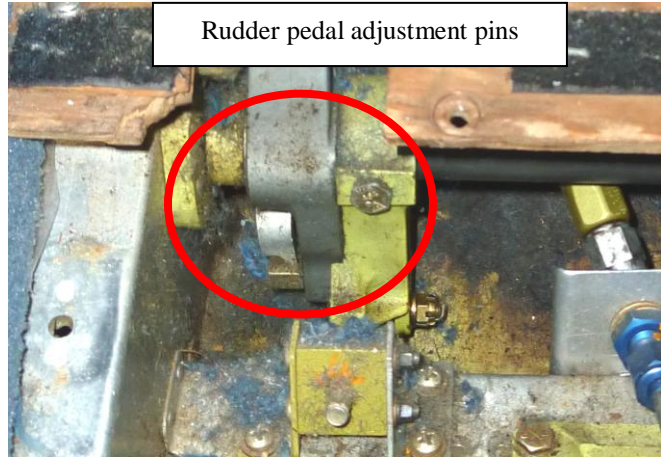
Rudder pedal adjustment pins

Tip: Frozen rudder adjustment pins are usually the result of corrosion.

1. Apply penetrant oil on the latch pin. Allow it to seep in to free up the pin.
2. If penetrant oil does not work, remove the latch pin lever. It is held on with a screw on the forward side of the pedal arm.
3. Gently rotate the latch pin with an open end wrench until it is free.
4. Clean and treat any corrosion.
5. Lubricate the pin and reassemble the latch.
6. Check for proper pin engagement.

Tip: Remove corrosion with a small round wire brush, or 220 wet/dry sandpaper taped around a small wooden dowel. Use a cotton swap to apply Alodine and Magnadyne, then (after completely drying) zinc chromate.

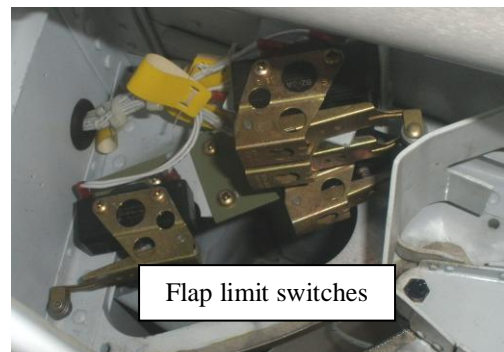
1. The flap motor limit switch is not turning off the motor prior to one or both flaps reaching the end of a flap track.

Tip: Flap limit switches are in the left flap well. The left flap is the master flap, and the right flap is a slave.

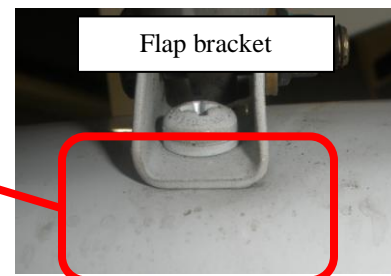
Discrepancy: The flap position indicator bounces during operation.

1. Check the flap transmitter in left wheel well.
 - a. The plastic sleeve on the transmitter arm becomes worn and often catches on the sheet metal tab.
 - b. Rotate the sleeve 90 to 180 degrees to a smooth area.
 - c. Check the operation of the indicator.

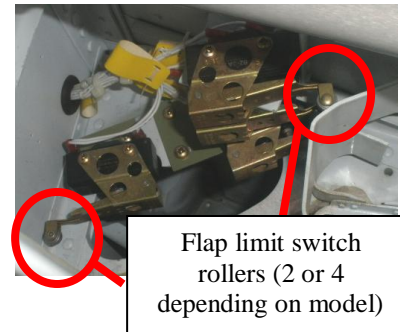
Flap limit switch rollers (2 or 4 depending on model)

Tip: Flap hunting normally happens in flight with an air load, but is sometimes seen when selecting the approach position on the ground. Periodically check rollers for freedom to roll, and frequently lubricate the rollers with LPS 1 to prevent bending the switch arms.

1. Check that the switch activator arms for the 11/14- and 12/16- degree position switches (the center two switches banked together) are not bent.
2. Straighten switch actuator or adjust switches for a 2 degree separation of flap travel as necessary.
3. Check that the rollers on the end of the switch arms are free to roll.
4. Lubricate the switches rollers with LPS 1.

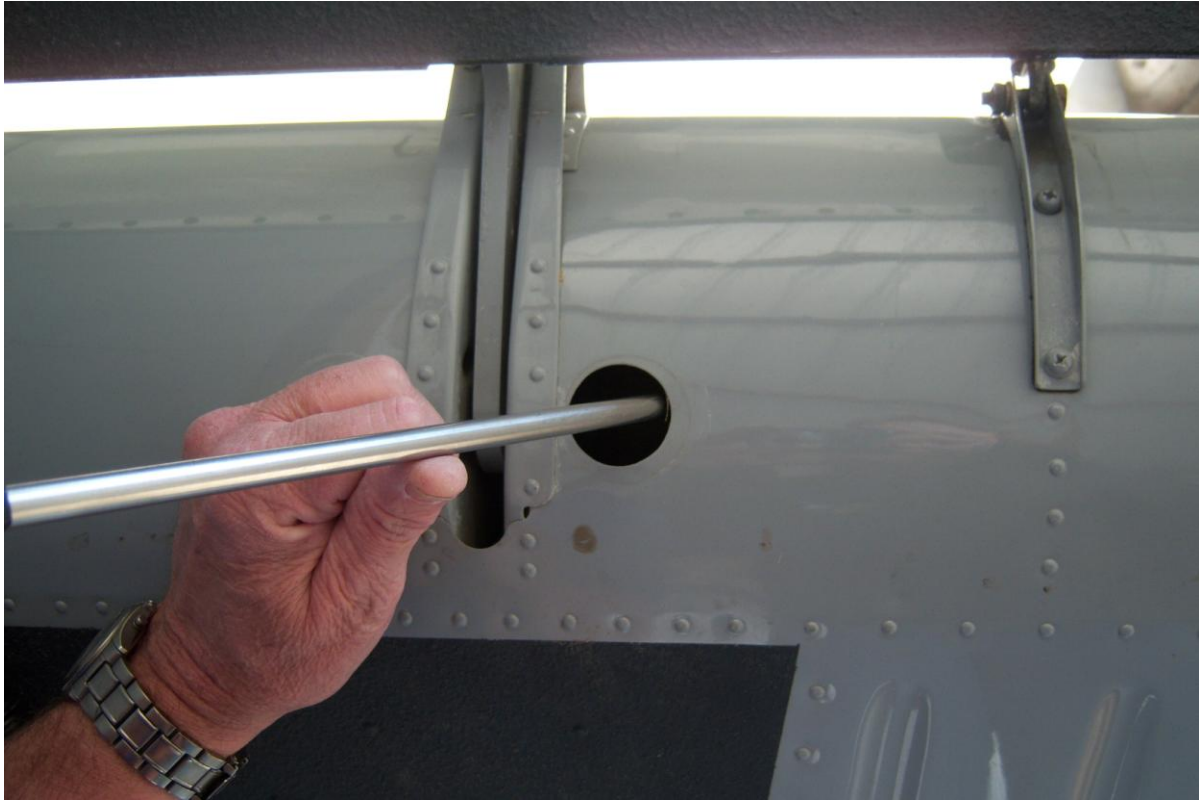
Discrepancy: There is crack damage to the nose rib assembly for the flap actuator attachment bracket.

AREA OF POTENTIAL CRACKS

EXAMPLE OF CRACK IN P/N 35-165050-84 NOSE RIB

EXAMPLE OF TORN FLANGE IN P/N 35-165050-84 WITH NUTPLATE MISSING

Address cracks in accordance with Hawker Beechcraft Safety Communiqué 313 rev. 1.

Tip: The leading rib can be inspected with a borescope by removing the Tinnerman plug at the inboard flap track. The leading edge rib will crack before the flap skin.

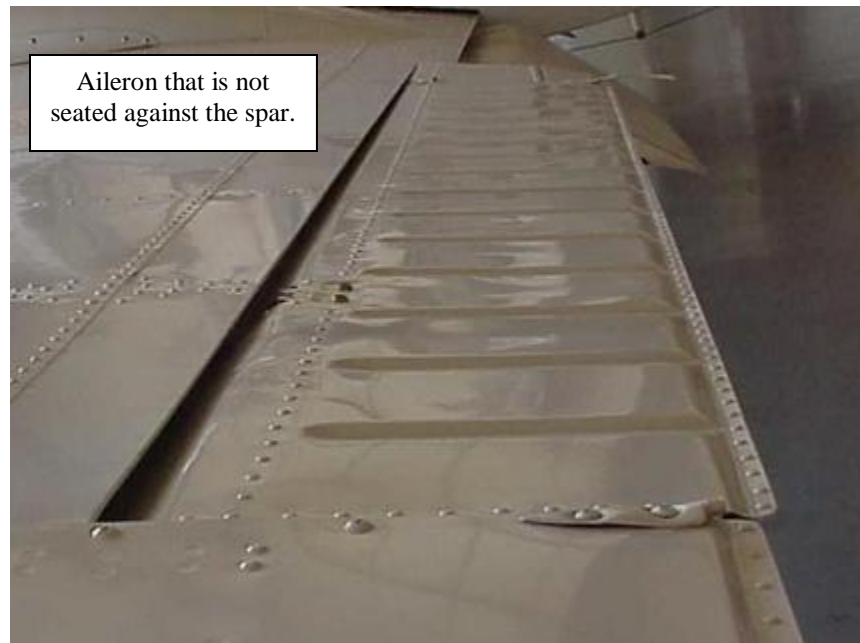
Tip: In most cases it's the aileron outboard hinge bracket lower attach flange that is discovered not seating against the spar. Since there is only a small load on the surface no damage occurs to the spar or bracket. The condition is more obvious seen from the trailing edge. The gap between the trailing edge skin and aileron will be considerably wider towards the unattached bracket when this condition occurs.

1. Remove screws on the unattached side of bracket.
2. Seat the hinge bracket against the spar.
3. Reinstall the screws.

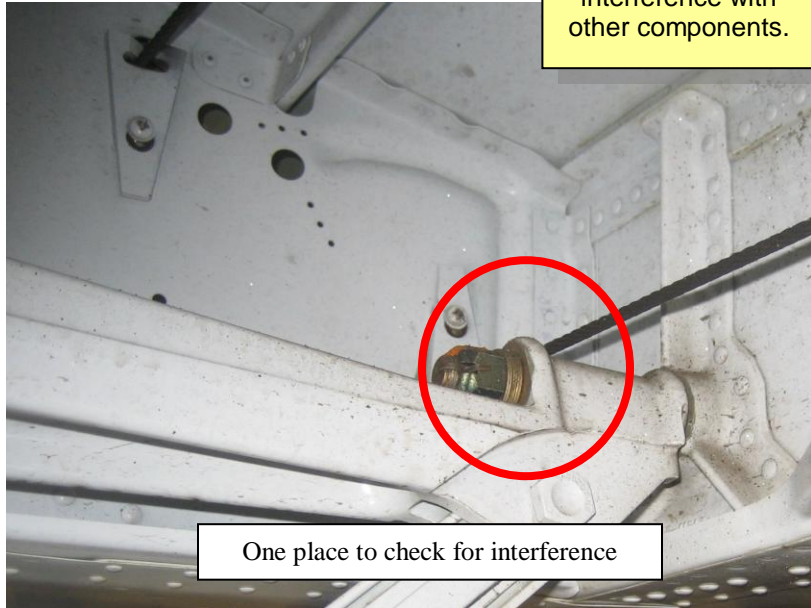
Check the aileron cable routing and fairlead condition in the main landing gear wheel wells for interference that may lead to cable wear.

One place to check for interference

1. Loosen the cable fairlead attach screw.
2. Adjust the cable fairlead to redirect the control cable and provide the needed clearance.
3. Retighten the attach screw.

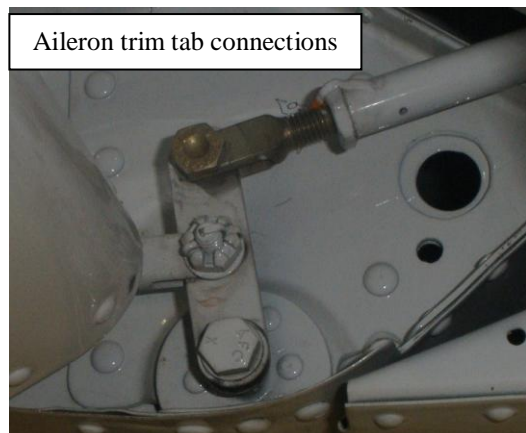
Aileron trim tab connections

Discrepancy: There is excessive vertical play at the trailing edge of the trim tab.

1. Measure the amount of play in the system using the Beechcraft device as described in the Beech Maintenance Manual.
2. Alternately, use a dial indicator clamped to tab's trailing edge, and a push-pull scale to accurately apply 3 pounds of pressure to tab.
3. Aileron trim actuator end play can be adjusted:
 - a. Loosen the jamb nut on the end of the actuator.
 - b. Slightly tighten the screw (a very coarse adjustment).
 - c. Tighten the jamb nut and check for binding.

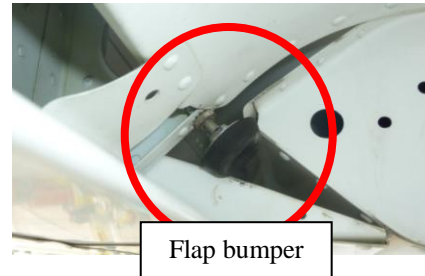
Discrepancy: A flap bumper is loose or a bumper nut plate is broken.

1. Remove the aileron for easier access.
2. Loosen the bumper from the broken nut plate.
3. Remove the bumper and mounting screw.
4. Drill out the solid rivets.

Tip: Because of restricted access, bucking a solid rivet is very difficult. We suggest installing a washer with a lock washer under the flap bumper jamb nut.

5. Install a new nut plate using countersunk nut plate P/N CCR244SS-3-02 blind rivets.
6. Adjust the flap bumper to supply a light preload on the flap.
7. Reinstall the aileron and check operation.

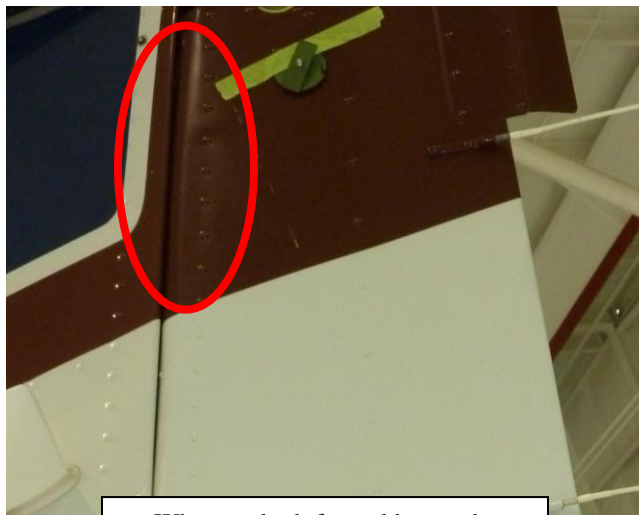
Where to look for rudder cracks

Tip: Check for cracks developing on the skin from any rivet location with a preload on the skin. If caught early, a small stop drill hole 1/8 inch from the end of the crack can arrest the crack progression. Cracks normally run parallel with the rivet line along the spar. Often a small crack is undetected and travels quickly with oil canning of the skin.
