Troubleshooting Factory Wiring Issues for Ignition Coil Upgrades - R32 GTR

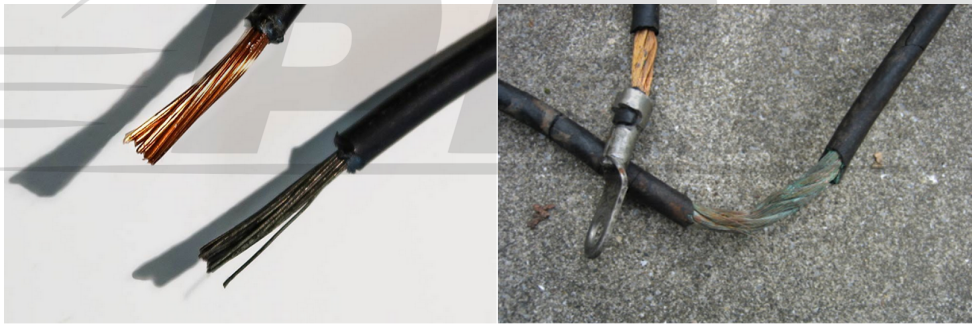
Obvious signs of wire degradation are darkened black copper strands and extreme corrosion signs are green strands with chalky residue with cracked/split/melted insulation.

Unfortunately, these wires cannot be repaired, they must be replaced. Not replacing effected wires may result in numerous electrical gremlins (faults) that may seem very intermittent or random and hard to pinpoint.

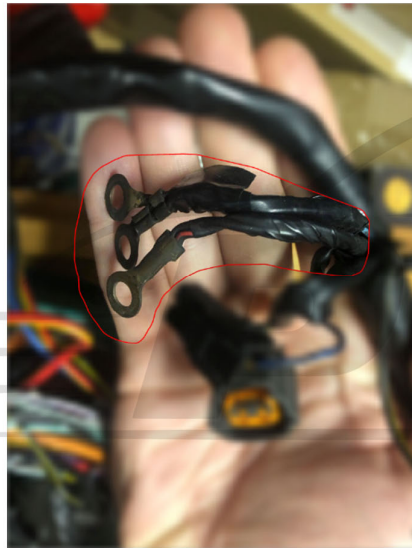
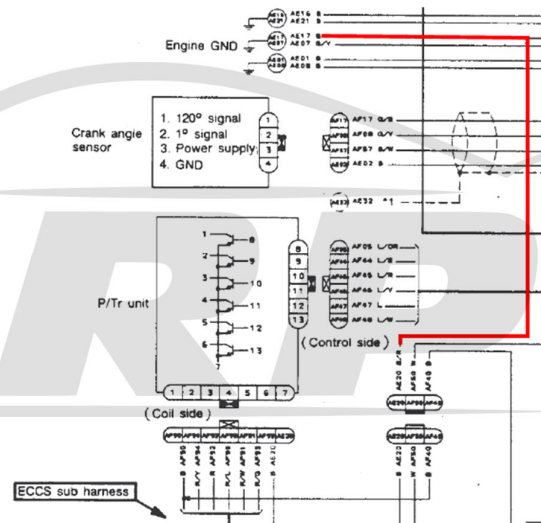
Grounding eyelets are another important aspect that should be checked. All grounds should be monitored, cleaned and tightened periodically to ensure no bad earths occur. On the R32 GTR, the ignition connector ground wire loops around to the front of the engine and joins with the ECU ground near the top water neck.

You must check this grounding point is tight and contact face not insulated by paint or dirt. If eyelets show any signs of degradation, replacing is highly recommended.
