# CERTIFICATION TEST REPORT

TEST REPORT  
16634-2  
MECHANICAL STRENGTH TESTS  
ON  
SURFACE MOUNT FOLDING CLEATS  
WITH NO VISIBLE SCREW HOLES (STUD MOUNT)  
FOR  
ACCON MARINE, INC.

**REPORT NO.:** 16634-2  
**IMANNA JOB NO.:** 16634  
**CUSTOMER P.O. NO.:** N/A  
**CONTRACT:** N/A  
**PAGES IN REPORT:** 3

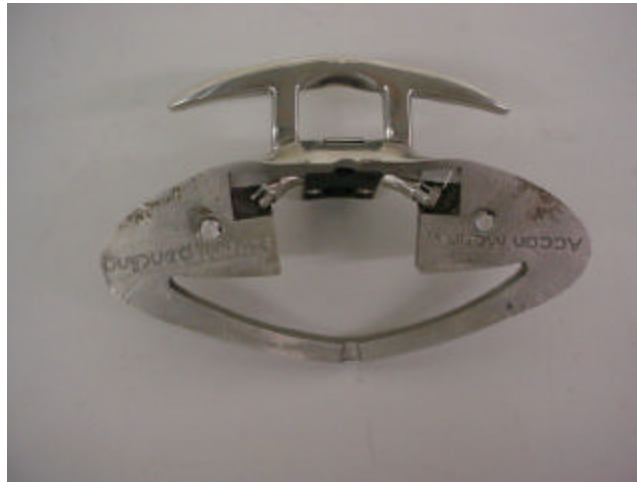
<b>4 1/2" Cleats</b>		
SAMPLE #	MAX LOAD (lbs)	FAILURE MODE
1	9,300	MOUNTING STUDS BROKE
2	9,100	MOUNTING STUDS BROKE
3	9,100	MOUNTING STUDS BROKE
AVERAGE	9,167	
<b>6" Cleats</b>		
SAMPLE #	MAX LOAD (lbs)	FAILURE MODE
1	12,250	MOUNTING STUDS BROKE
2	12,000	MOUNTING STUDS BROKE
3	12,900	MOUNTING STUDS BROKE
AVERAGE	12,383

**Figure 1. 4 1/2" Folding Cleat; typical failure mode (mounting bolt failure).**

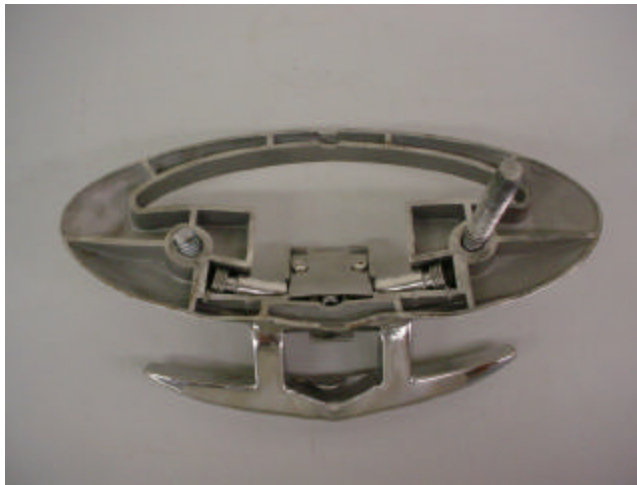
**Figure 2. 6" Folding Cleat; typical failure mode (mounting bolt failure).**

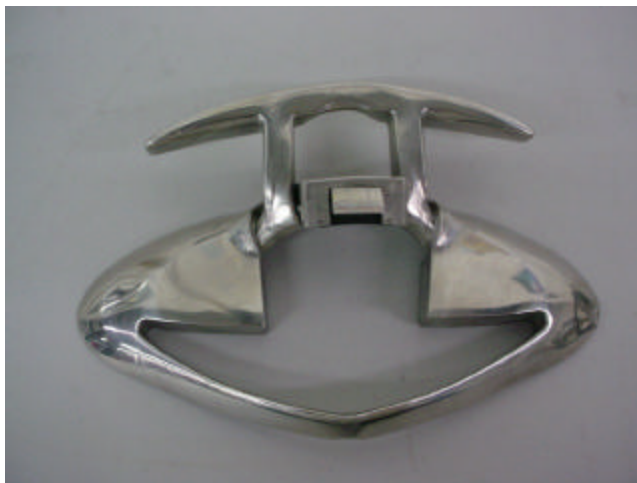
The following table contains the values obtained during the tests. In addition to the failures each of the tested samples also experienced some deformation as a result of the tests.

**Figure 3. typical deformation experienced during tests**
