# **CERTIFICATION TEST REPORT**

**TEST REPORT** 17080-1 MECHANICAL STRENGTH TESTS ON SURFACE MOUNT POP-UP CLEATS FOR ACCON MARINE, INC.

DATE: JAN 31, 2006

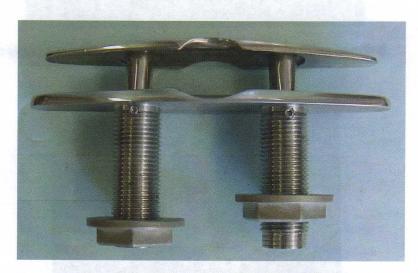
Figure 1. 6" Pop-Up Cleat Sample 1; typical failure mode (pop-up leg bending).

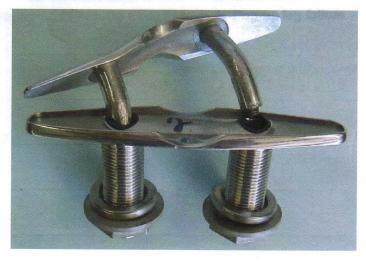
Figure 2. 6" Pop-Up cleat Sample 2; typical failure mode (pop-up leg break).

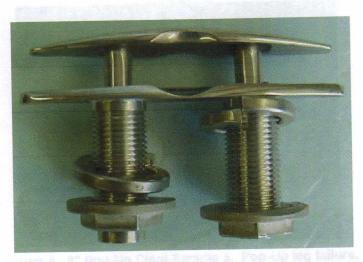
Figure 3. 4" Pop-Up cleat Sample No. 4 Pop-Up mleg bending.
