Detect Protocol Failed

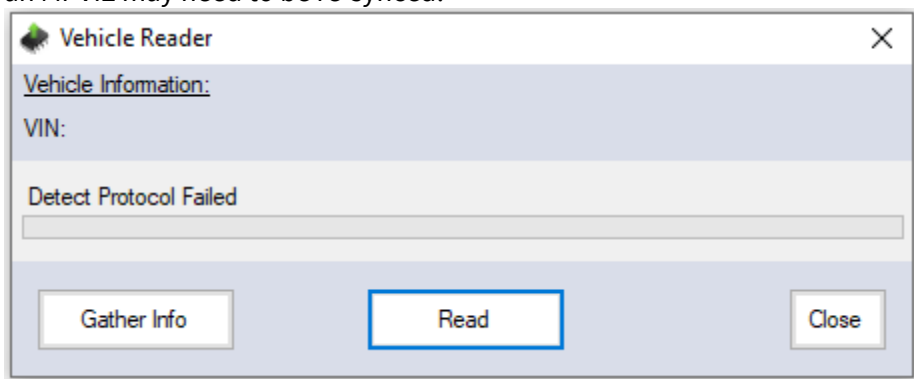
The Detect Protocol Failed error is generally caused by either noise in the vehicle's communications or an MPVI2 may need to be re-synced.

If you have an MPVI2, first ensure your computer is connected to the internet, Click "Help" and choose "Resync Interface".
