# TC OR NOT TC, THAT IS THE QUESTION

## Troubleshooting Converter Symptoms in the 5R110W TorqShift

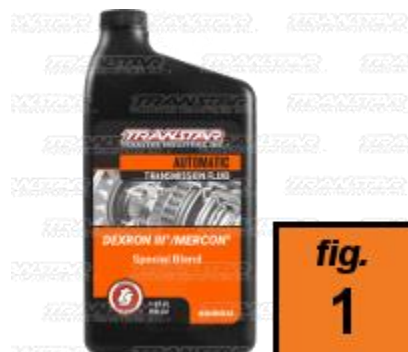
A common mistake that can have severe consequences is to fill the transmission unit with fluid but forget to put fluid in the torque converter prior to installation. Failure to follow fluid-filling procedures with the 5R110W unit creates a situation with no forward and/or no reverse. If this

happens, you have most likely killed your oil-pump assembly. In most cases, this means that you have broken pump gears due to a lack of fluid. Make sure to add fluid to the torque converter prior to stabbing it into the transmission unit. Then add 8 quarts of fluid to the unit, run it for 30 seconds, then shut the engine off. Add 4 more quarts of fluid to the transmission, then restart the engine. Complete filling the transmission to the correct level as recommended by Ford. Save your pump and save your torque converter **(Figure 1)**.

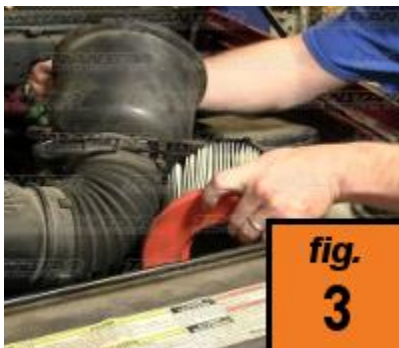
The symptom of harsh TCC apply can be caused by two different types of issues with externally accessed items. The first issue is that the air filter can be restricted or dirty. Much like the mismatched tires, this can cause engine surges or simply an engine that runs poorly. This can cause lockup to be dramatic. This can be easily addressed by cleaning or replacing the engine air filter **(Figure 3)**.

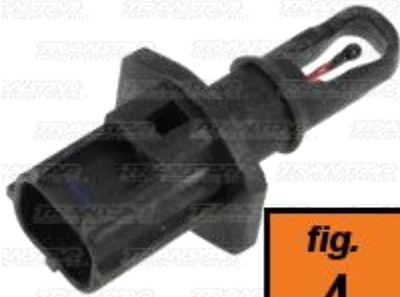
**fig.**  
**4**

The second area causing harsh TCC apply is issues with the four different vehicle sensors. Related to the air filter, the Intake Air Temperature Sensor (**Figure 4**) can be dirty or it can be malfunctioning. Replace this sensor if it is found to be dirty or faulty.

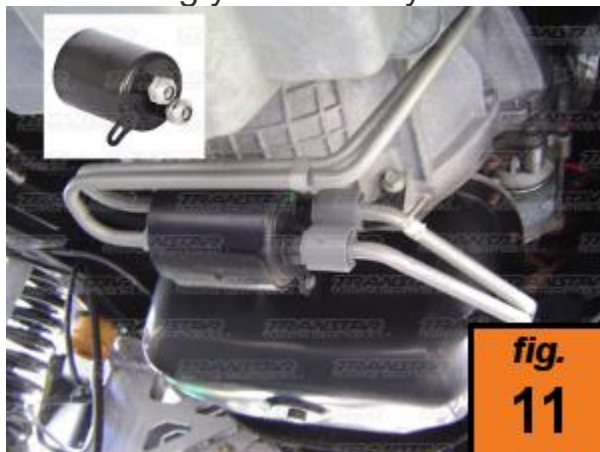
**fig.  
10**

The first would be to eliminate the direct cause of overheating. That could be as simple as making sure the lines are properly flushed to ensure that there is no restriction of cooler flow. It could also be making sure to install an additional aftermarket transmission oil cooler.

The second is to check on the bypass filter. This filter functions similarly to the traditional aftermarket bypass filter installed after a unit is rebuilt to help collect any leftover metal missed in flushing and installation. This OEM designed filter, however, is to provide an additional superfine filtration process to normal transmission function. For the years 2003 to 2007, the filter is a toilet paper roll type (**Figure 10**). From late 2007 to 2010 it is a sealed metal canister that installs directly to the transmission case or to the vehicle underbody (**Figure 11**). In 2011, Ford shifted this filtration function to inside the case. Regardless of model year, this filter must be changed to avoid killing your recently rebuilt unit.

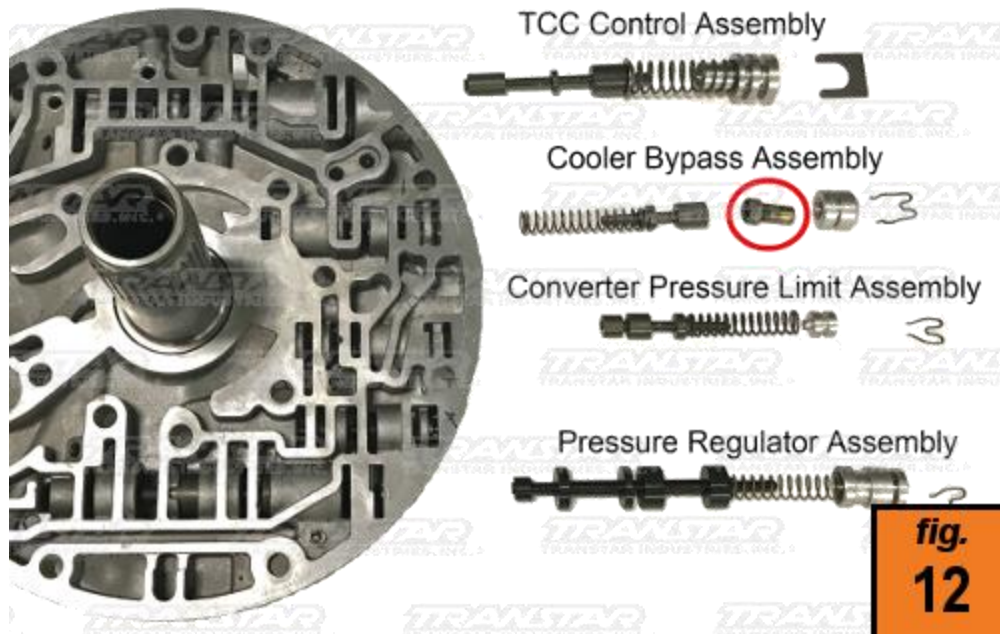
The TCC Control Valve section can have problems due to wear, as well as due to mistakes made when rebuilding the TCC Control Valve Assembly (**Figure 12**). A worn TCC Control Valve circuit will cause lockup slipping, cycling, as well as lockup related codes 741 and 1783. All components in this circuit should be replaced as a full assembly. However, there are three different versions of this valve. The 2003-04 models have a valve that has a spool outer diameter of 0.402 inches and is 3.570 inches long. The 2005 and up valve is almost a quarter inch longer at 3.770 inches long. The early version of this valve is not available new, and cannot be used in 2005 and up pump assemblies. Both the 2005-08 and the 2009-up pump assemblies retrofit to the earliest application. However, do not reuse this early type valve. It will cause torque converter lockup failure. When installing the retaining clip for the correct diameter and length TCC Control Valve, make sure that the sleeve feed hole is visible. If assembled incorrectly, the code P1744 will show up during transmission operation. And nobody likes to drop a unit to fix a problem that can be avoided by getting it right the first time.

The Converter Pressure Limit Assembly may be one assembly that can cause almost all of the torque converter malfunction symptoms in your customer's 5R110W unit (**Figure 12**). The wear or failure in this assembly can cause TCC codes, lockup slipping, erratic or harsh lockup apply, leading to torque converter lining failure, as well as excessively high torque converter pressure. And that excess pressure can lead to clutch failure and torque converter ballooning. It is like the transmission engineer stepped back, looked at the unit, and decided to choose one circuit to ruin them all. The truth is, just like this one circuit can be completely to blame, it can just as quickly fix all of the issues, too.

A small item that can cause overheating is the thermal element found in the cooler bypass valve assembly (**Figure 12, circled**). The heating element pin should function when it reaches the correct temperature. If stuck shut or open, the transmission can function poorly in cold weather or overheat in hot weather. Make sure to heat the element to determine if it is functioning properly and replace when necessary to save your torque converter and

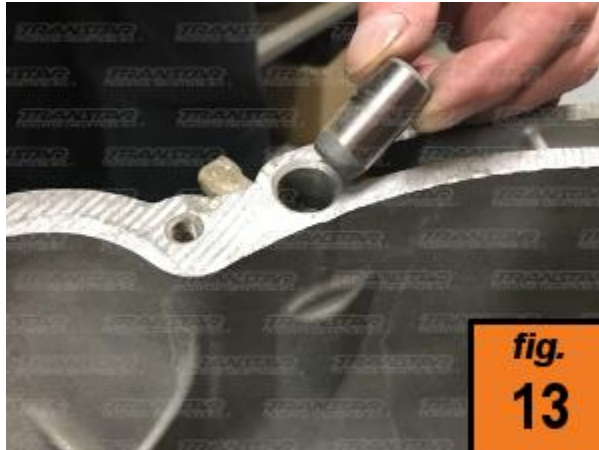
Finally, you will find in some cases that you have broken pump gears. And this is after you have rebuilt the unit. It makes you start to question the overall height of your torque converter, the unit end play, and whether you should have shimmed the flexplate. It must be the torque converter that broke your pump gears! An easy problem with this unit is that worn dowel pins can cause case misalignment. Make sure that you check dowel pins when reassembling this unit. If you do, you can save yourself money and time and avoid frustration. **(Figure 13)**.
