TECH TIP

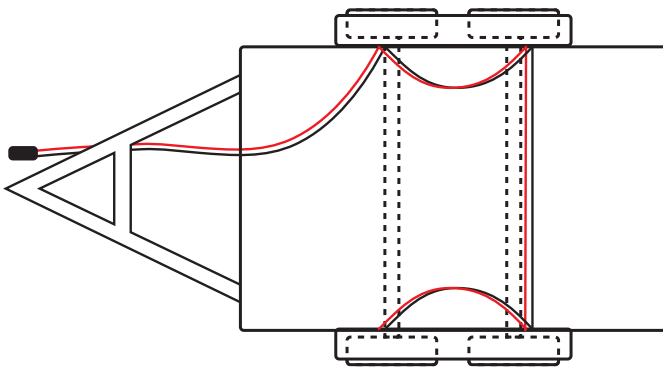
- Broken wire or open circuit coil one side.
- Unbalanced trailer loading.
- Incorrect mechanical adjustment of one side.
- Mismatched linings fitted.
- Mismatched tyres.
- Broken or disconnected spring in a brake assembly.
- More friction one side due to extra corrosion in one brake drum.
- Bearing lubricant leaking on to linings one side.
- Contamination one side, E.g. a piece of broken spring or a rock embedded in lining.
- Unbalanced wiring, see diagram below.

Unbalanced braking

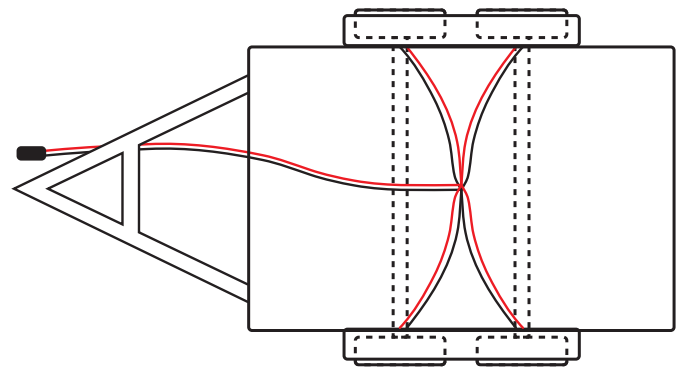
Balanced braking
