Technical Tip

The Use of Steel Wool

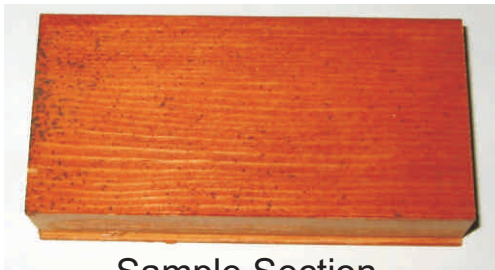
Sample Section

the impression that the discolorations could well be mold or some flecks of dirt that may have been present at the time of staining. Even under the microscope at 10X there's no indication of what caused the black spots.
