TORTURE TEST MAGAZINE FOR SCIENCE... AND FUN

2004-2017 CRF250X PART 1

VOLUME 2, PART 1

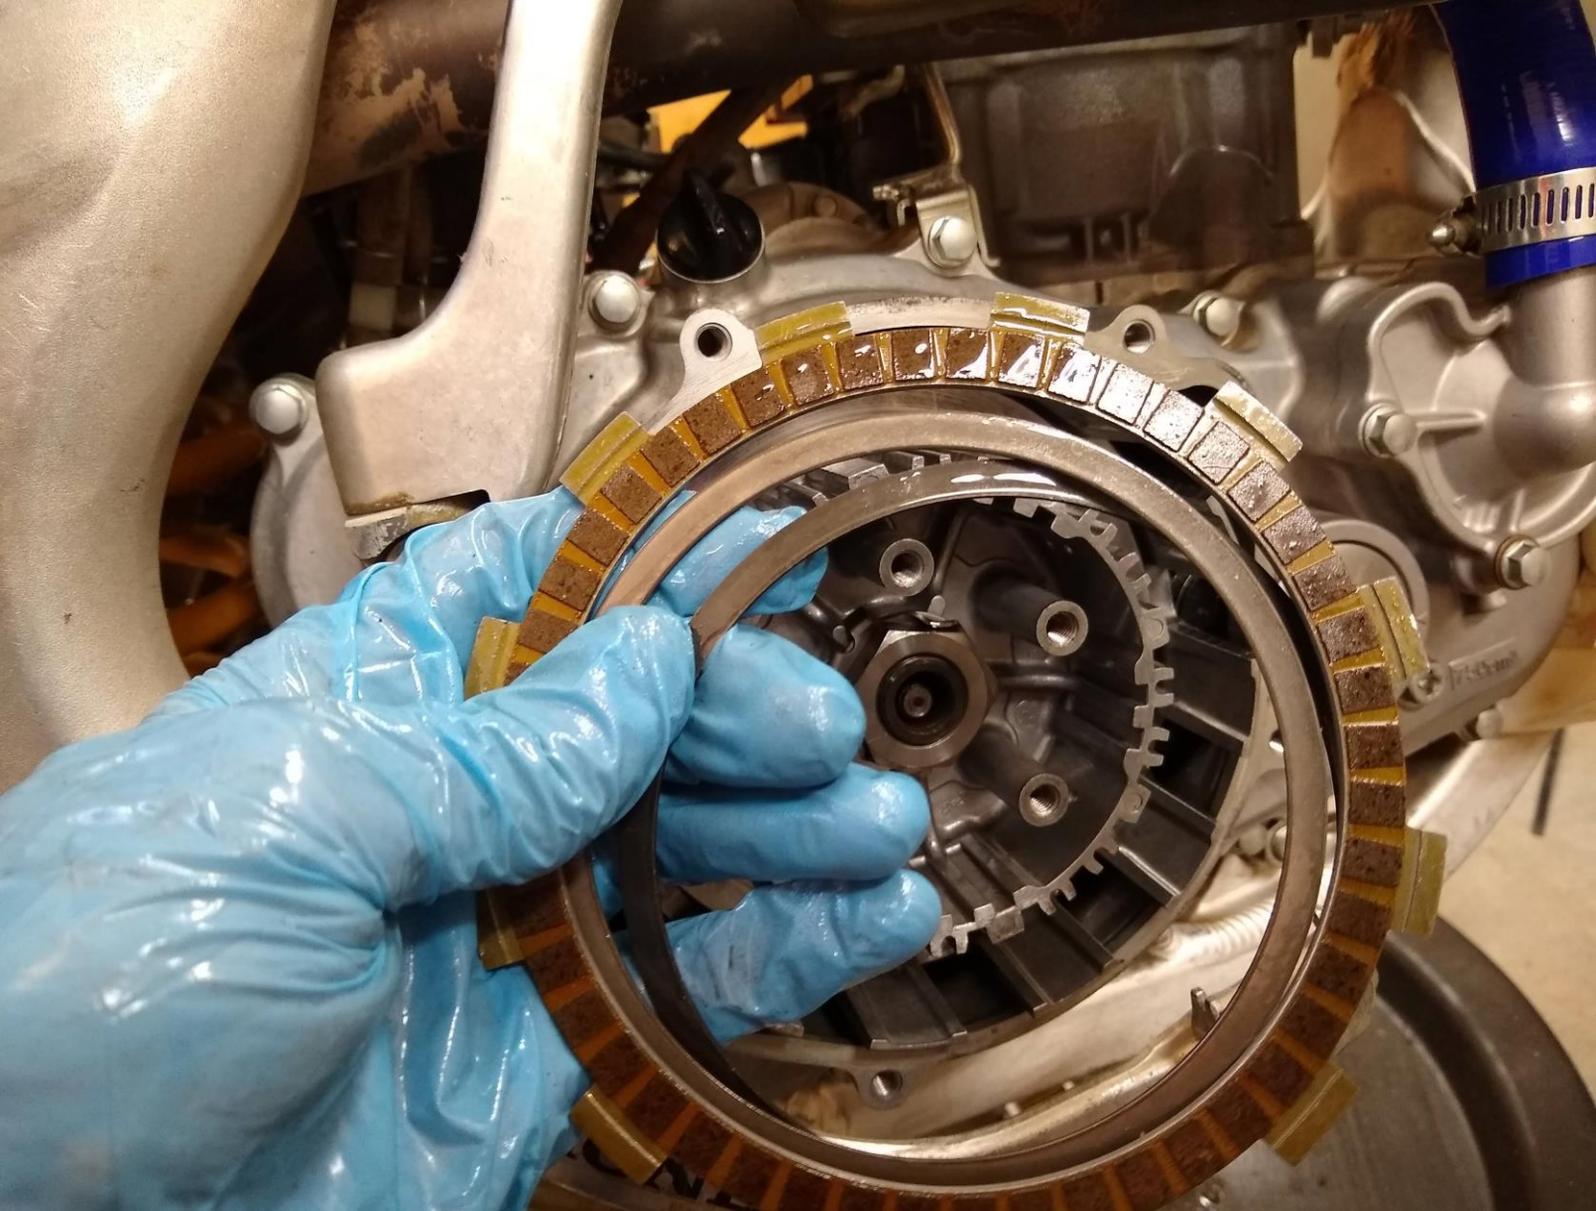
With the clutch pack in hand, I picked out the judder spring mechanism from the stack. The mechanism includes a large inner diameter friction disc with a steel Belleville style spring that fits within the extra inner diameter of the friction disc, and a hard steel seat for the spring. This mechanism simulates a thicker, though compressible, friction disc in order to provide a more progressive and predictable clutch engagement. The mechanism attempts to take up more space in the clutch pack when the clutch is lifted (disengaged) so that the clutch pack will start engaging sooner as the clutch is dropped (engaged), but in a gentle manner since the judder spring flattens out and takes up less space as more pressure from the main springs is applied to the whole clutch pack.

While the judder spring makes the clutch feel nice, it also significantly reduces the maximum friction available from the clutch pack. I got rid of the judder spring mechanism and replaced it with a full-sized friction disc.

As you can see, replacing the judder spring with a full-sized friction disc provides some extra surface area for the clutch to grab with. Since I didn't actually have a brand-new full-sized friction disc, and I wasn't going to wait to have one shipped, I just installed the least-worn one from the previously used clutch pack.

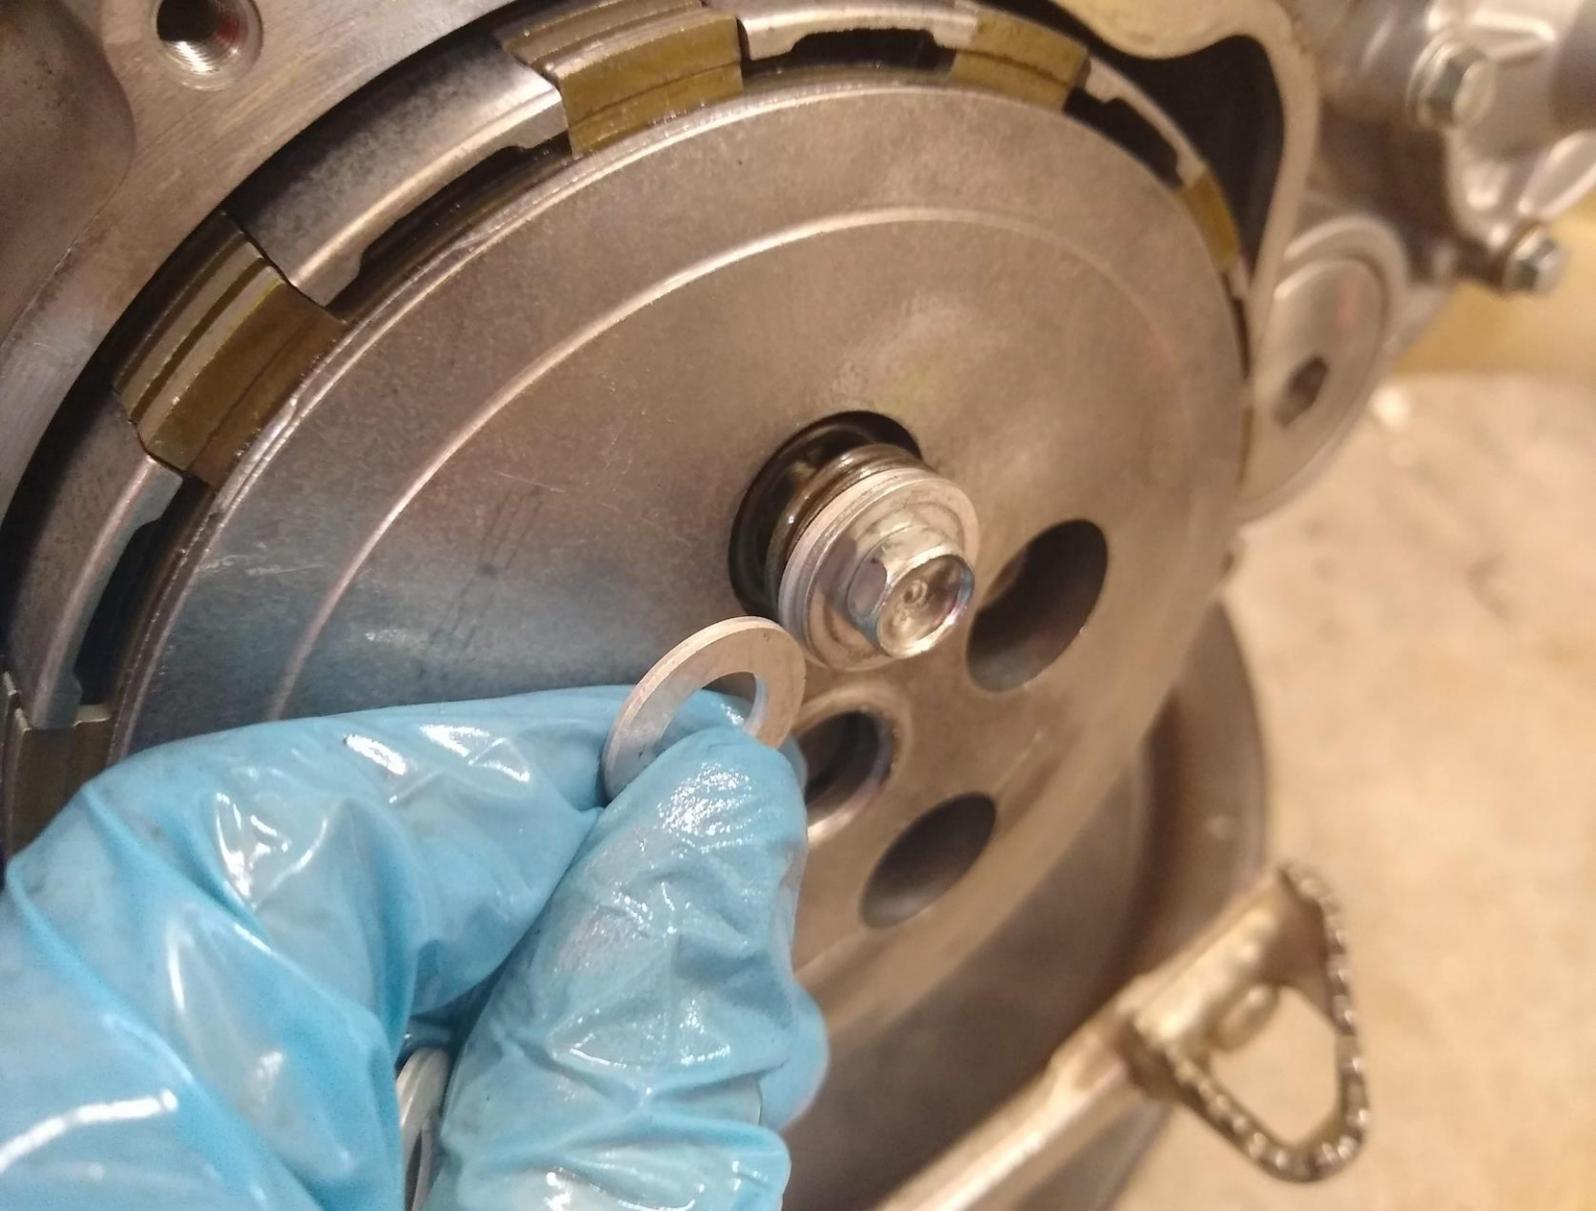
While assembling the clutch, I started playing with one of the pressure springs and thought it felt quite soft for a clutch spring. I dug through my pile of parts to see if I had some stiffer springs that might fit, but didn't find anything in the right size. I did, however, have some drain plug washers that were exactly the right size to preload the clutch springs a little bit. In an attempt to simulate stiffer springs, I used those drain plug washers to add extra compression to the clutch springs. Using drain plug washers in this manner is risky business, because if they are too soft they will eventually just be eaten away by the spring. This just made me want to go ahead with this modification even more, because I had to find out if this will actually happen. We will get to find out at the next clutch tear down, or whenever one breaks loose and grenades the transmission. What fun!

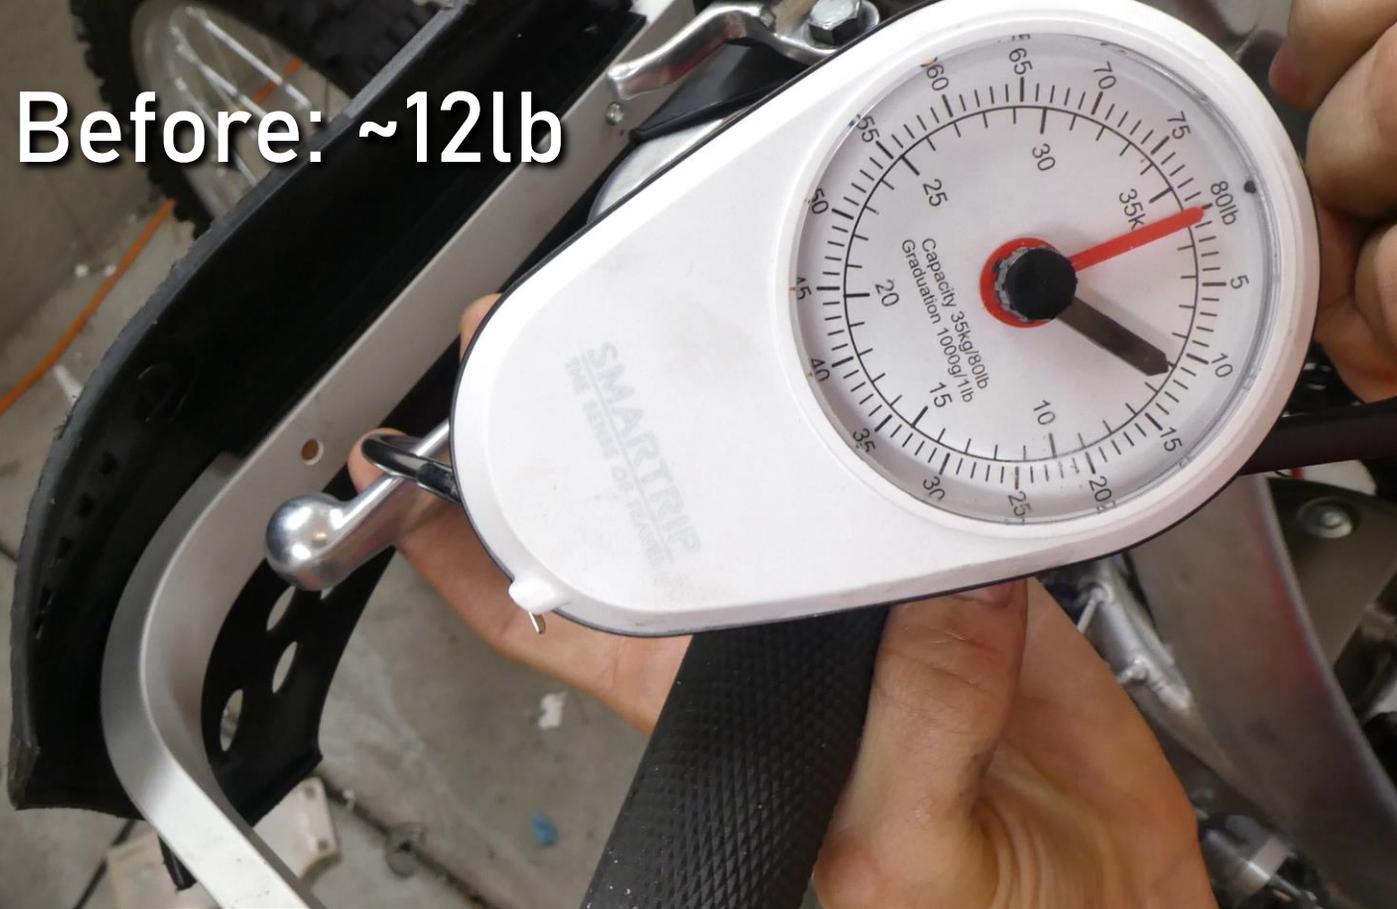
Before: ~12lb

Of course, adding extra load to the springs to simulate stiffer springs must increase the maximum force required to pull the clutch lever. That, plus the removal of the judder spring could really hurt the ease of clutch control on this bike. To find out how much the clutch lever maximum pull force was increased, I measured the pull force at the point where my clutch finger rests before and after the modification. Before the modification, the maximum pull force measured at about 12 pounds. After the modification, it was exactly one pound more difficult at 13 pounds. Although it might not sound like much, this is a fairly significant increase with the pre-modified pull being only 92.3% the difficulty of the modified pull. A little human clutch finger (and the associated forearm muscles which actuate it) is going to feel that after several hours of riding. I resolved to “just deal with it.”

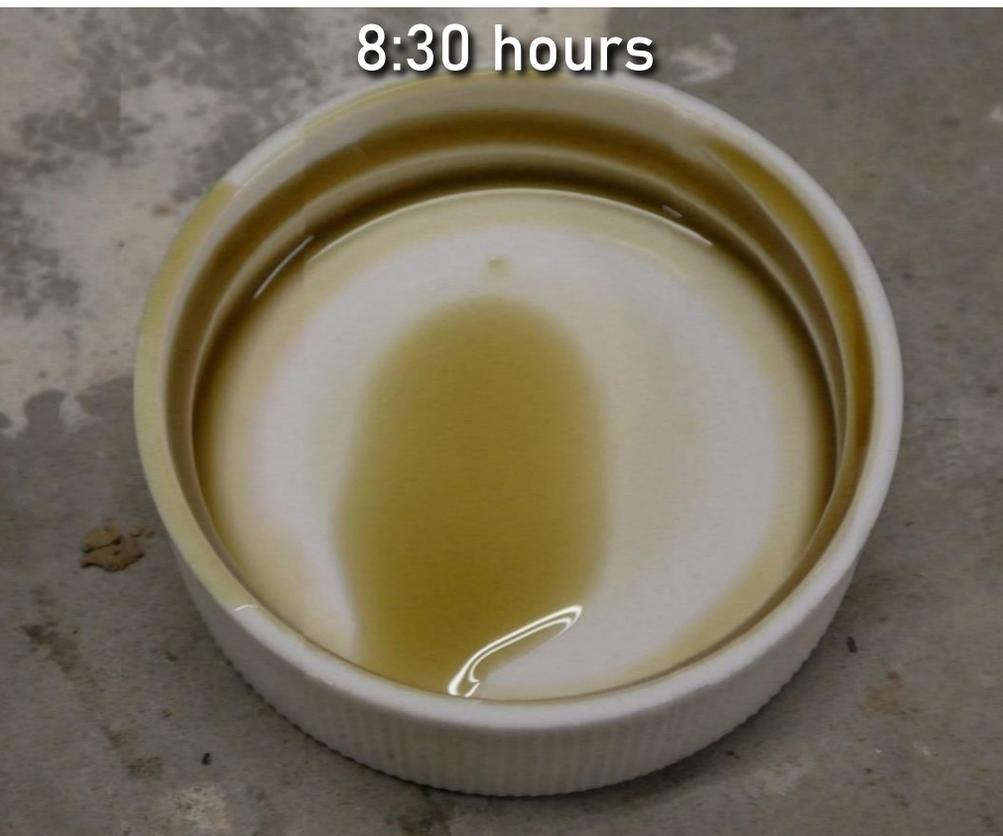
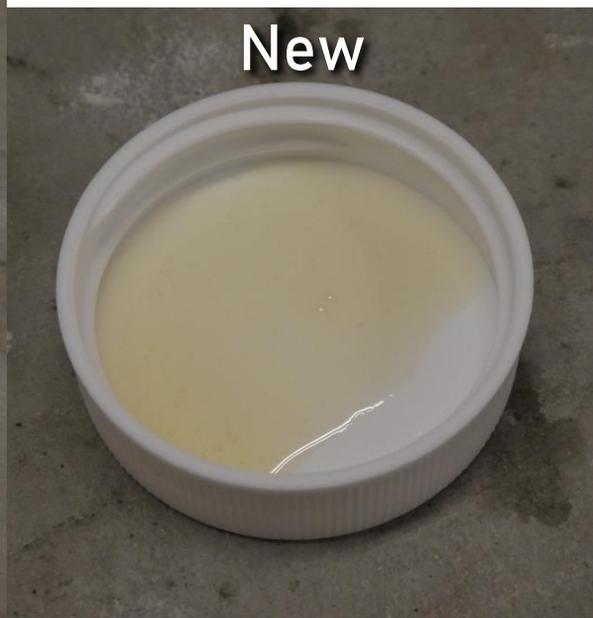
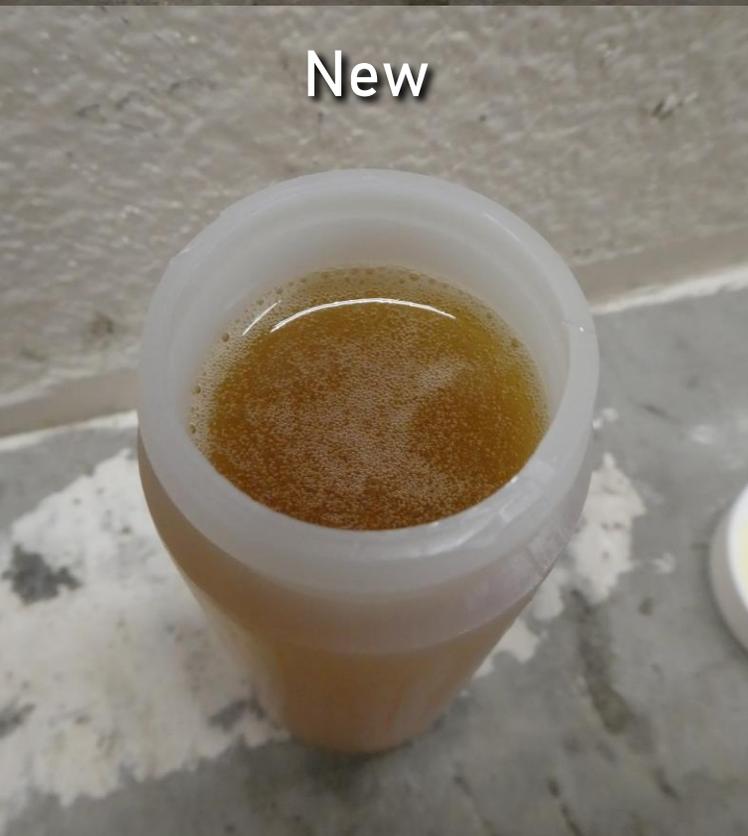
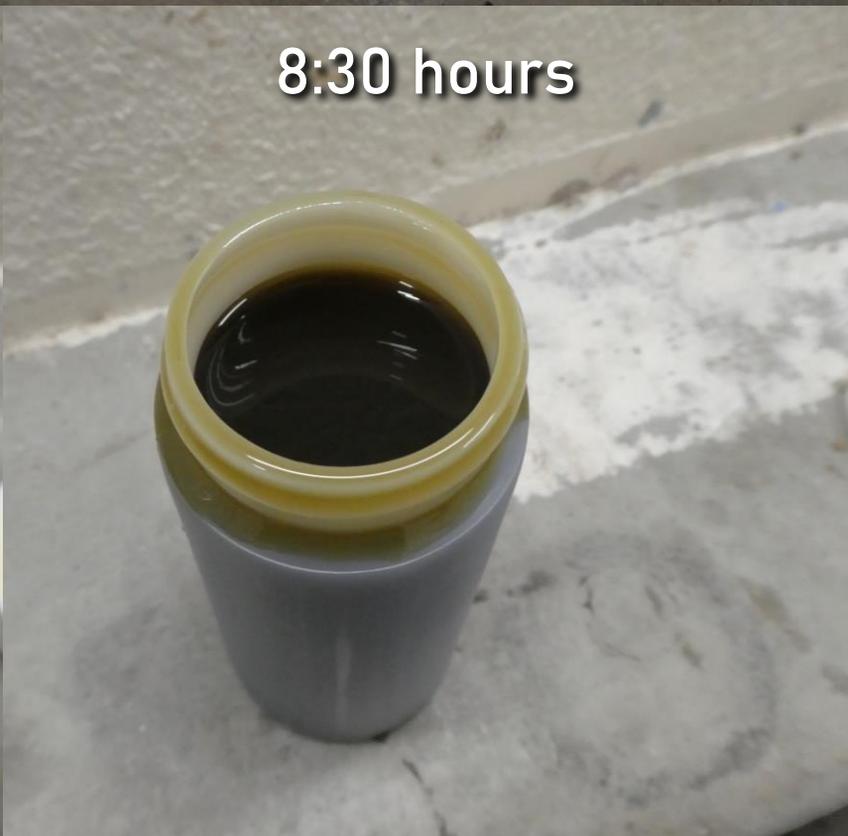
The oil in the motor side came out looking relatively clean. It still had the normal golden hue of new oil, but was substantially darkened.

The oil filter had a pretty good amount of visible solids stuck in it. I could easily identify most of it as aluminum flakes, blue paint from the intake valve springs, and green paint from the exhaust valve springs.

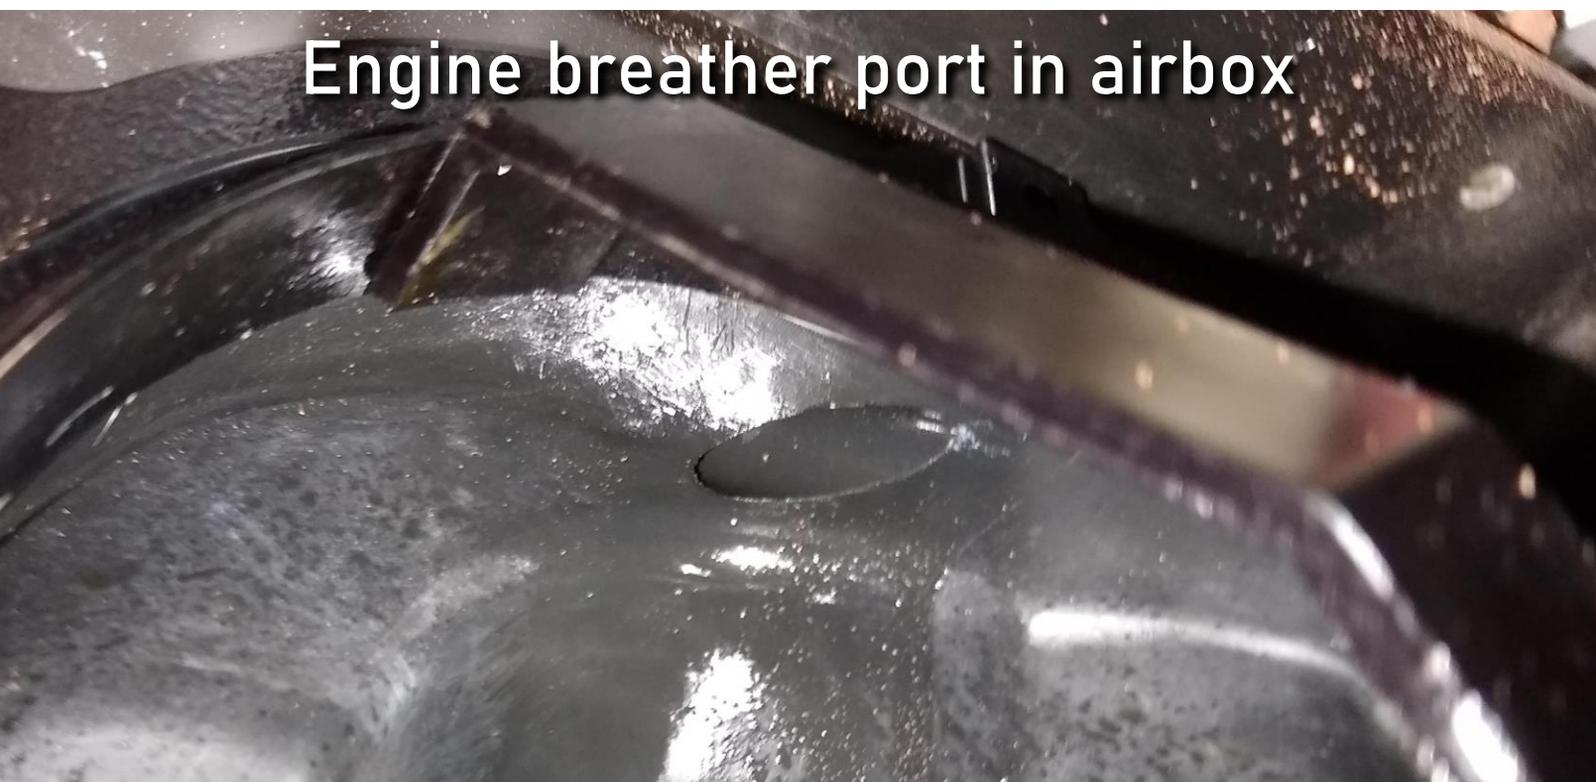
Engine breather port in airbox

The last piece of information I want to record about this oil change is that over the course of the 8:30 running hours, I had to add 100ml of oil to keep the level at the top of the dipstick. On a bike like this, oil is lost in several ways. Some oil leaks past the piston ring and some leaks down the stems of the intake and exhaust valves. On a fresh engine, those two sources of oil loss (known as oil burning) should only make up a very small amount of oil loss. Even when oil isn't sneaking its way into the combustion chamber, some is vaporized by heat, slinging and thrashing inside the engine and subsequently gets thrown out of the engine breather into the airbox. On this bike in particular, there is always plenty of motor oil that has been blown into the airbox where the engine breather connects, so that is usually the largest source of oil loss.

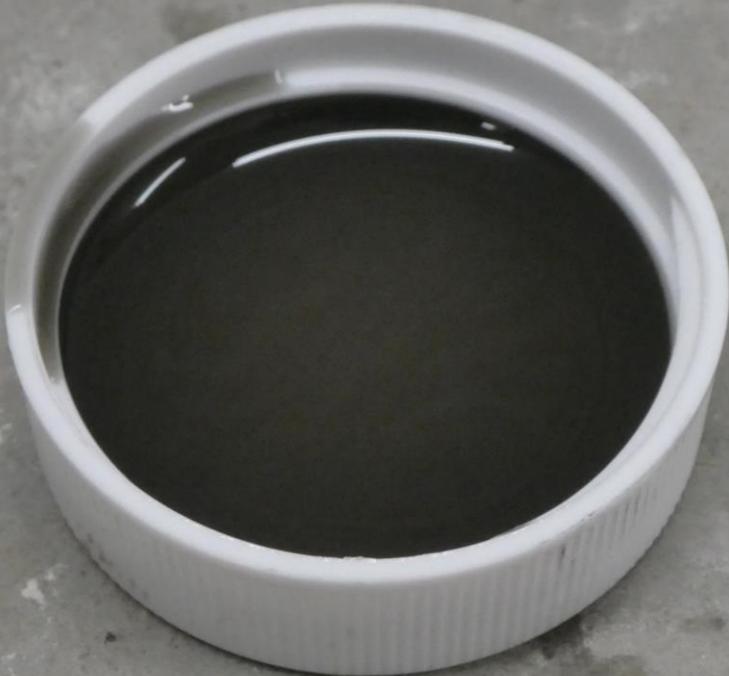
8:30 hours

The transmission oil came out much more discolored (grey/charcoal hue) and much more-opaque, with lots of very fine visible dust suspended in it. You can see how opaque it is with just a small amount poured into this white cap.

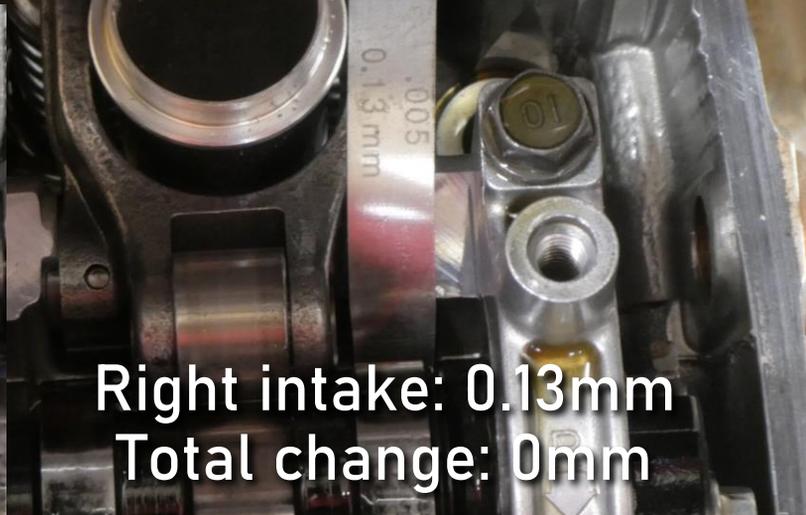
Left intake: 0.13mm
Total change: 0mm

Right intake: 0.13mm
Total change: 0mm

The required valve clearances for this bike are $0.12\pm 0.03\text{mm}$ for the intake valves and $0.28\pm 0.03\text{mm}$ for the exhaust valves. The left exhaust valve has worn by 0.03mm and is close to being worn out of the specified clearance range already. If it wears more, it will need to be shimmed back to the specified range. This has me worried since it happened so quickly. Fastheads of Saint George, Utah, urges CRF owners to get a head rebuild anytime any of the four valves reach 0.10mm of accumulated wear. This exhaust valve is already 30% of the way there. Will it really only make it to somewhere around 30 running hours? I sure hope not. The previous 2006 head survived longer than that.

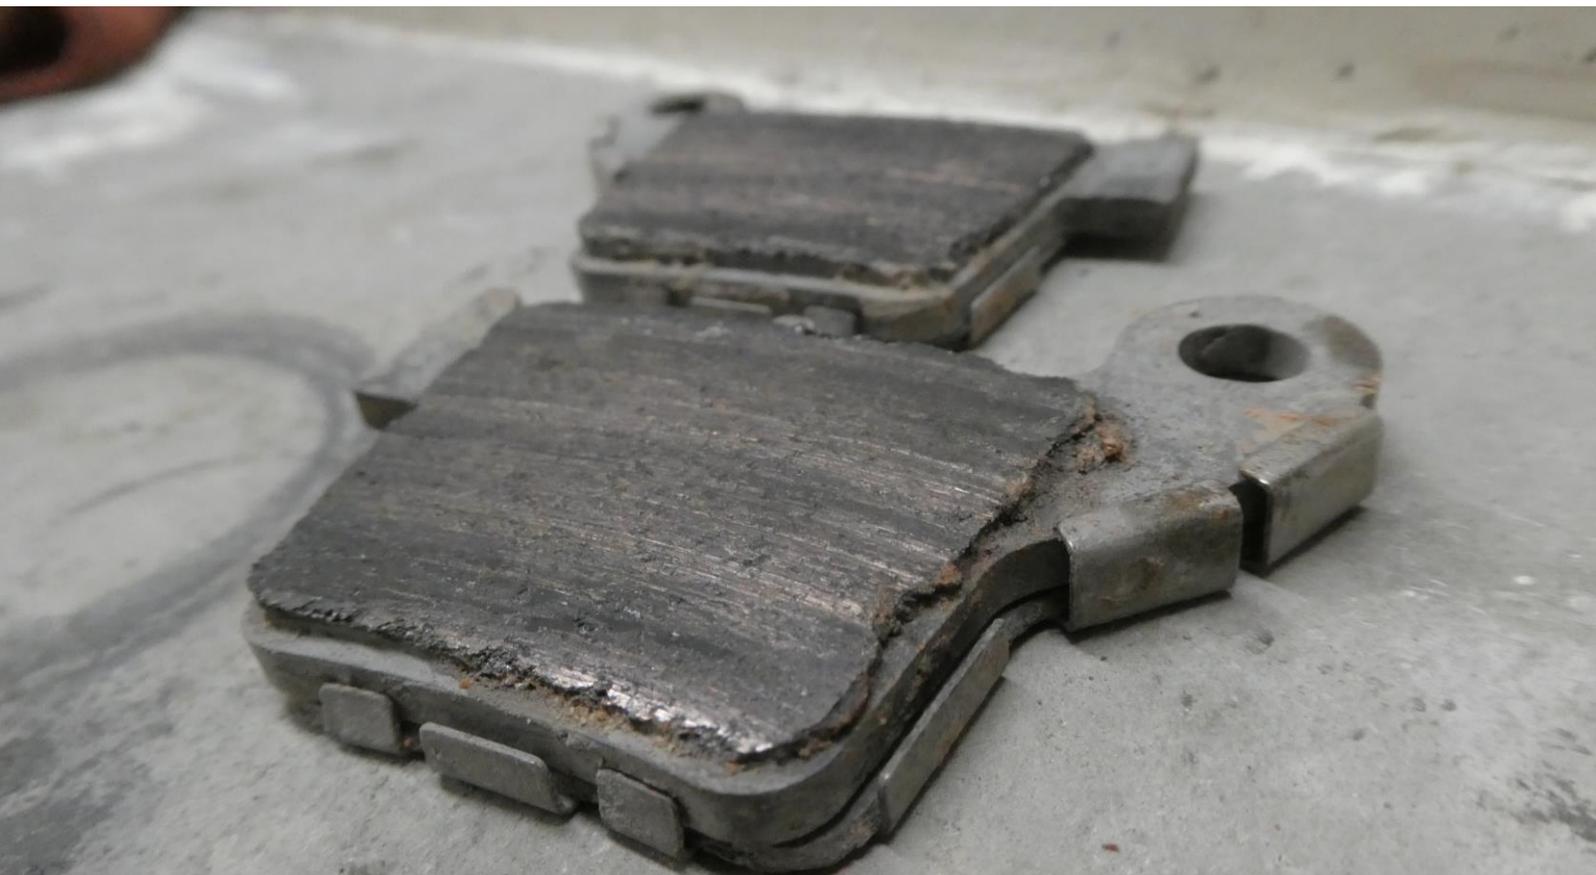
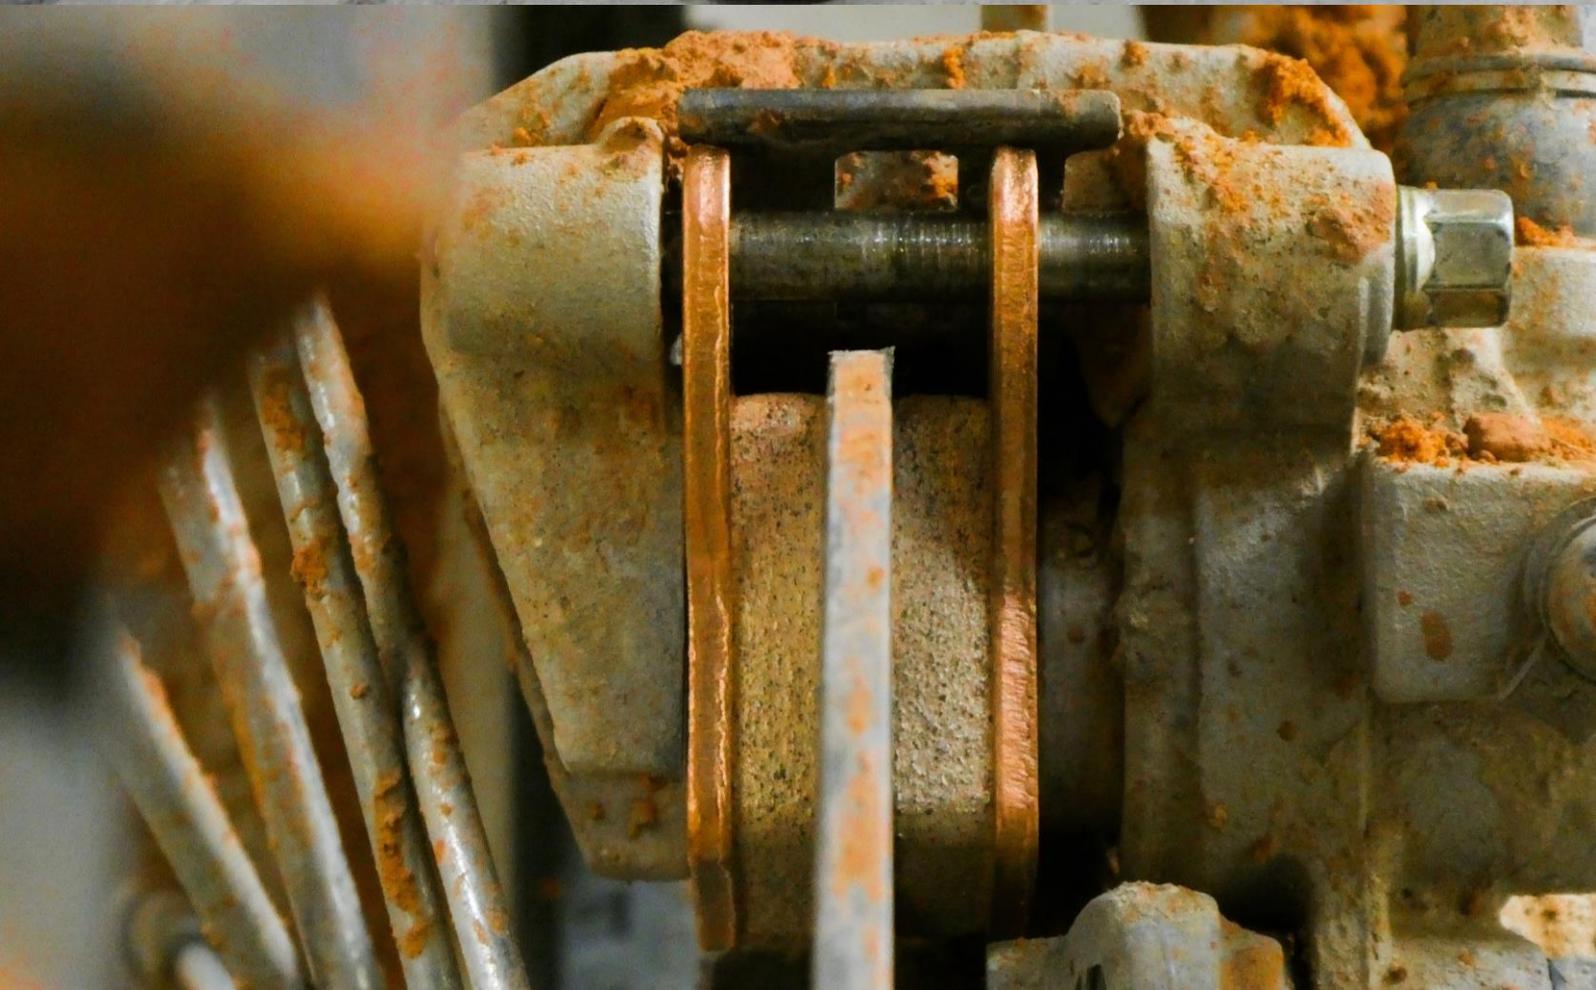
Riding cautiously in wet, icy conditions apparently makes me use the rear brake in a more abusive manner, because I chewed right through the last quarter inch of the OEM rear brake pads as if they were made of Styrofoam. I replaced them with Pro X brake pads for \$22.95, simply because I had never tried Pro X pads and wanted to give them a shot. They turned out to have a good feel, so I have no complaints yet.

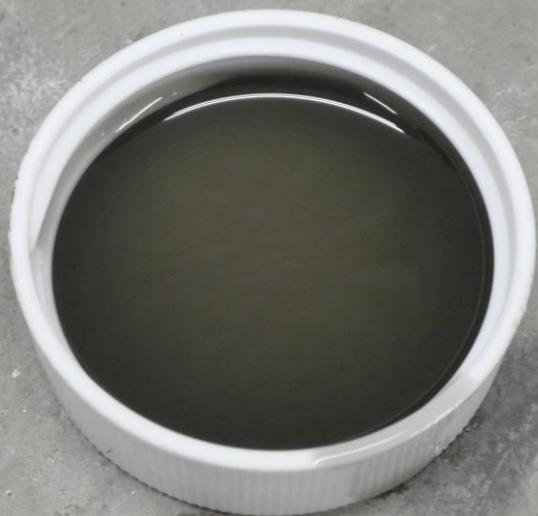
16 hours

The transmission oil looked pretty much the same as the 8-hour run.

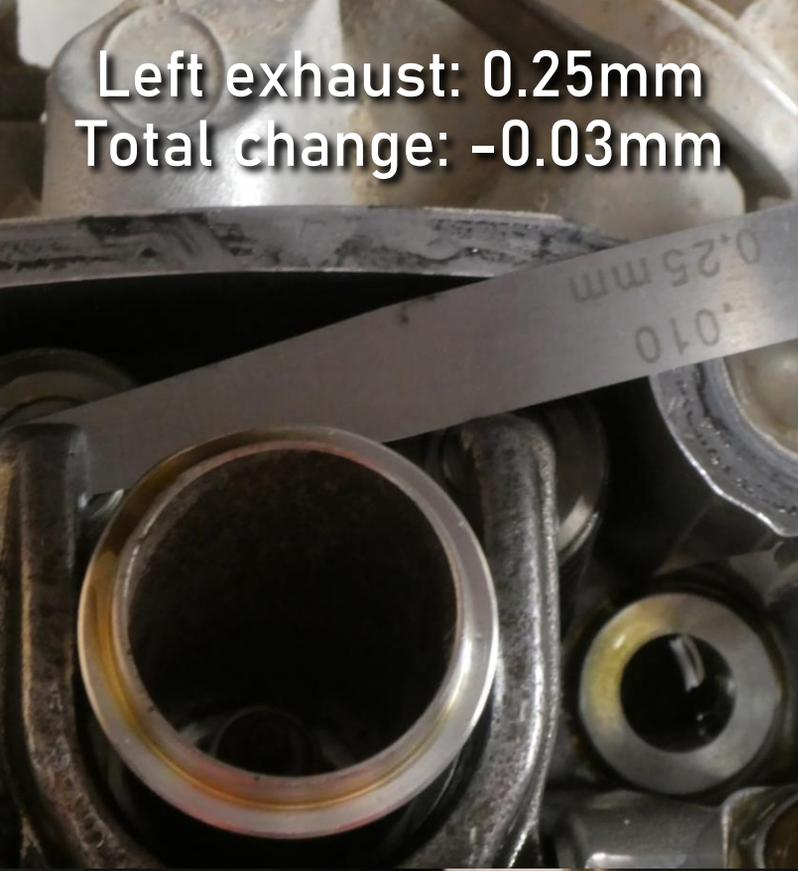
Left exhaust: 0.25mm
Total change: -0.03mm

This image shows a close-up of the left exhaust valve assembly. A metal feeler gauge is held across the valve stem and seat. The gauge has markings for 0.25mm and .010. The valve is partially open, and the feeler gauge is positioned to measure the clearance between the valve stem and the seat.

Both exhaust valves still sat at 0.25mm and both intake valves held steady at 0.13mm. Reaching 30 hours without the bike requiring a clearance adjustment offered a little bit of relief from my “CRF Anxiety” because a lot of the complaints early on with the unicam CRFs stated that the early heads “didn’t even make it to 30 hours.” Well, this one with the updated valves and seat material has made it, even with an aftermarket camshaft and lazy air filter maintenance. Yes, there has been some change in the clearances, but the run-away wear indicative of CRF Valve Issue™ is not occurring yet. The cam chain still did not require an adjustment.

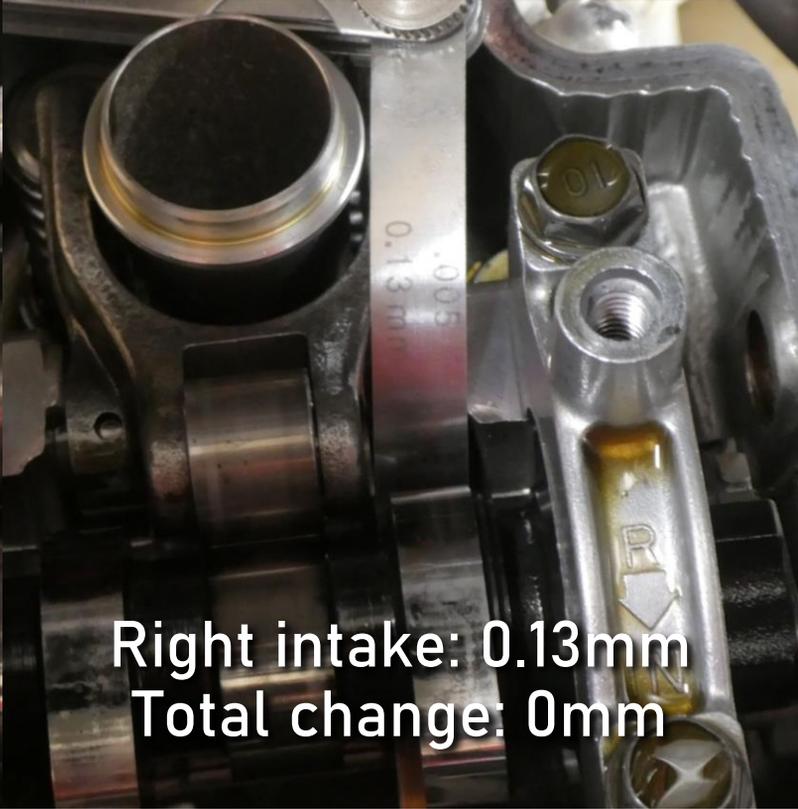
Right intake: 0.13mm
Total change: 0mm

This image shows a close-up of the right intake valve assembly. A metal feeler gauge is held across the valve stem and seat. The gauge has markings for .005 and 0.13mm. The valve is partially open, and the feeler gauge is positioned to measure the clearance between the valve stem and the seat.

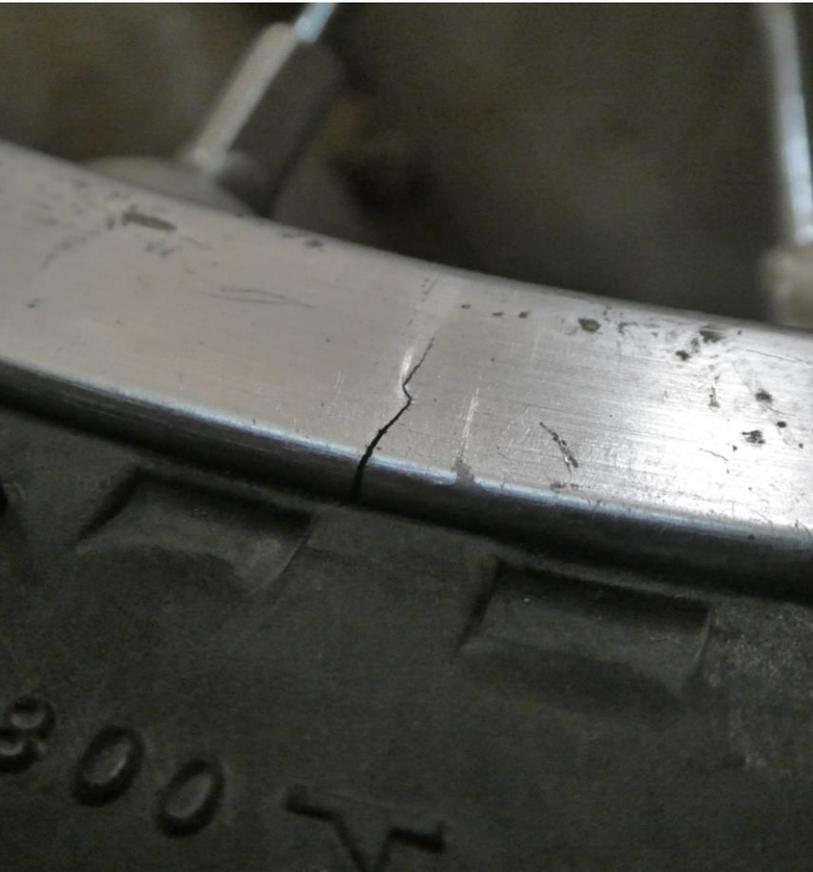
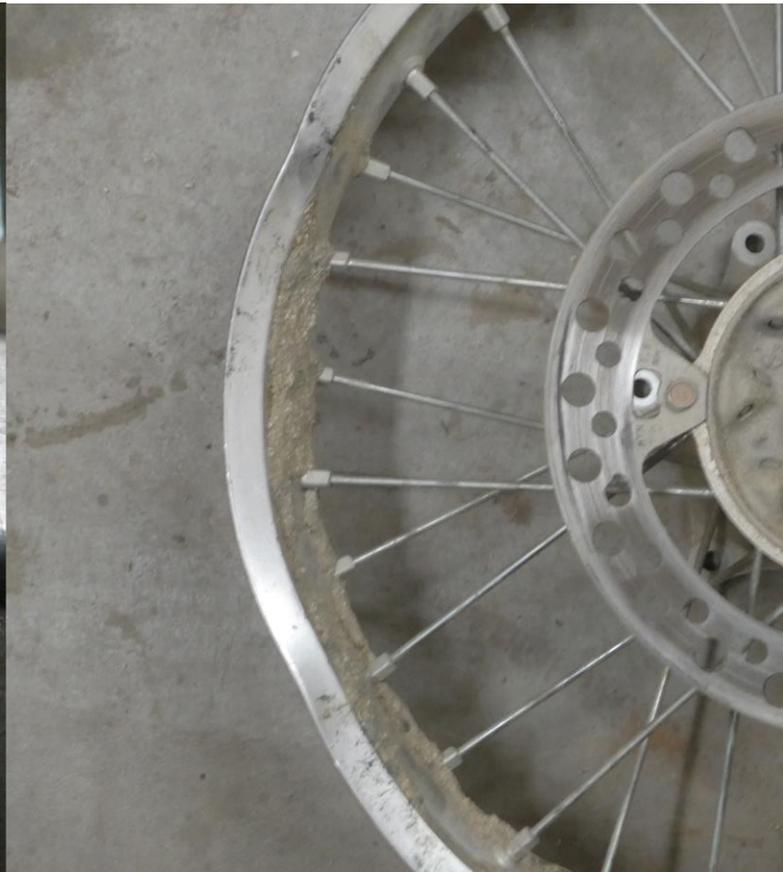
The front rim crack actually occurred before the race, and I noticed it while getting ready before leaving town. I went with the quickest fix, which was buying a complete wheel. I purchased a Warp 9-brand, fully-assembled wheel, and threw it on for the race. The OEM rear rim got busted up during the race by a concrete edge that was in the race course, which resulted in 5 hours of the race being run on a rear flat. After the race, I fixed up the OEM wheel with Tusk rims, so in the cost of running calculation I am only using the price of those Tusk rims and new spokes.

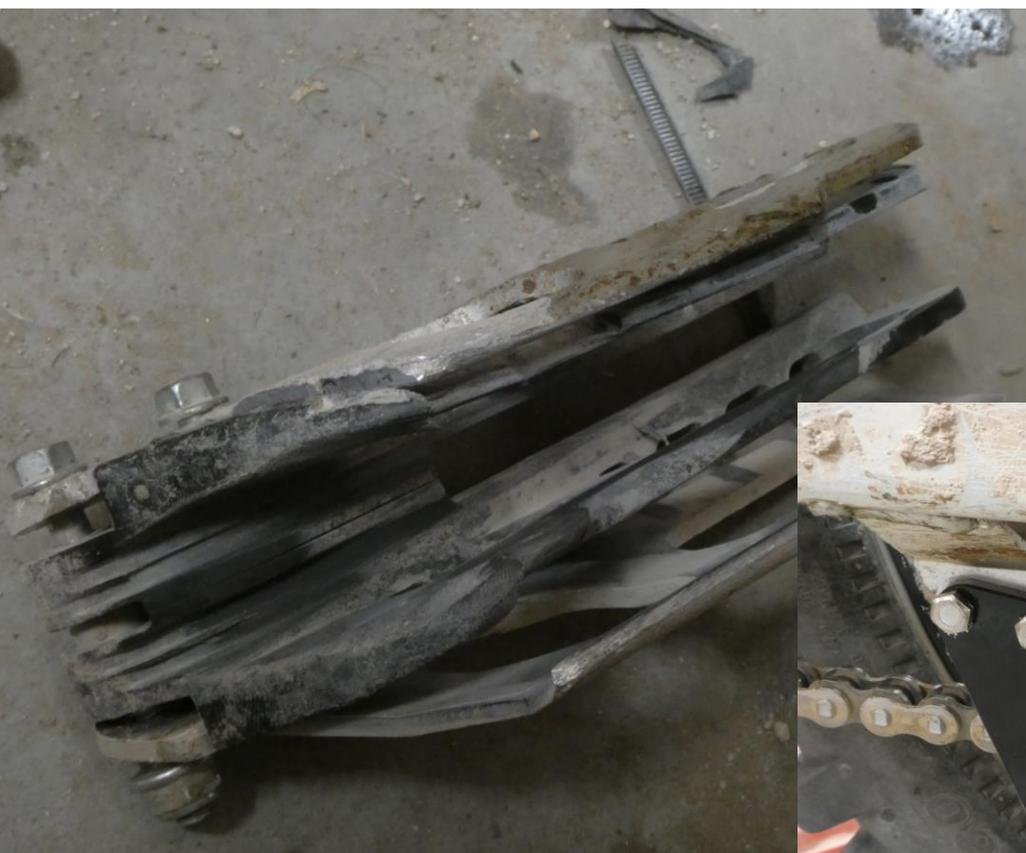
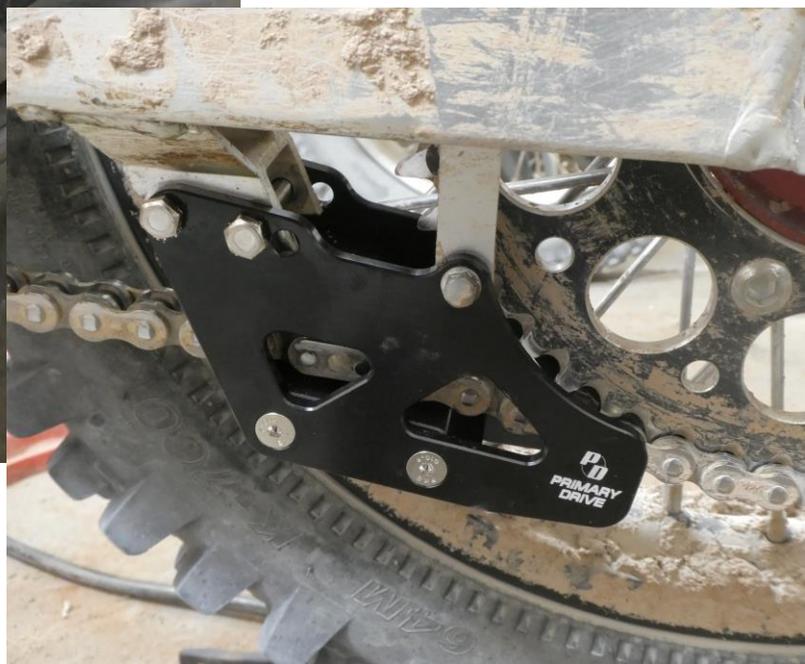
The rubber on the bottom of the chain guide simply wore through. I replaced it with a Primary Drive chain guide for \$35.99 to see if it will last longer. However, it's interesting to point out that the wear-out of the OEM chain guide was within 5 hours of the wear-out of the OEM chain, which I replaced before the race, so if I'm ever using the OEM guide again it will be a simple maintenance task to just replace the rubber every time the chain is replaced.

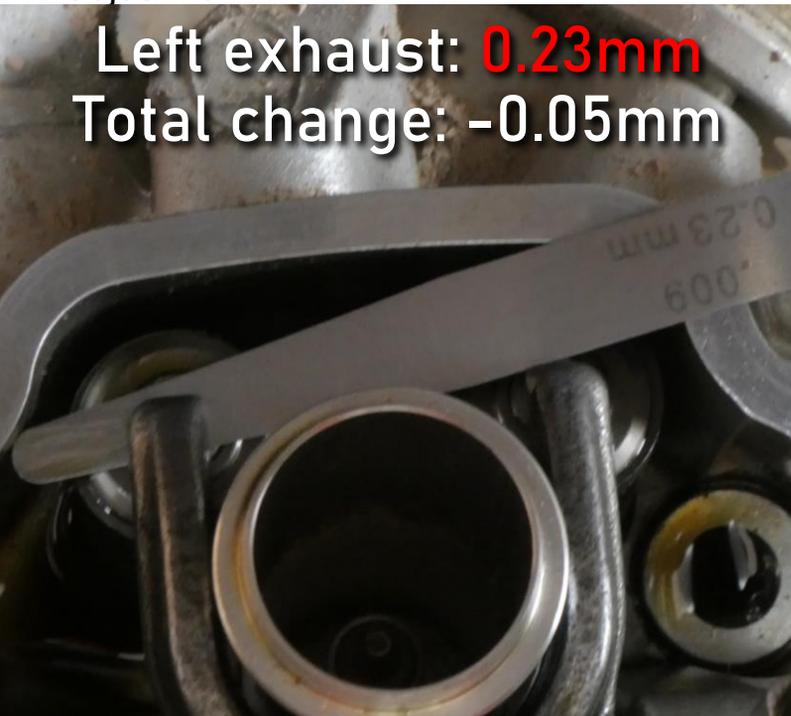
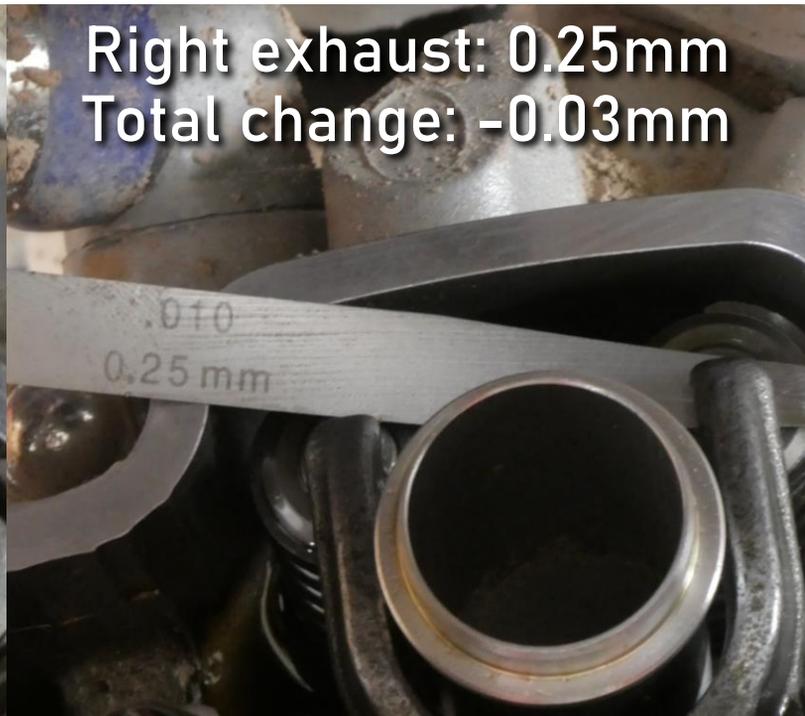
The "CRF Anxiety" has returned. At 39:47 hours (810 miles), the valves are starting to look like a problem. The left exhaust valve has continued to wear steadily, shrinking the clearance out of the specified range and requiring a shim change. That exhaust has now worn a total of 0.05mm, or half of what is allowed before the head should be removed for work. It's starting to look like this thing will just barely make it through Tier I.

To bring the left exhaust valve clearance back into the specified range, I swapped out the 2.45mm shim for a 2.40mm shim. This brought the clearance back to 0.28mm. The intake valve clearance *increased* on both sides, oddly enough. They are both now at 0.15mm, up from 0.13mm at the last inspection. I hope that is not an indication of cam or bucket wear! They are both still in the specified range, so an adjustment is not needed at 0.15mm. The cam chain still has not required any adjustment.

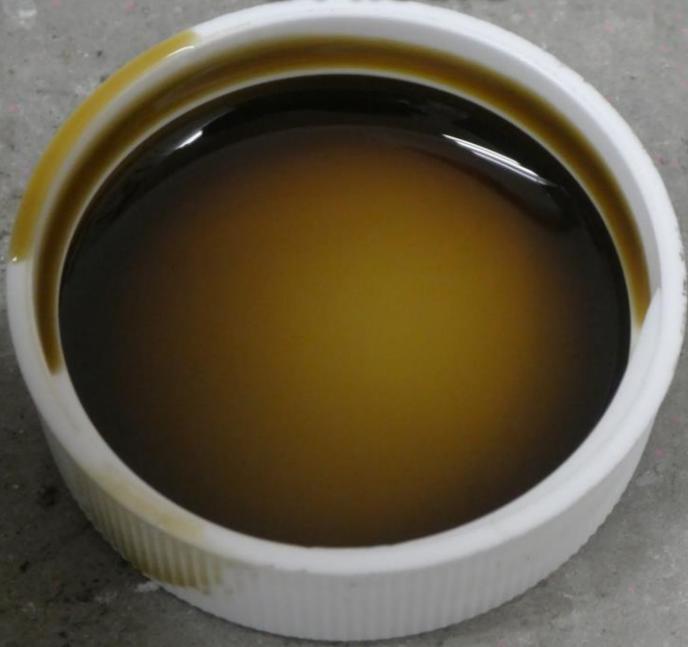
24 hours

No large change in the appearance of the motor oil compared to shorter runs.
