TORTURE TEST MAGAZINE FOR SCIENCE... AND FUN

2004-2017 CRF250X PART 1

VOLUME 2, PART 1

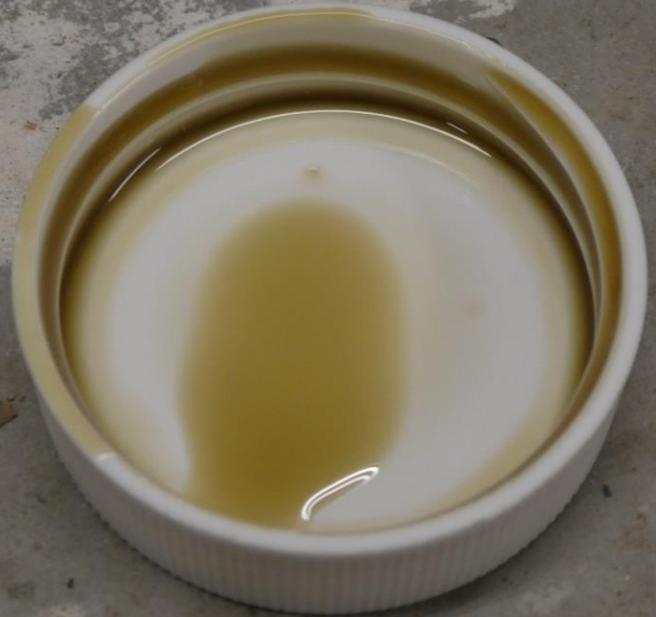
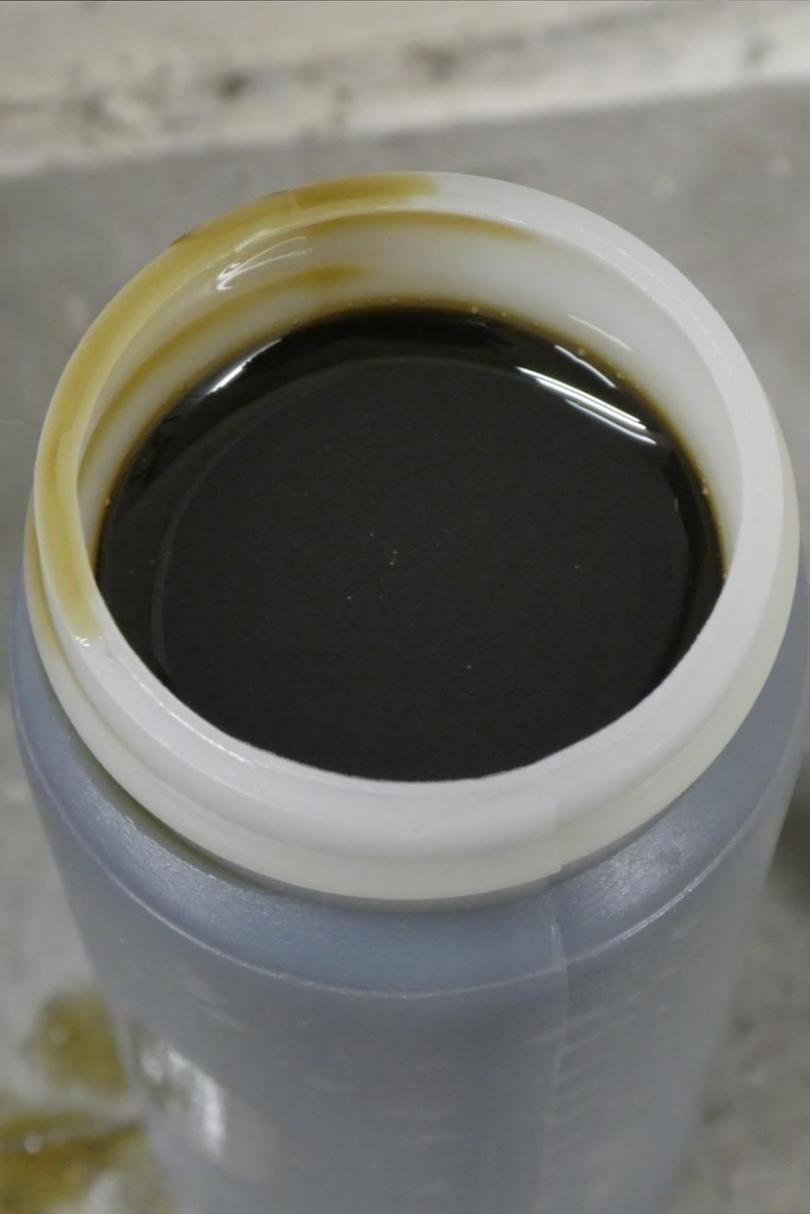
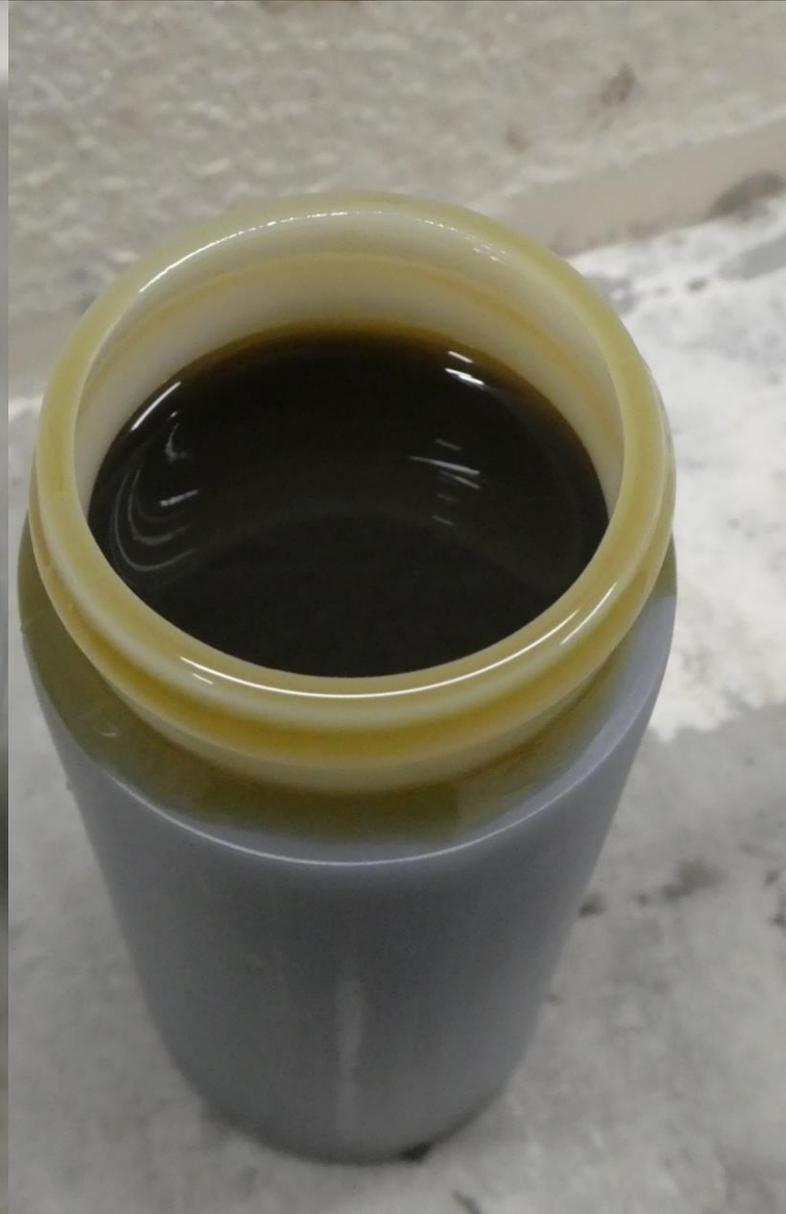
The oil filter was stained a lot darker this time. It is probably more saturated with fine, sooty dark junk after that whole hour of wide-open riding during the euro scramble. The visible solids caught in it look the same as the last oil change. The visible chunks are still just some aluminum flakes and blue paint.

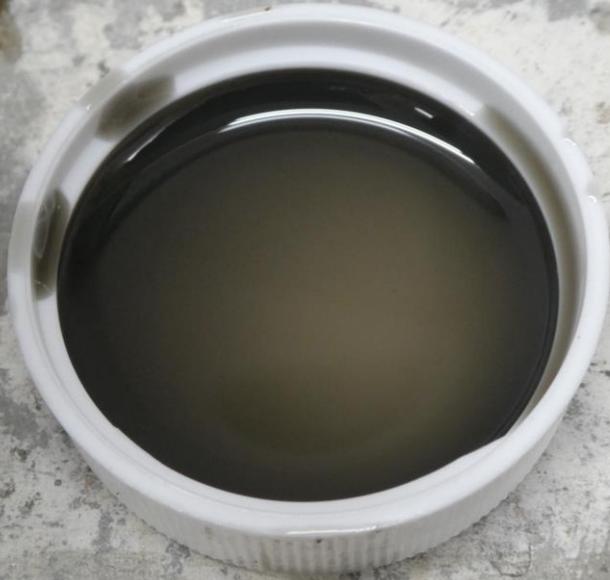
24 hours

No large change in the appearance of the transmission oil compared to shorter runs.

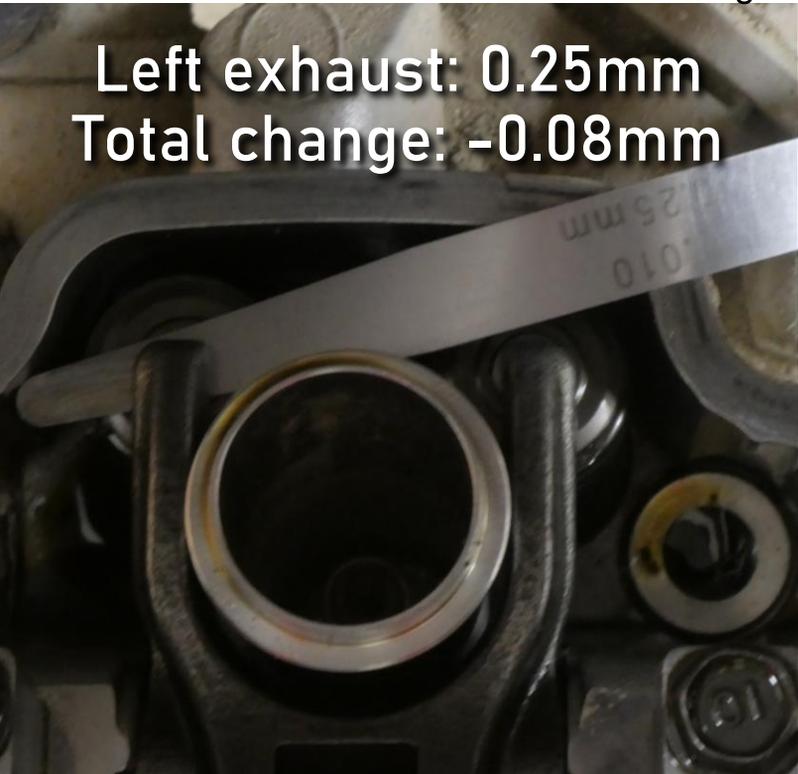
At 60 hours, the valve clearances had stayed the same with the exception of that pesky left side exhaust valve. It has worn itself back down to 0.25mm of clearance, which means it is 80% of the way to the safe limit or “danger zone.” It barely made it through the tier, which is a little bit disappointing. It could just stop wearing where it’s at, but that is extremely unlikely, so this head will probably not make it through the next tier. The frustrating part is that it is only that one valve which is being a problem. It was the same deal with the 2006 CRF250X head that the bike came with. Nothing ever wore in the head except for one exhaust valve which wore consistently.

Left exhaust: 0.25mm
Total change: -0.08mm

If this head hits the danger zone in Tier II with everything else on the bike still looking good, we’ll just go ahead and swap to an upgraded head setup so we can compare Honda OEM to an aftermarket solution. Ending the torture test due to one little exhaust valve would be such a lame thing to do!

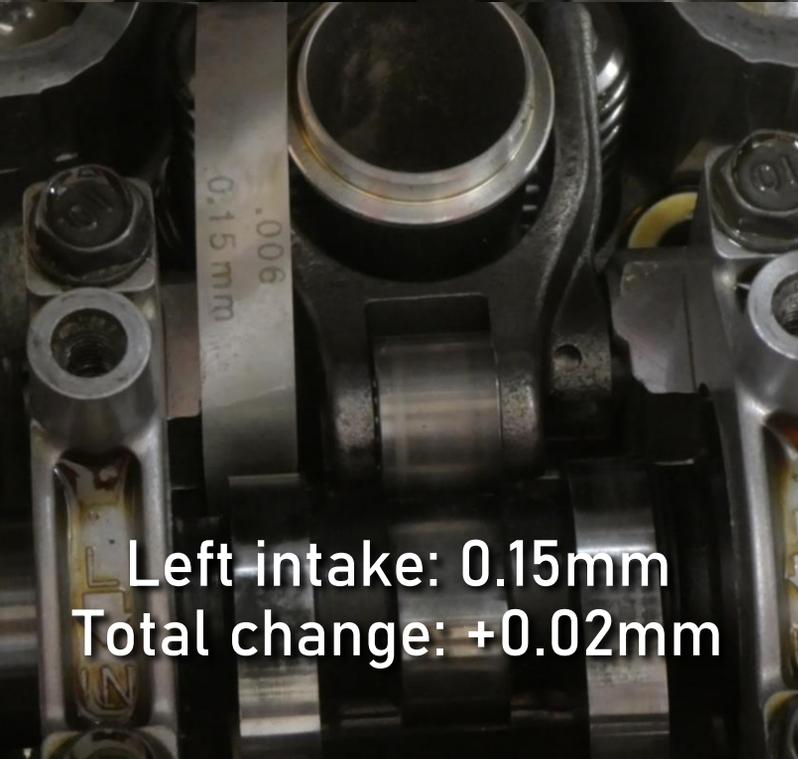
Left intake: 0.15mm
Total change: +0.02mm

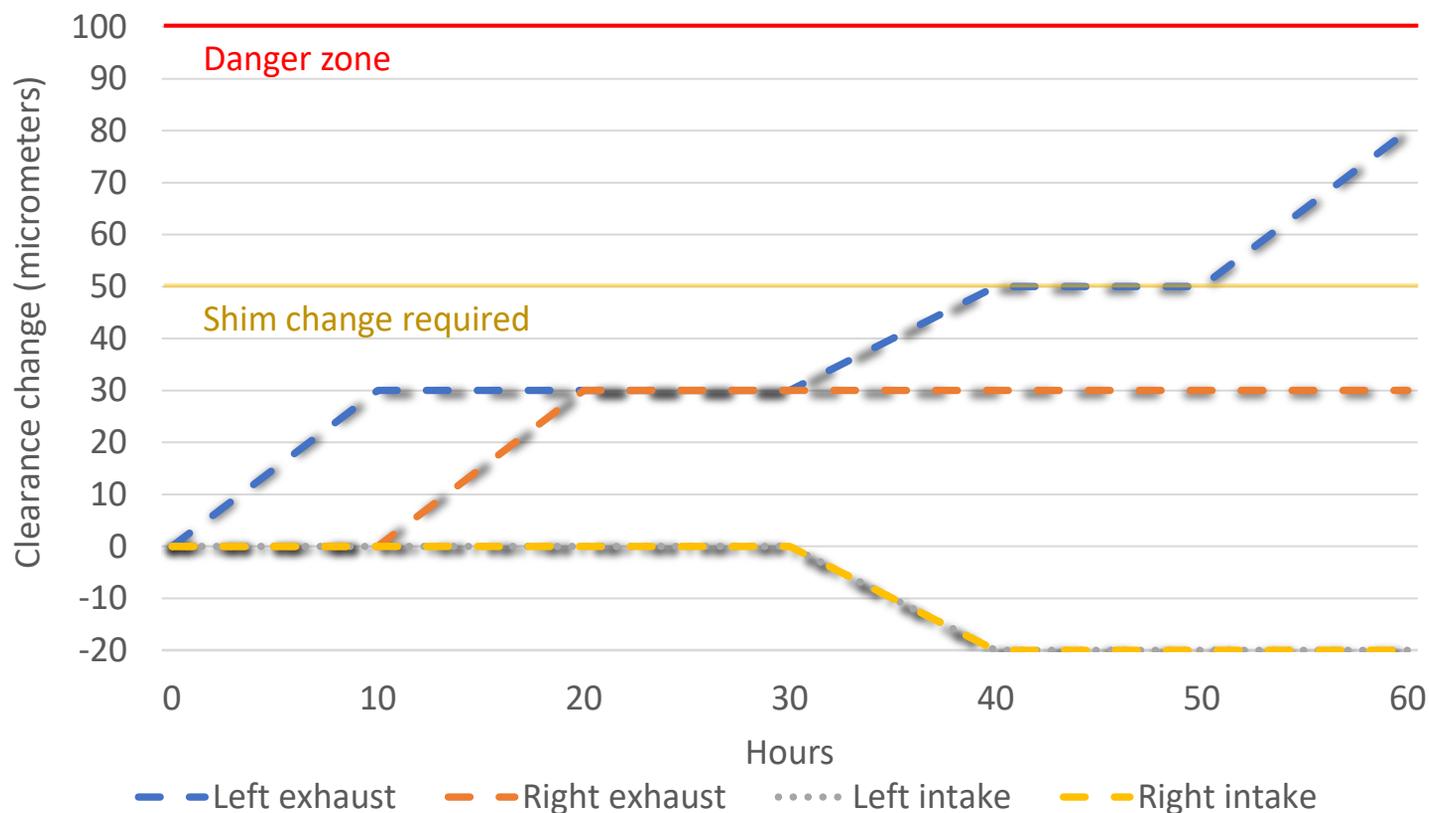
Valve clearance change (hours)

Looking at the charted valve clearance change for Tier I, the only valve showing a real trend is that left exhaust valve. It is averaging about 13.3 micrometers (0.0133mm) of wear-in every 10 hours, and it looks like it's only speeding up.

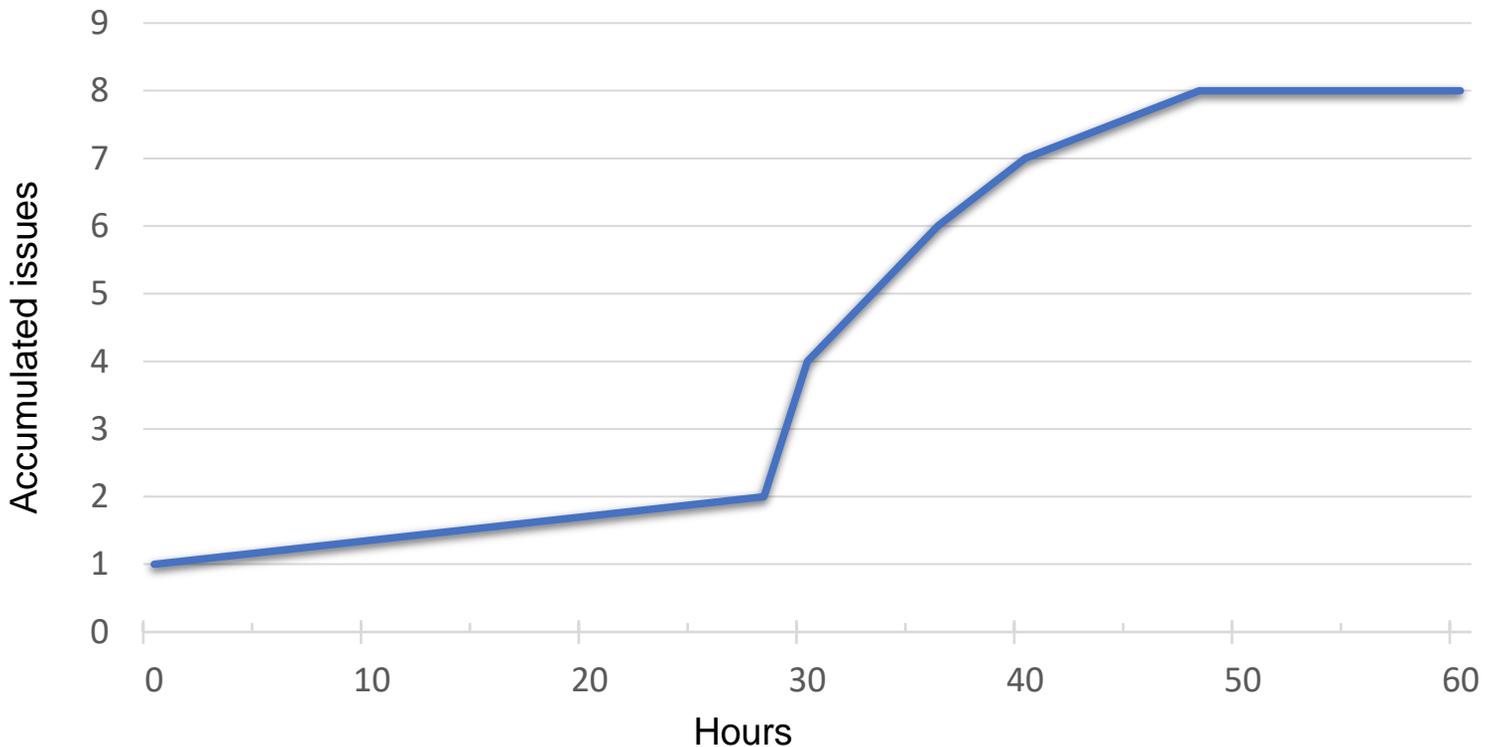
Accumulated Issues (Hours)

The CRF250X has had 8 issues requiring attention throughout Tier I. Averaged out, it has required attention once every 7 hours and 30 minutes, which is pretty close to once every four rides. I'd say this is a pretty normal result. The KDX200's worst result was 9 issues in Tier I, and it's best result was when it had only one single issue in Tier II. So far, the CRF250X isn't doing worse than the KDX200 in how often it requires attention. The 0-60MPH time is about the same, but came out 0.1 second faster at the end of the tier. The motor seems to have loosened up just a bit.

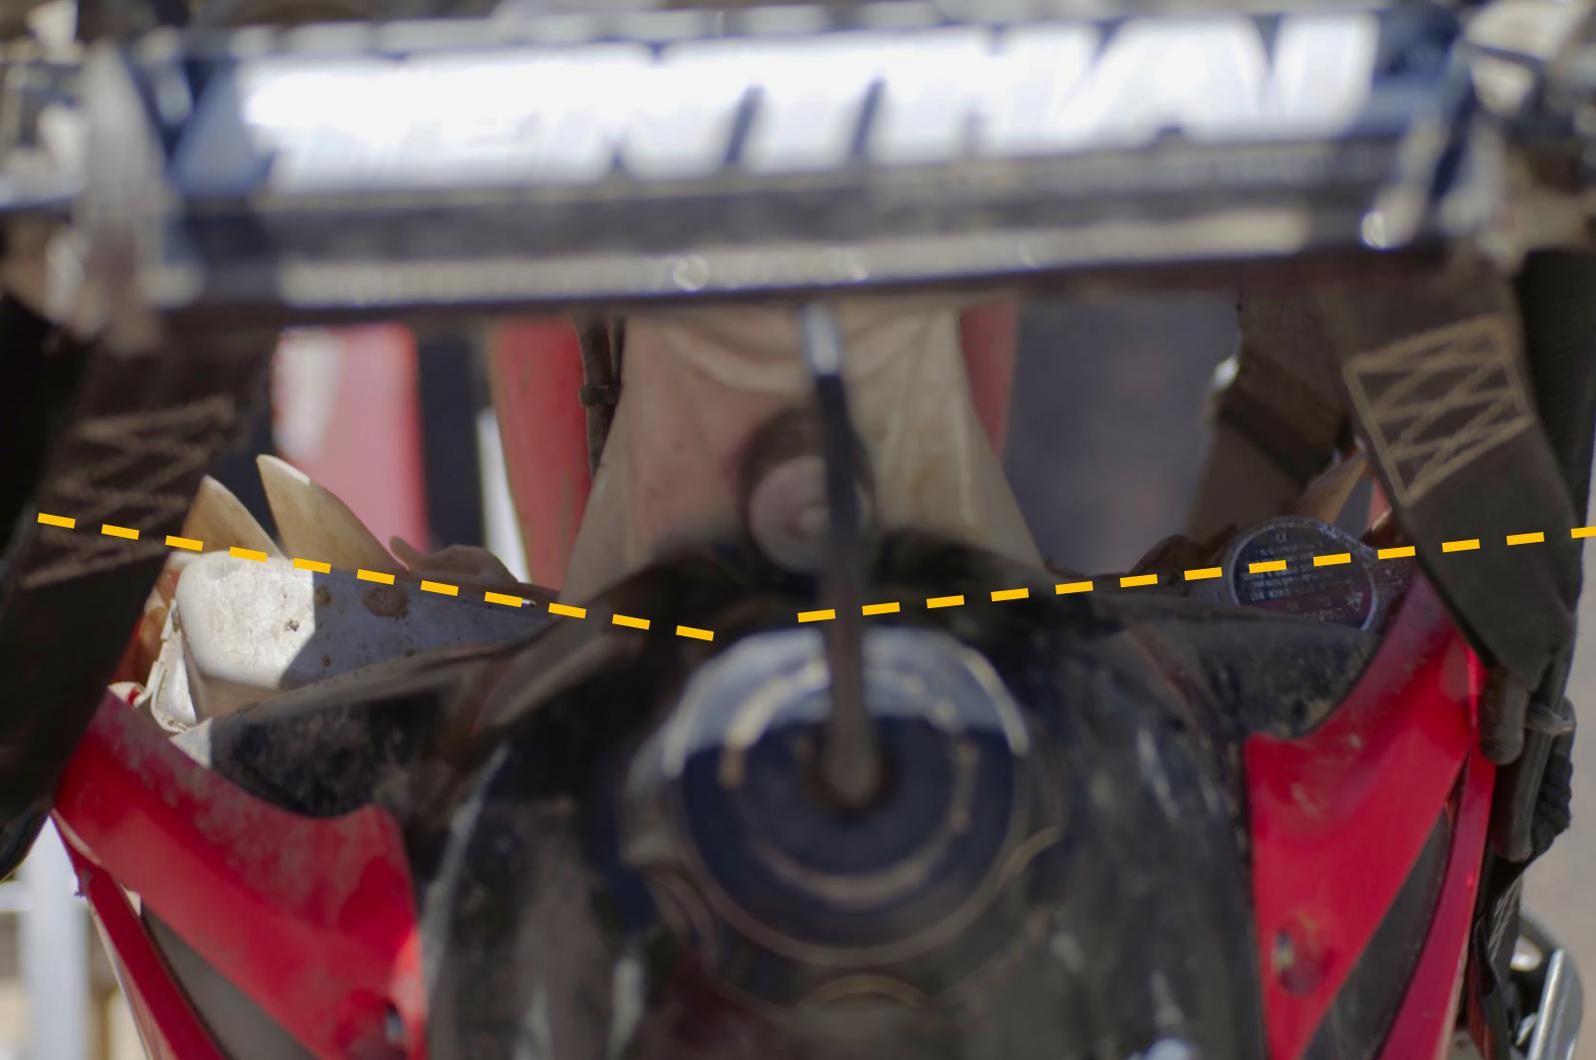
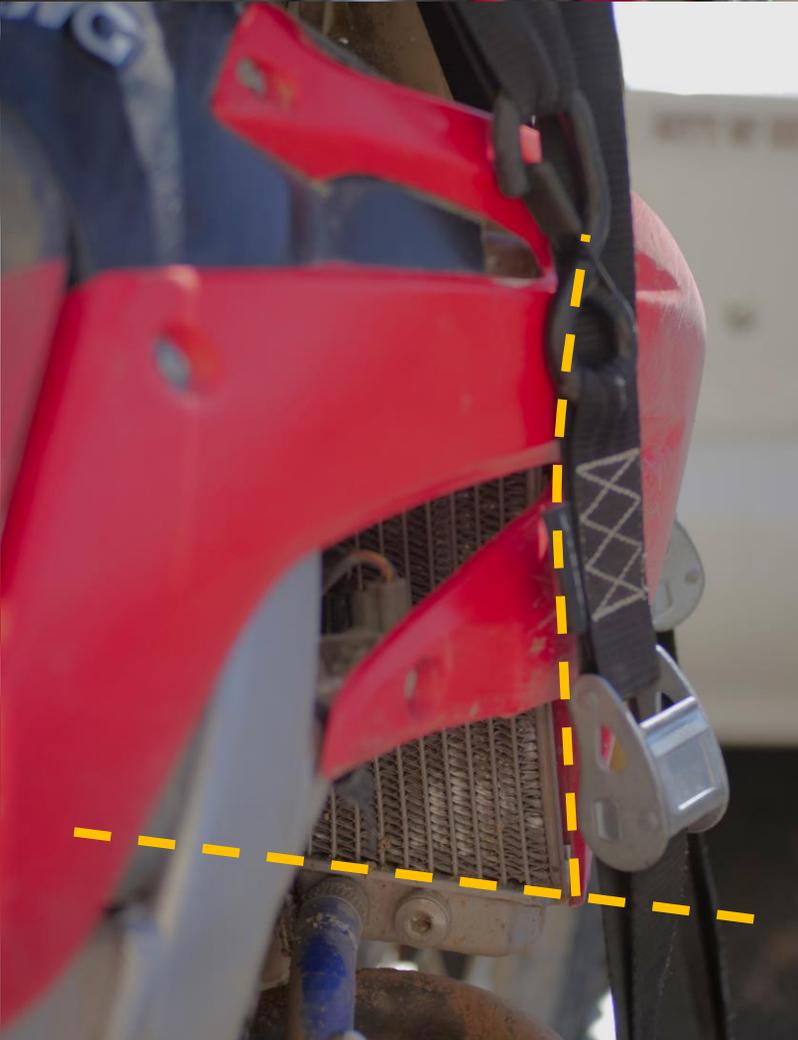
...There is definitely some external wear and tear. Most notably, the subframe is getting ground through badly where I grip it with my boots. It is especially bad on the left side of the bike. It might actually rub through if not addressed.

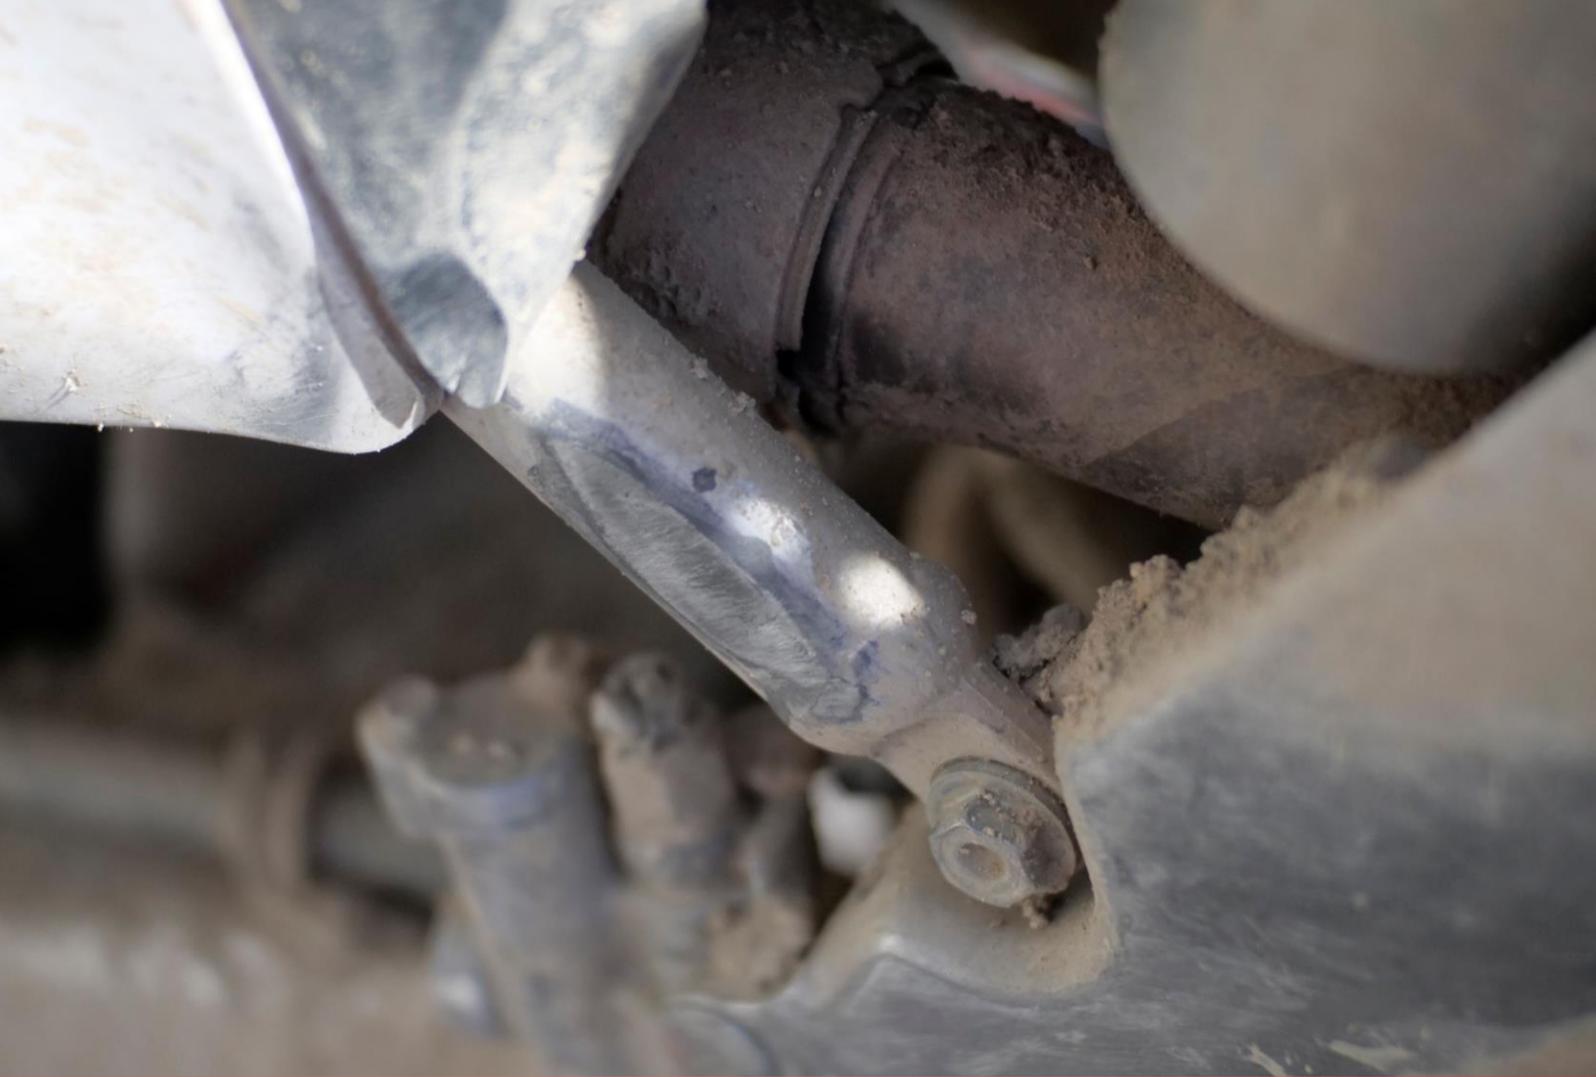
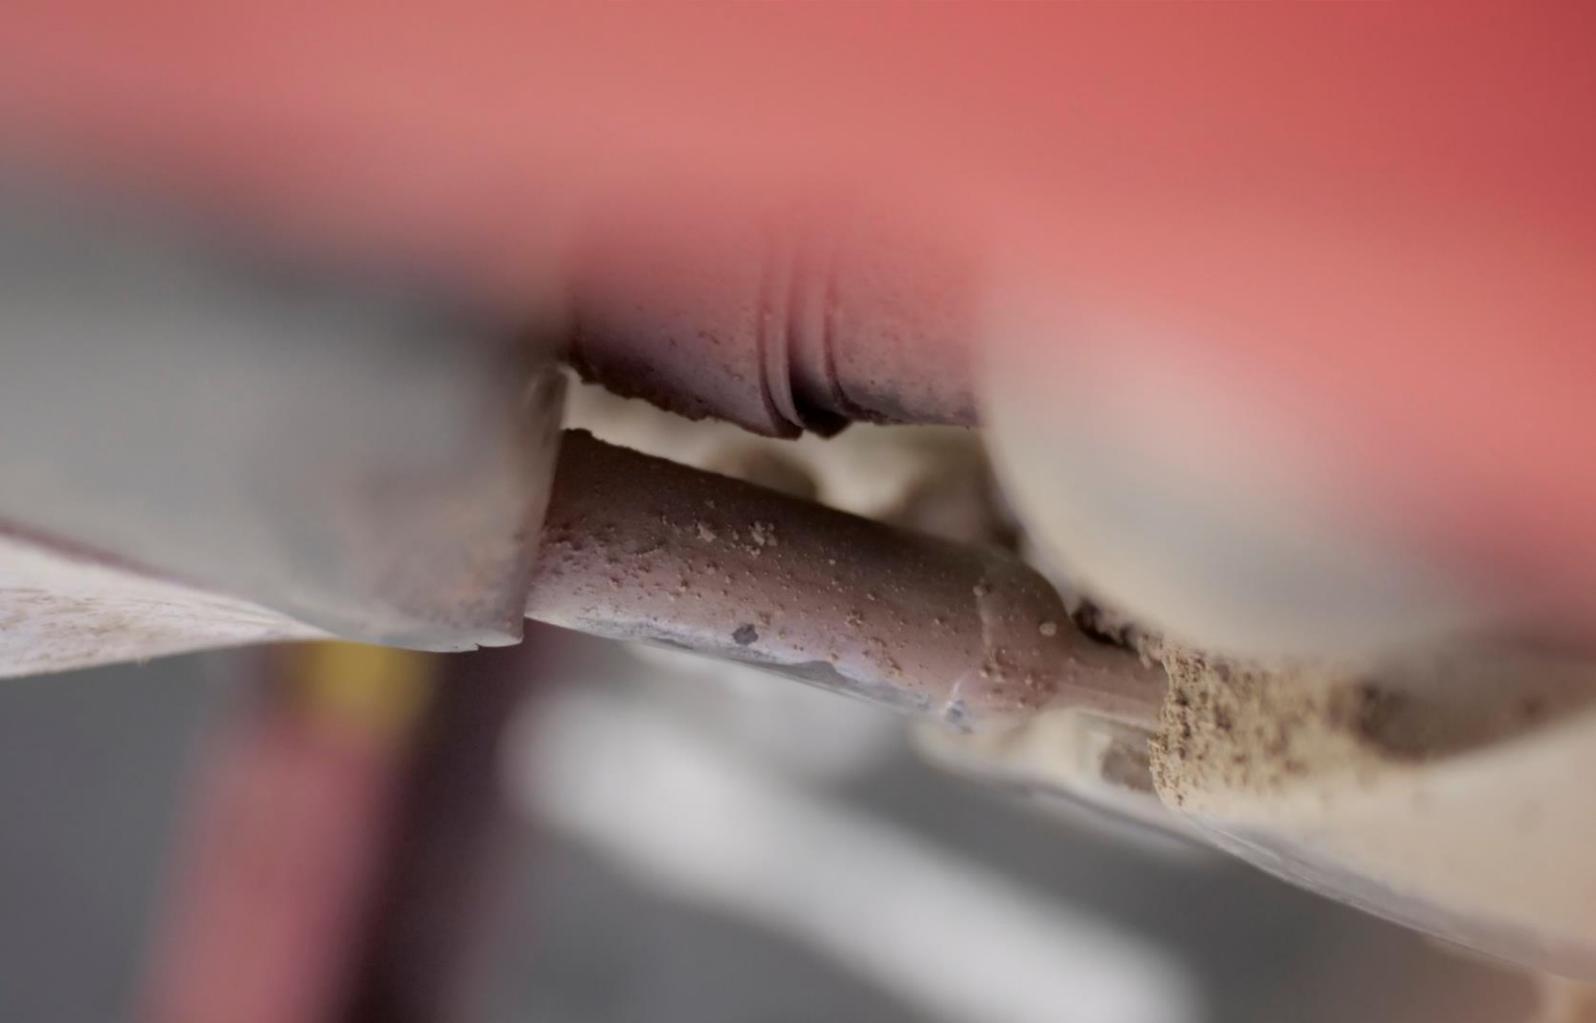
The swingarm has a rub mark from the kickstand rubbing on it, but there's not much depth to it. It would probably never rub through.

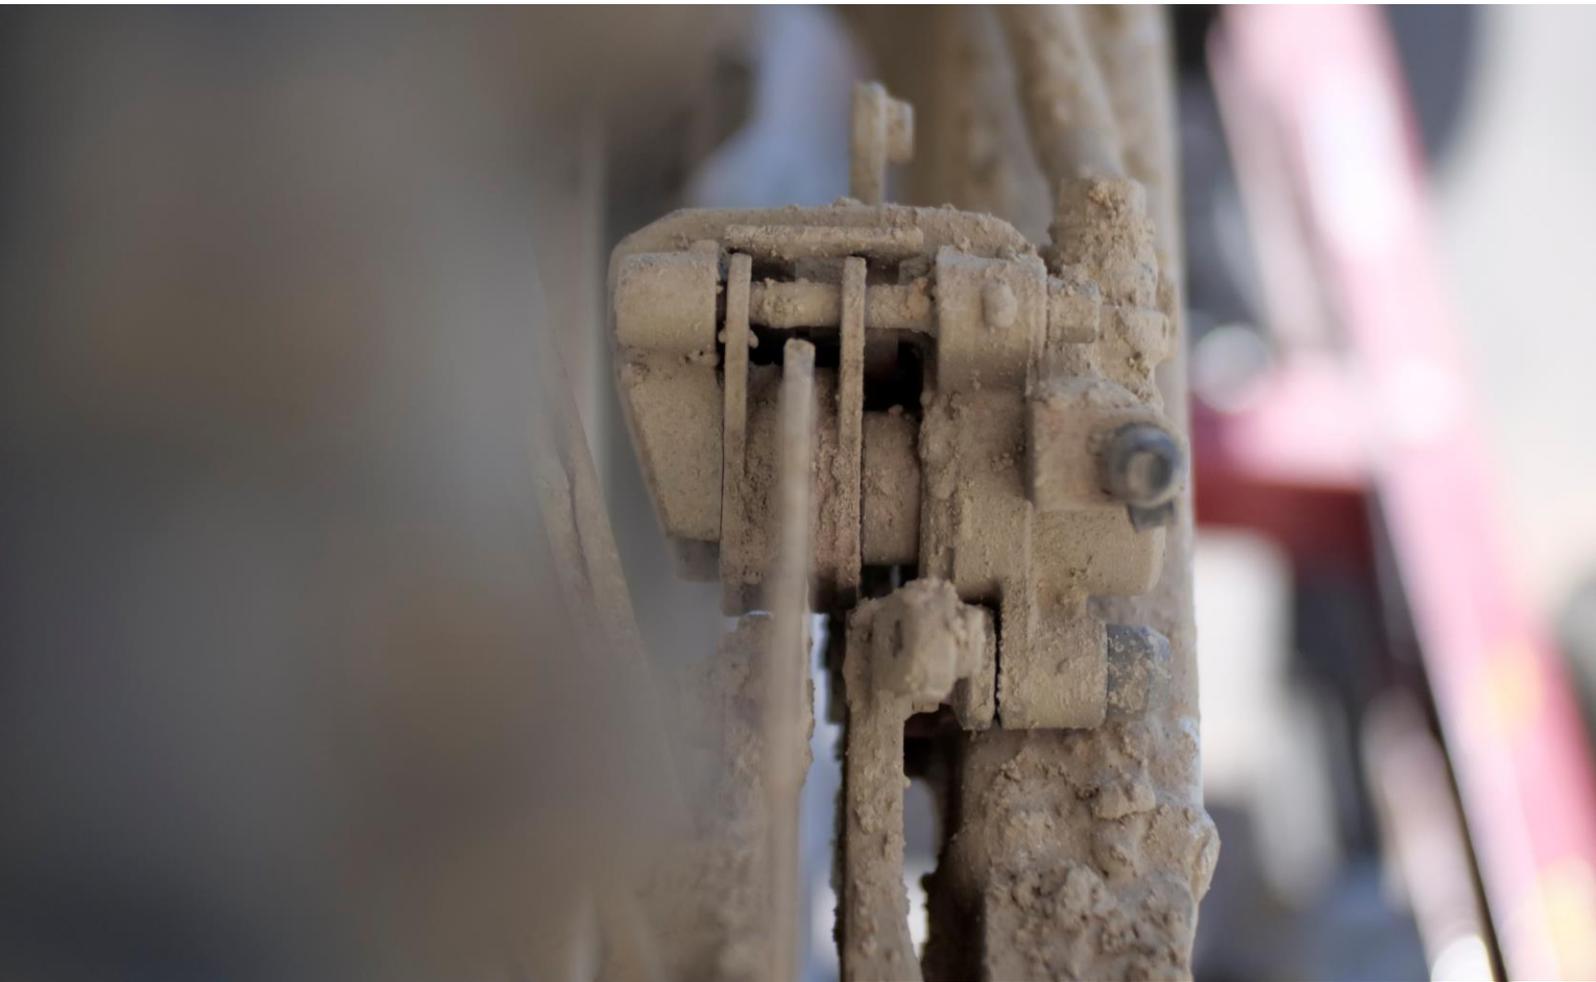
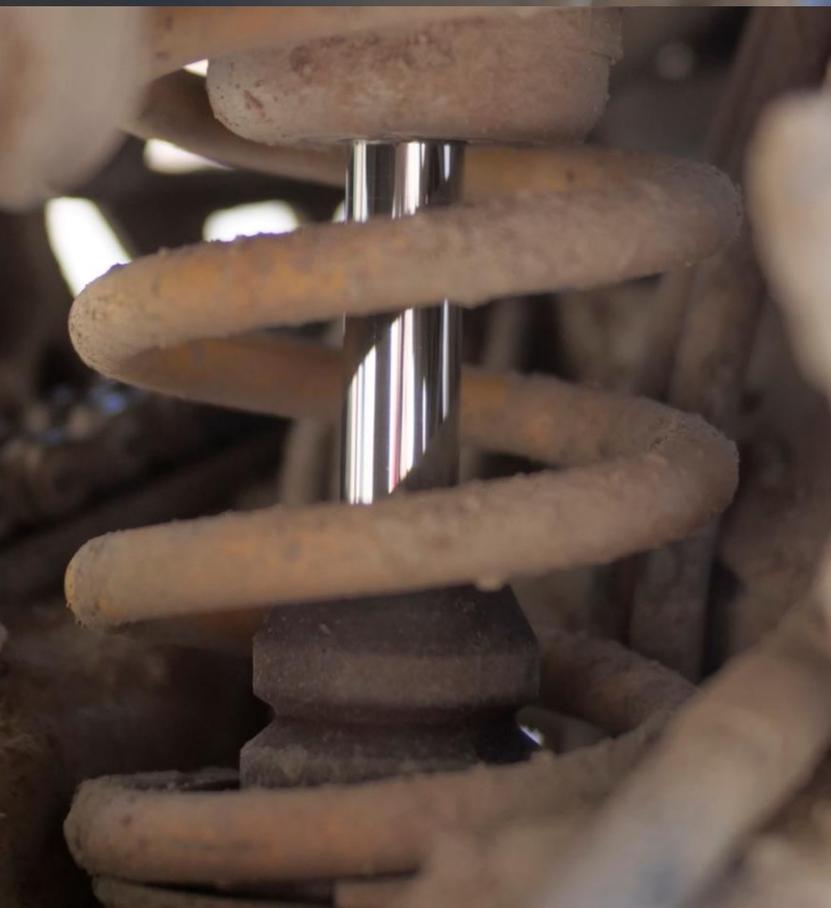
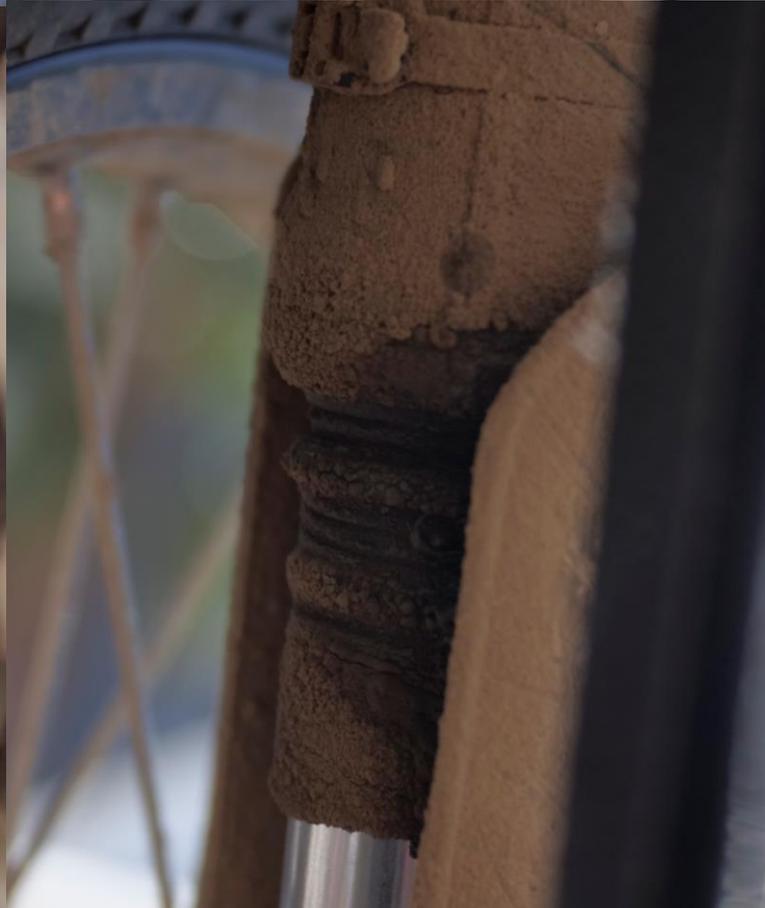
The front brake looks completely fine, and the rear pads are back down to about 50%. It's funny how quickly I wear out the rear pads on this bike compared to the KDX200. The heavier rotating mass of this four-stroke engine really makes the rear brake less responsive. The suspension is fine except for a minor leak of the right fork.
