This rock driller had it's entire systems treated with Cerma STM-3 treatments. Oil wear test were reported showing how the Cerma STM-3 Engine Treatment dramatically decreased engine wear.

Unit # : 890284  
Component : ENGINE  
Location :  
Manufacturer : CATERPILLAR  
Serial # :  
Model : R1600

**Fluid Life**  
*Oil Analysis*

**Fluid Life**  
*Trend Analysis*

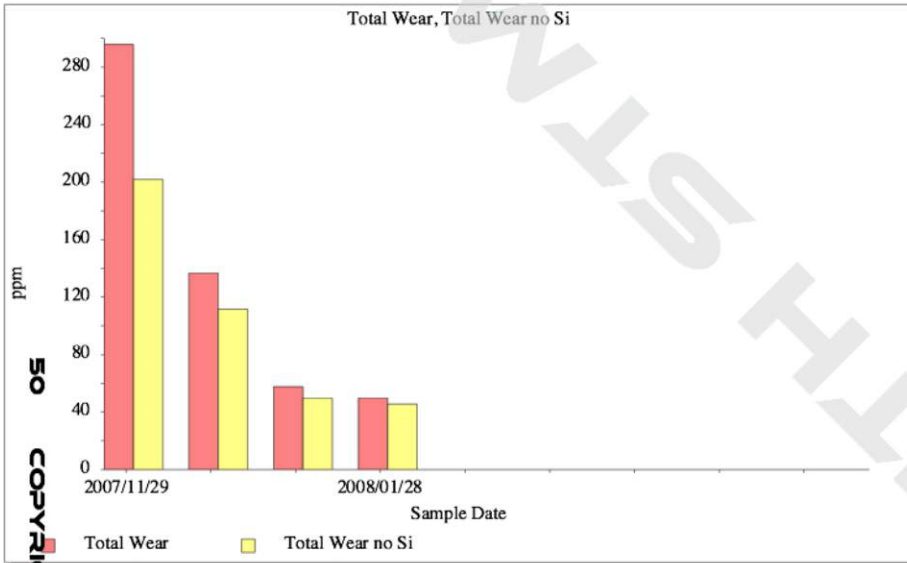
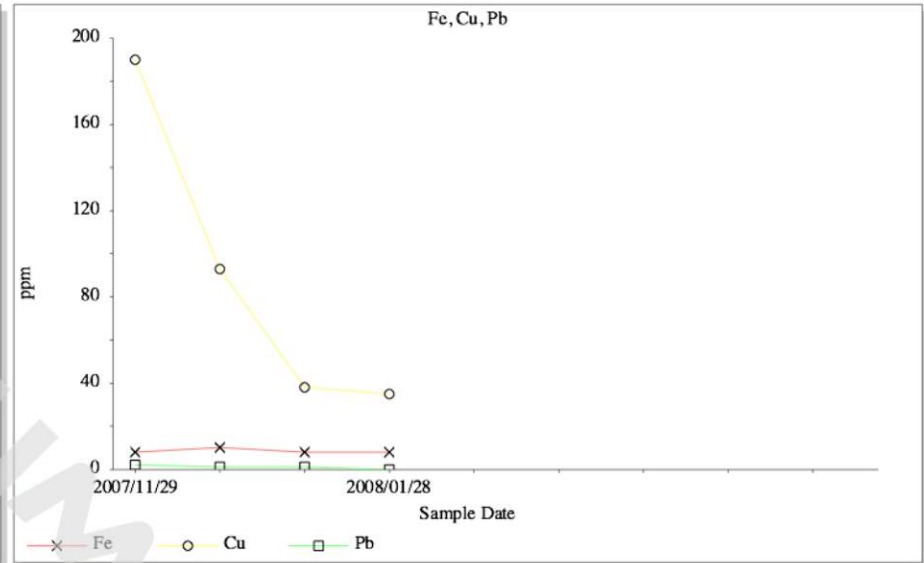
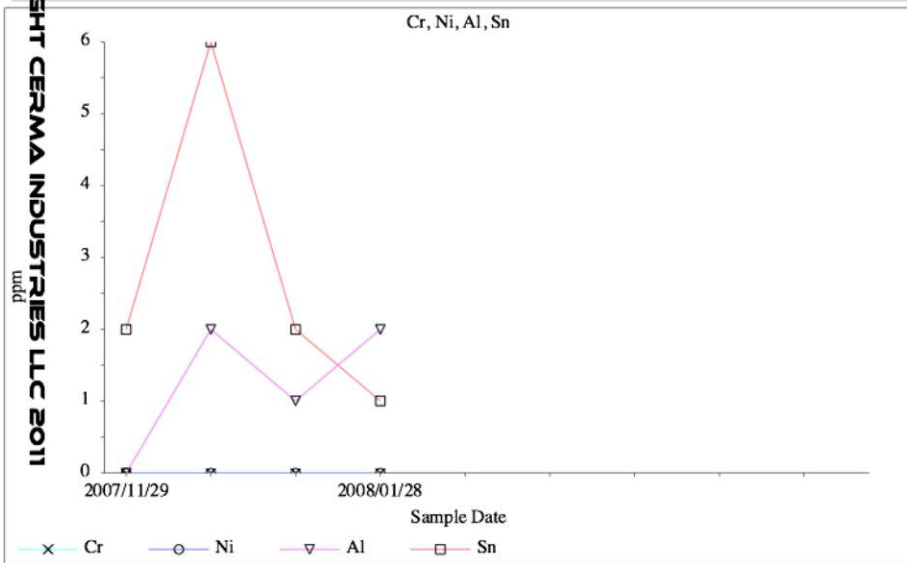
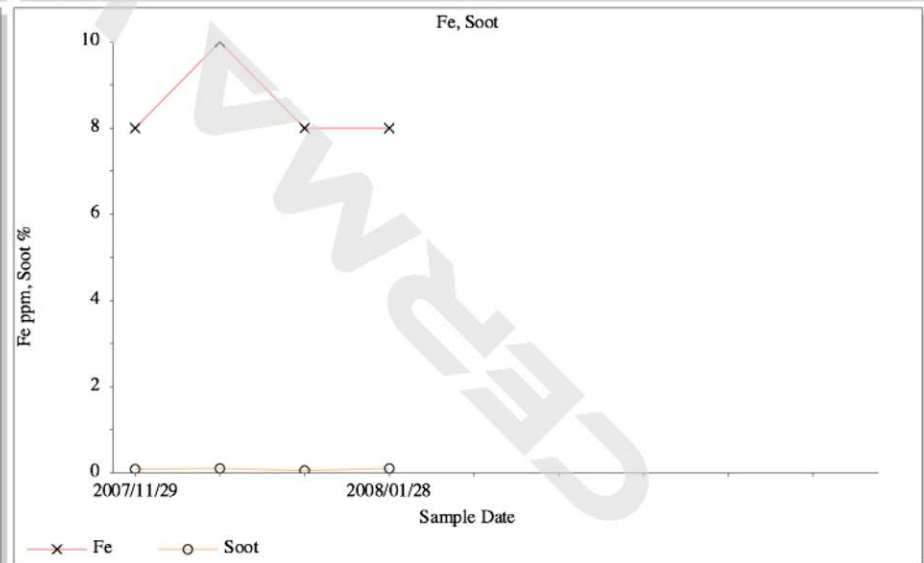
- Note the flagged element Copper.
- Copper can be found in cooler cores, bearings, bushings and thrust washers. It is also sometimes an oil additive and/or an anti-seize compound.

- If copper is the only element flagged, it is typically caused by surface leaching from cooler cores. In this case continued normal monitoring is sufficient.
