To Steve Lunn, AAS Metal Suppliers, Caringbah, NSW, Australia
From Jim Wright, co-owner and restoration project leader, Bowen Island, BC
Re the beach-access handrail and bench with your AAA fittings, September 8, 2021

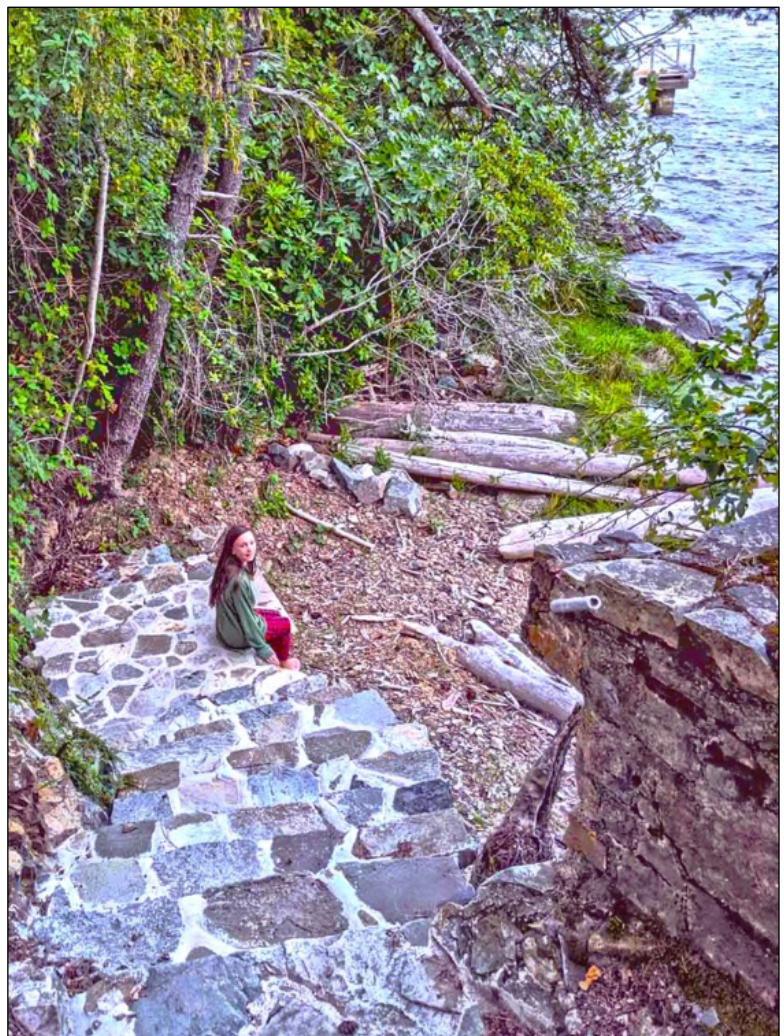
When a Bowen Island stonemason felt ready to meet the needs, he took the grouted-stone steps apart and reused all the stone. While restoring, he added bulk, drainage culverts and reinforcing bars that extend deep into bedrock behind and below the steps.

At right, looking downward, we see the structure at a largely restored stage. The view is from the cliff path that leads into the steps.

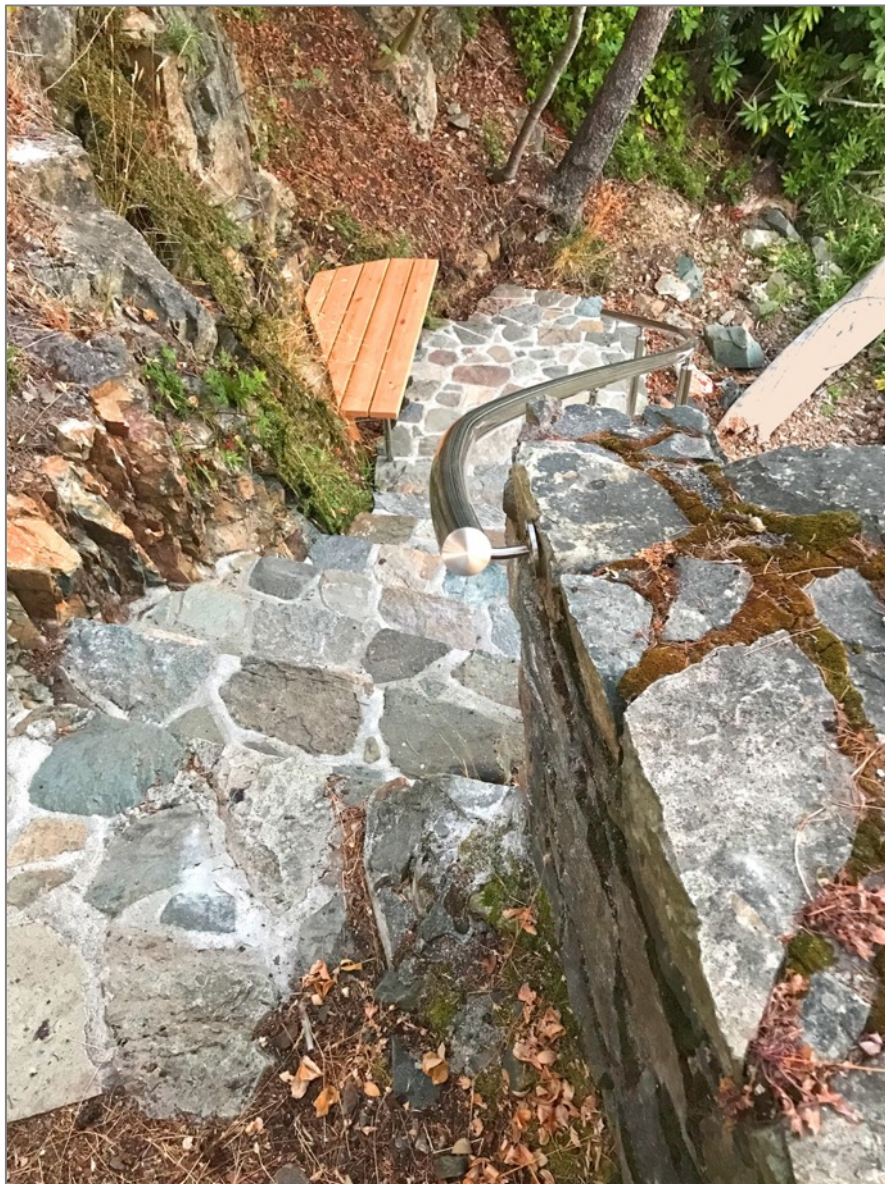
We obtained 1.5-inch marine-steel tube from the helpful local Metal Supermarkets. The tube finish is compatible with the AAA satin fittings. The tube is annealed—well suited to curving.

In an elongated S-shape, the curved rail that Chris created leads people from the cliff path at the top into the centre of the top step.

It then follows the curve of the steps downward.

Finally, it leads into the centre of the lookout-bench landing. (For optimal safety, it leads toward the bench and away from the front edge of the landing.)

Even though it has no *vertical* curve (just horizontal curve), the rail stays within the handrail-height range stated in the provincial building code.

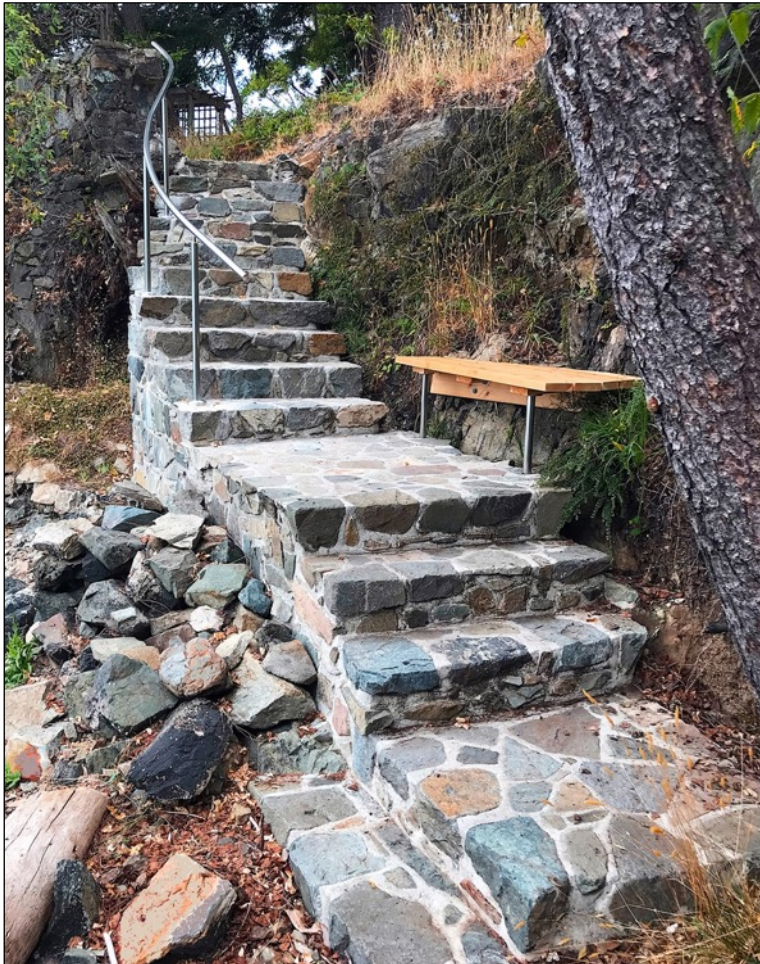
The three handrail posts, 1.5-inch marine steel tube like the rail, are embedded deep in the steps so that the rail can withstand 200 pounds of outward pressure (roughly as the building code prescribes). There's an AAA cover plate at the bottom of each post.

From this perspective, which is from the beach, looking westward, the fittings don't draw attention to themselves.

However, the results they enable are suitably safe, fittingly attractive, and designed to endure with a little care.

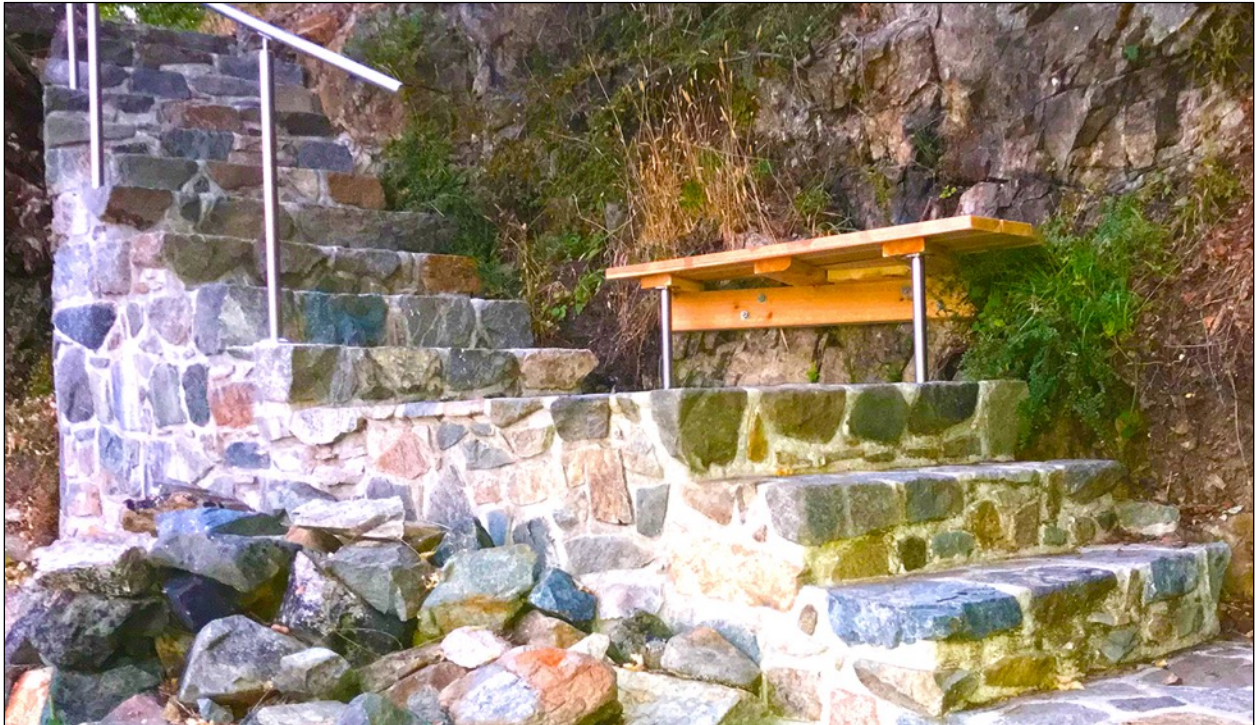
For the lookout bench on the main landing, just above the beach at the bottom of the long set of railed steps, the bench lumber is durable native Western Red Cedar. Especially since the cedar may need replacing every few decades, the whole bench structure is designed for efficient removal—as a single unit—for restoration when that is eventually needed.

At the back, the cedar bench is supported by threaded steel rods (extending from deep in the cliff bedrock), with washers and tightened nuts visible (from the beach) at the outer end. They secure in place the large cedar board at the back. (It serves like a beam for three joist-like front-to-back boards supporting the set of five boards that comprise the bench seat.)

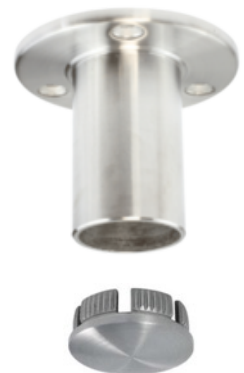
The two front legs of the bench (marine steel tube, 1.5 inches in diameter, from the local Metal Supermarkets) are held in place by long base plates from AAA Metal Supplies. They were inverted and screwed (upward) into the bottom of the joist-like cedar bench-seat support near each end. At the bottom of each leg, there's an inverted AAA end cap inserted into the tube. The described construction enables strength and may preclude damage when the bench is inevitably rocked or pounded in several directions.
