This is a repository copy of *Method for evaluating the snagging propensity of roofing membranes in buildings by roosting bats*.

Essah, EA, Russell, SJ [orcid.org/0000-0003-0339-9611](https://orcid.org/0000-0003-0339-9611), Waring, SD et al. (5 more authors) (2020) Method for evaluating the snagging propensity of roofing membranes in buildings by roosting bats. *Building Research & Information*. ISSN 0961-3218

# Method for evaluating the snagging propensity of roofing membranes in buildings by roosting bats

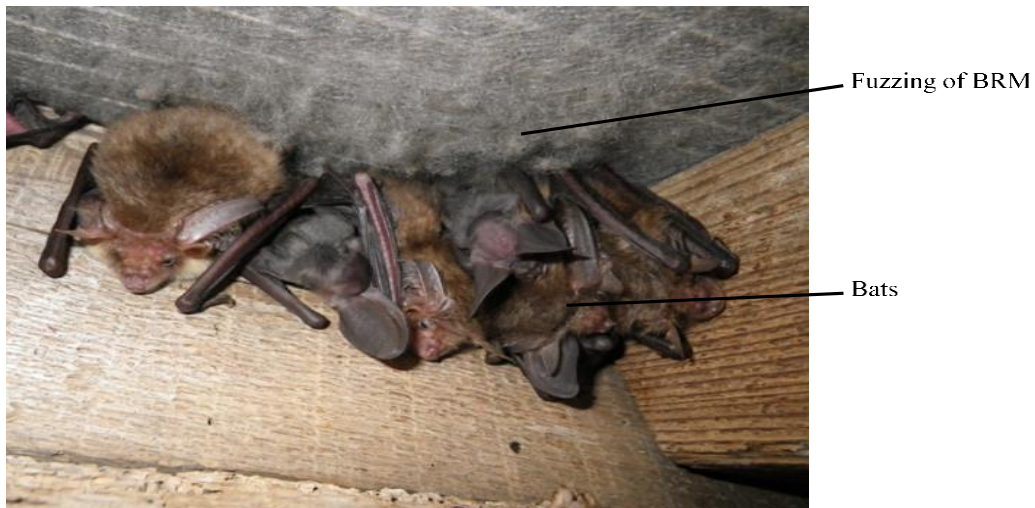
**Figure 4.** Example of fuzzing on a nonwoven membrane within a bat colony (Courtesy of John Martin, Cumbria, UK)

During roosting, bats physically interact with the surface of roofing membranes through the gaps between battens and in the roof space (Figure 4). Their claws snag the surface of the NBCRM, which can cause loops of continuous filaments to be teased free from the fabric structure to produce surface 'fluffiness'. Concerns have been raised since 2004 about the level of bat mortality (Waring et al, 2013; Waring, 2014) as they are often caught in these loose, strong filaments, becoming fatally entangled. In Scotland this situation would not normally arise in the roof void as the membrane would be located behind the wooden sarking boards, against which the bats would roost. However, there is still potential for crevice dwelling bats such as *Pipistrelle* species to interact with the NBCRMs when roosting underneath roof tiles.

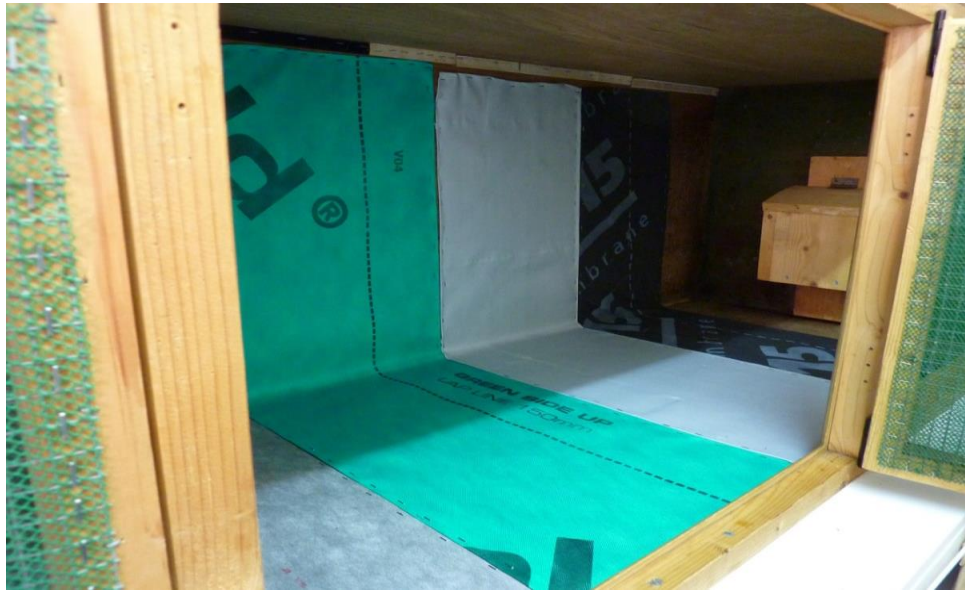
**Figure 10.** Photograph showing the four test specimens fitted inside the pipistrelle aviary

A small field study was conducted to verify susceptibility to disintegration and loop formation of three different BRM samples (sample A-C) and one nPRM (sample D) when bats crawl across their surface within a roost. These observations were then compared with the corresponding laboratory pilling box, test data. A sample of each NBCRM specimen (300mm x 900mm) was fitted into an aviary at the Isle of Wight bat hospital (Figure 10). Two aviaries were chosen because they contained bat species; pipistrelles and serotines, which have been previously reported to have been found entangled in BRMs installed in real buildings. The four specimens A, B, C, and D (see Table 1) were fitted into the aviaries (Figure 10). An aviary (flight cage) at a bat hospital was chosen as this enabled ground truthing of the interaction of bats with the membrane but within a controlled environment in which the bats were under observation to prevent any risk of injury or death as a result of entanglement. This approach would have not been possible in a roof-void roost and was therefore discounted as unethical. This is acknowledged as a limitation of this approach although the bat hospital proved a valid proxy. In addition, the fact that only the front surface (i.e. where bats mostly roost) of the NBCRM was considered maybe a limitation since bats can be found to also roost between the tiles and the battens (i.e. the back surface of the material).

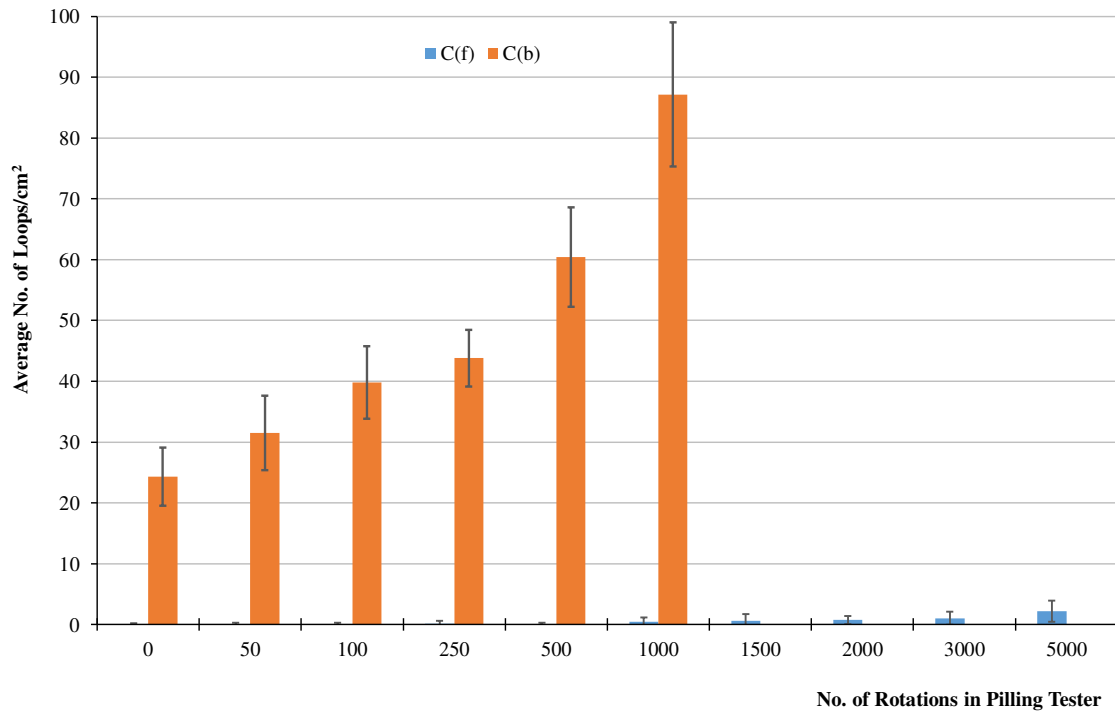
**Figure 13.** Average loop formation per cm<sup>2</sup> developed after a known number of rotations of Specimen C within the Pilling Box tester

It must however be noted that in contrast to standard building design configuration, where bats find themselves roosting between the roof tiles and at the back of the membrane, then Specimen C (Figure 13) becomes the most susceptible to loop formation and potentially bat entanglement. Specimen B (Figure 12) has comparable loop formation regardless of the side considered however, for the same number of rotations, loop formation on the back was marginally higher than that of the front. This is further explained by considering the overlapping of the error bars of the data for the front in comparison to that of the back and vice versa, which implies that the data is not significantly different. In addition, confirming that the loop formation at the front is similar to that which was formed at the back. The implication of the overlap is evident in Specimen A (50 and 1000 rotations).

It should be noted that loop formation appears to be recorded after 'No. of Rotations in Pilling Tester' is 0 (Figures 11 – 13) however this is due to the nature of the spunbond fabric structure, where surface filaments project as loops at only certain points across the surface.

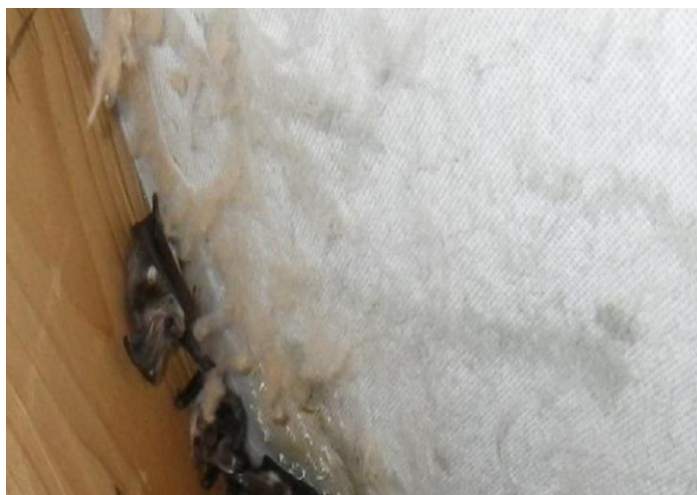
**Figure 14.** ‘Fluffing’ of a BRM surface four months after being fitted in a bat roost (Sample B)

It is informative to consider these results in the light of the field study data obtained for the samples exposed to live bats at the Isle of Wight bat hospital. Firstly, it is evident from Figure 14 that the mode of damage, i.e. dislodgement of continuous filaments and ‘fluffing’ of the fabric surface evident in the bat aviary-retrieved samples is replicated in the pilling-box test method reported herein.
