# Aqua Lung America **TECHNICAL BULLETIN**

Jan 31, 2010  
No. 30

**SUBJECT: POWERLINE GRAY BUTTON COVER (PN 15100)**

**PRODUCTS AFFECTED:**

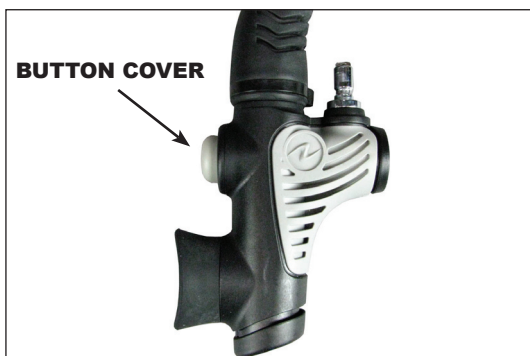
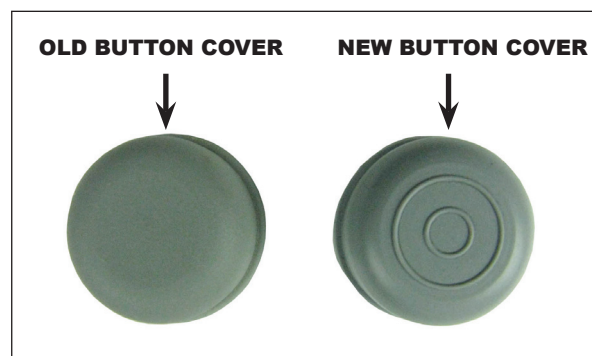
Aqua Lung is aware that some of the **Gray** Powerline Inflator buttons are not as durable as we had anticipated. Some buttons show aging, discoloration and lack of resiliency (they remain compressed).

To improve this situation, Aqua Lung has made a material change to the button which will provide better performance and longevity. The image below helps you to identify an older button from the improved button.

In an effort to upgrade the buttons in the field, Aqua Lung will be including the improved button in each of the Powerline service kits, p/n 42609, at no additional charge, for a period of one year. When servicing a Powerline inflator, please take the time to swap out an older button for an improved one.
