## **Refrigerator Kit Instructions**

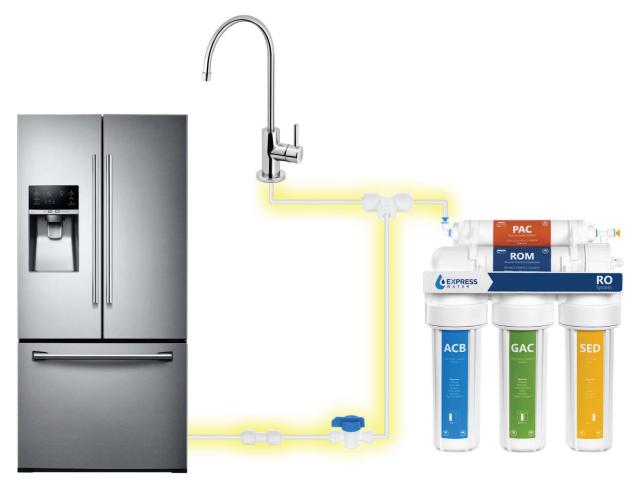
- 2. Turn OFF the water supply to the system with the Feed Water Adapter Valve.  $\,$
- 3. Close the Tank Valve.
- 4. Turn ON the RO Faucet to relieve pressure and release water in the system until water flow stops completely.
- 5. Locate the tubing that connects your RO System to your RO Faucet and place a small bucket and dry towels under this tubing.
- 6. Cut the tubing straight approximately 12 inches from where the tubing comes out of the RO System and allow water to drain into the bucket.
- 7. Install the Union Tee fitting on the tubing connected to the RO System by pushing one of the two aligning ends on the tubing as far as you can, then pulling it lightly to verify tubing is secured.

- 8. Install the other of end of the aligning Union Tee fitting into the remaining cut tube connected to the RO Faucet.
- 9. Take the new  $\frac{1}{4}$ " tubing and cut a 10" piece off. Insert this 10" tubing into the Tee line, which should be perpendicular to the tubing line going from the RO System to the RO Faucet.

- 10. Connect the shutoff Inline Ball Valve into the other end of the 10" tubing.
- 11. Connect one end of the remaining long ¼" tubing to the other end of the shutoff Inline Ball Valve. This valve should be turned off (pointed perpendicular from the tubing line) until RO System flushing process is complete (applicable for new systems and filters)

- 12. Run the 1/4" tubing from the RO System and connect to the refrigerator/ice maker using the Union Connector fitting if necessary.
- 13. Be sure you have the recommended water pressure to your ice maker according to the refrigerator manufacturer.
