SUZUKI

TYPE: Jimny

MODEL: SN413, FJB33V

DETAIL: 3 Door 1.3L Hard Top / Soft Top, 1.5L TDi GJ 2018 ON

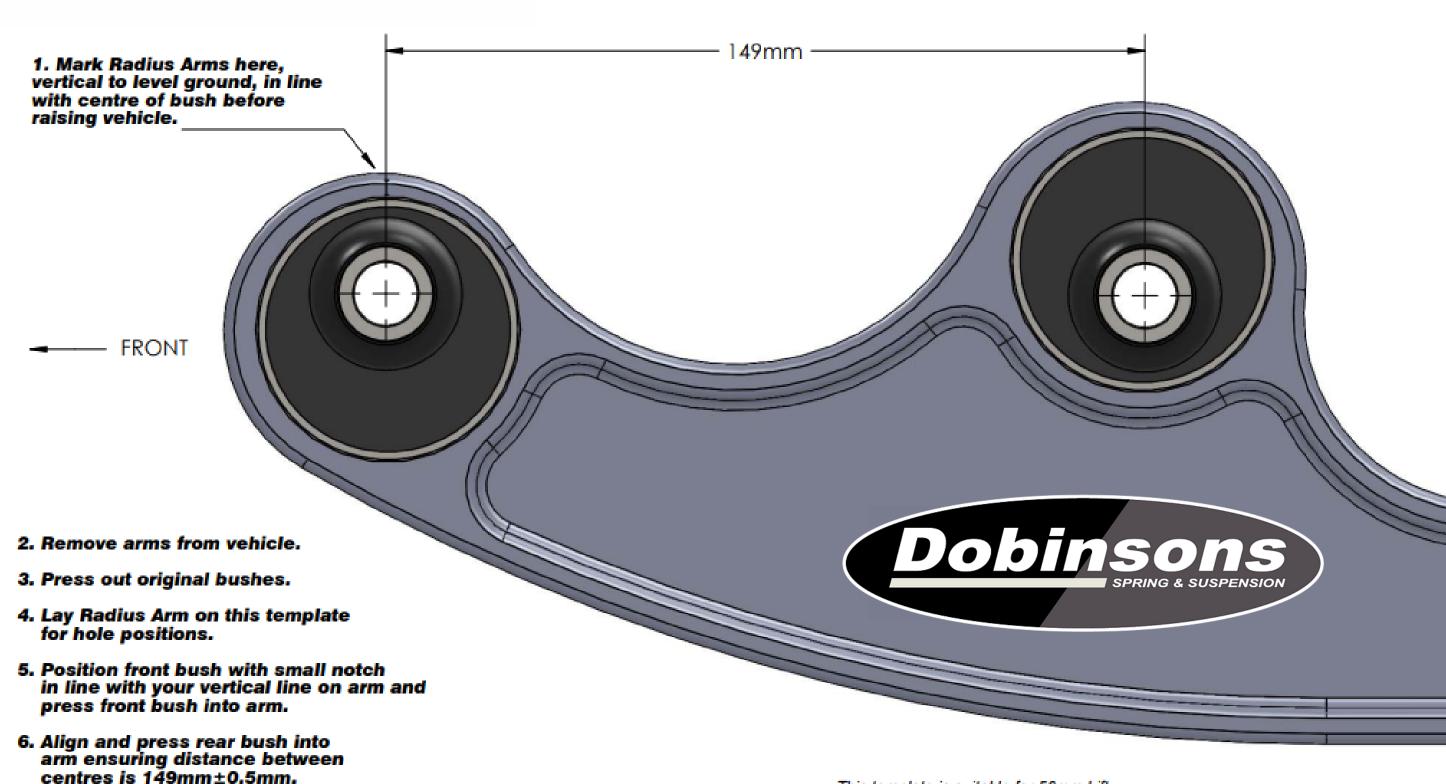
This template is suitable for 50mm Lift.

For lifts other than 50mm, your vertical line
may be positioned different to this template, in such a case,
use your vertical line and disregard this template.

Not suitable for vehicle lifts greater than 80mm.

7. Ensure bushes in both arms are identical. (Lay arms together to verify)

8. Re-install arms to vehicle, and perform wheel alignment. (Check tension of bolts after 500km)
