Subject: **Report of Evaluation and Testing of Salt Scaling Resistance
GAIA Enterprises Ice Melt and Traction Products
Safe Paw and Traction Magic
TEC Services Project No. TEC 16-1297.01 (Lab ID: 16-607)**

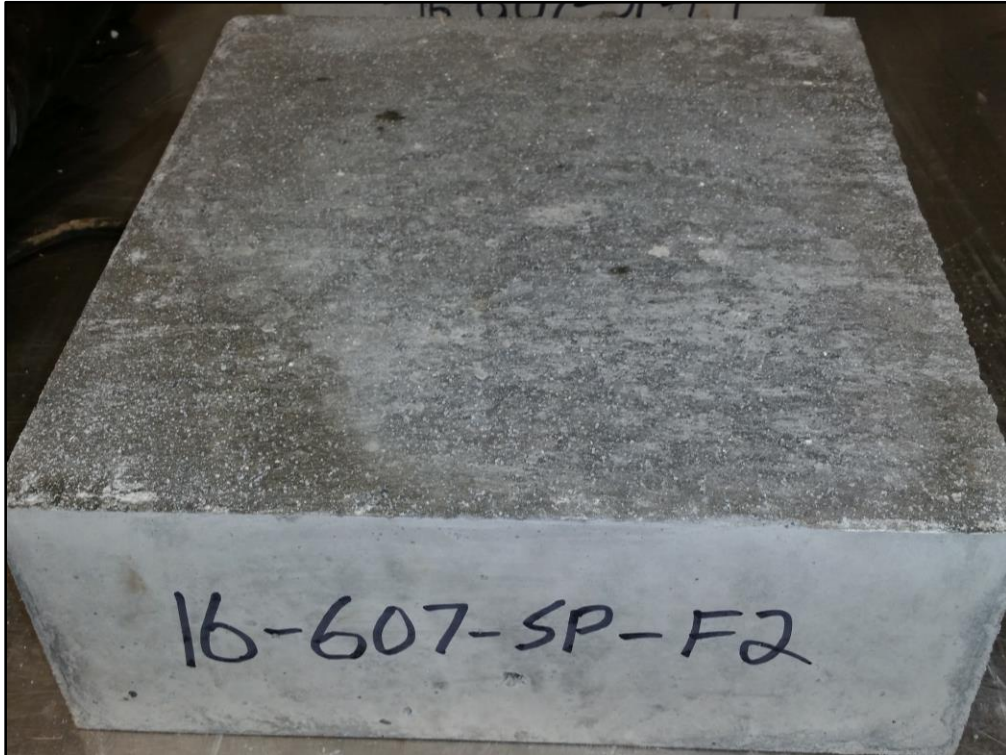
Figure 1. Photo of the Safe Paw sample prior to testing.

The SafePaw and Traction Magic materials were applied to the surfaces of three day old concrete test slabs and tested in accordance with ASTM C672-12, *Standard Test Method for Scaling Resistance of Concrete Surfaces Exposed to Deicing Chemicals*. Testing ran for 14 cycles. Photos of the test slabs for both materials taken prior to, during, and after the completion of the testing are provided in **Figures 1 – 6** at the end of our report.

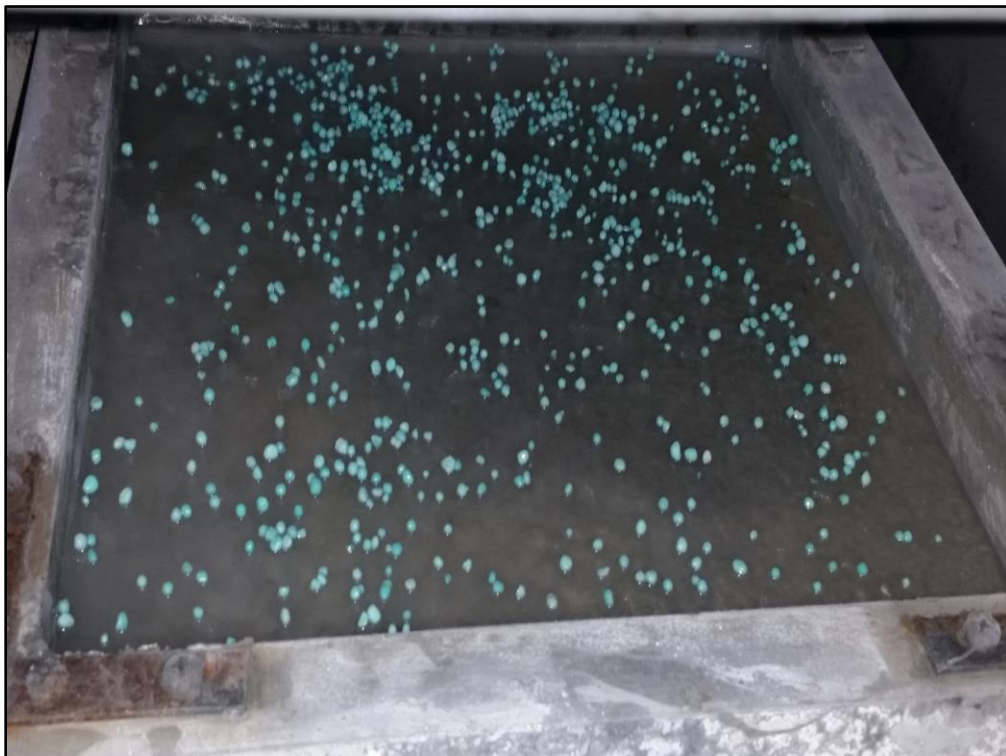
Figure 2. Photo of the Safe Paw sample during testing.

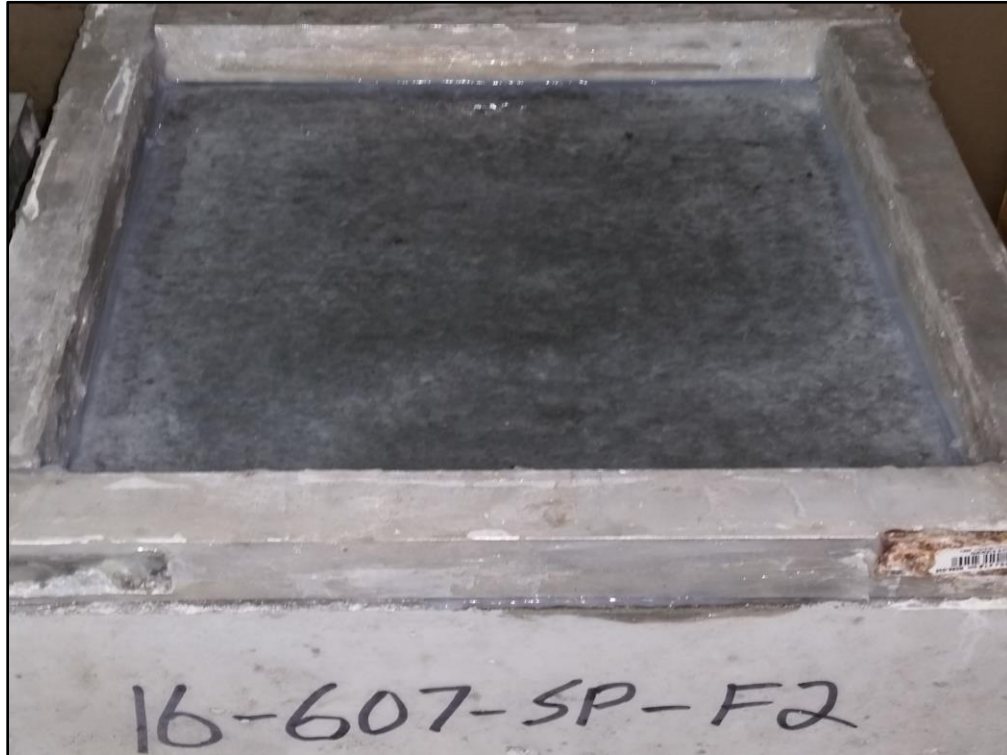
Figure 3. Photo of the Safe Paw sample after testing.

The results of our testing are reported in **Table 1** at the end of our report. The results of the testing indicate no surface scaling occurred.

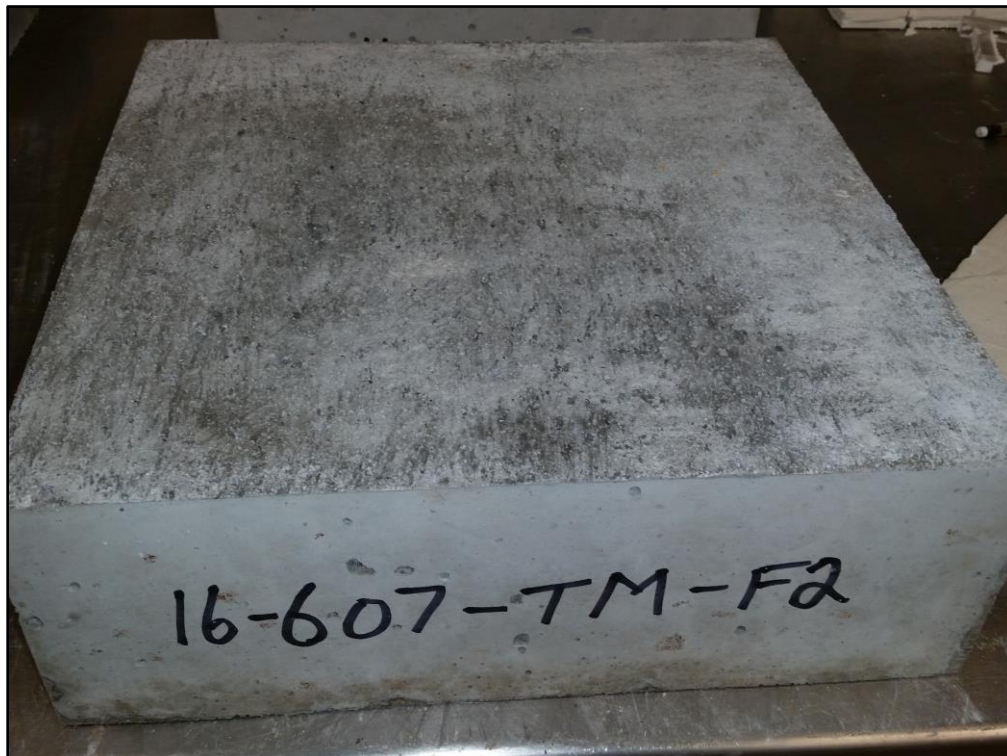
Figure 4. Photo of the Traction Magic sample prior to testing.

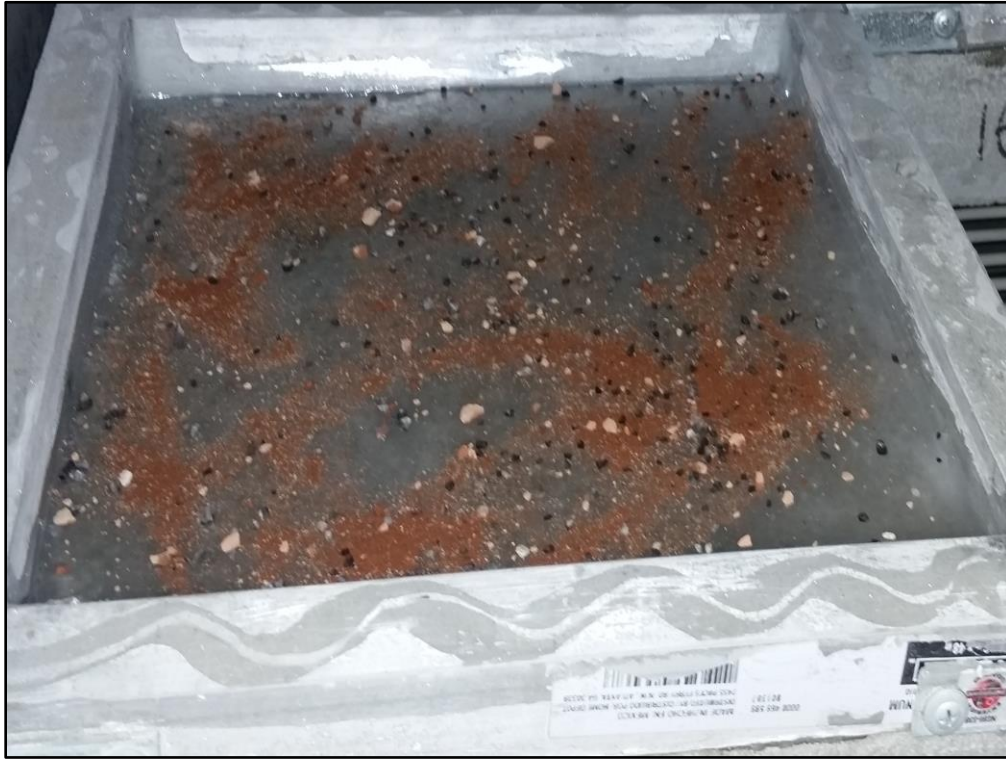
Figure 5. Photo of the Traction Magic sample during testing.

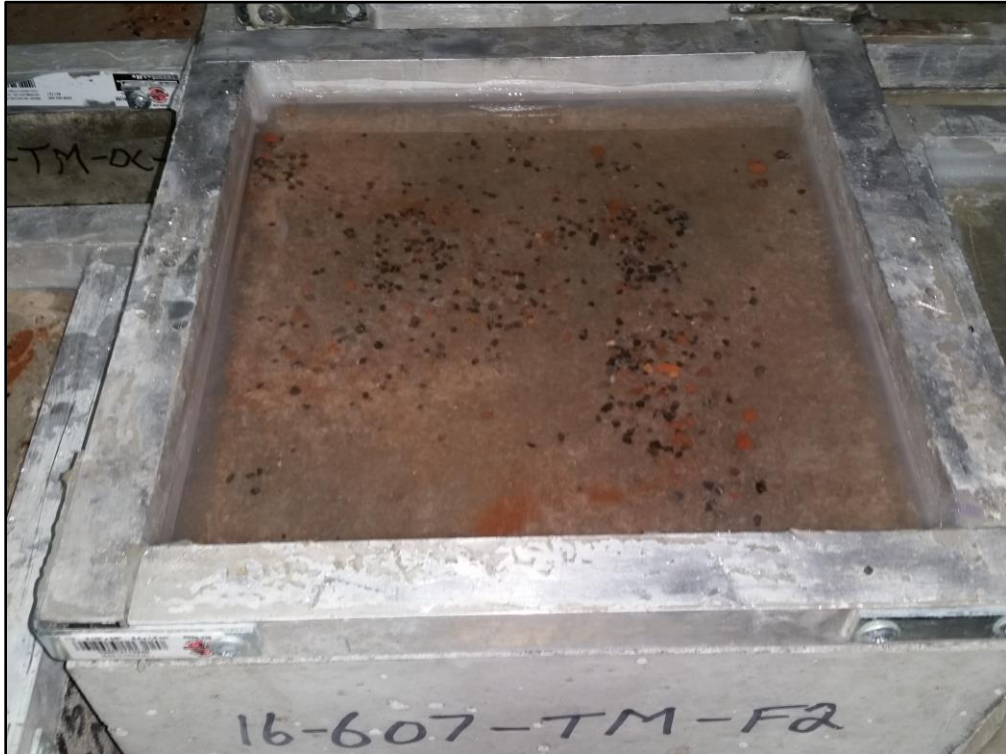
Figure 6. Photo of the Traction Magic sample after testing.

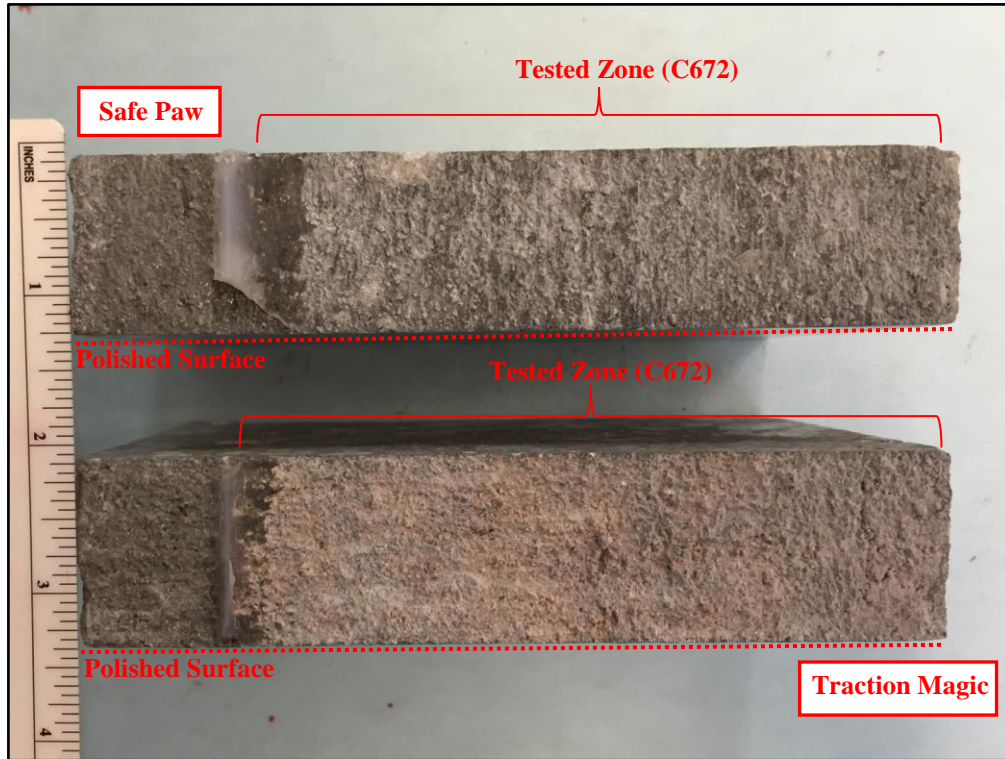
Figure 7. Photo of top surface of polished sections after sawcutting.

A section was obtained through the tested zone of the two (2) concrete salt scaling samples by sawcutting the samples perpendicular to the top surface (**Figure 7**). The sawcut plane intersected zones of the surface which were and were not tested for scaling resistance. One sawcut surface of each sample was ground flat and polished with progressively finer diamond polishing discs

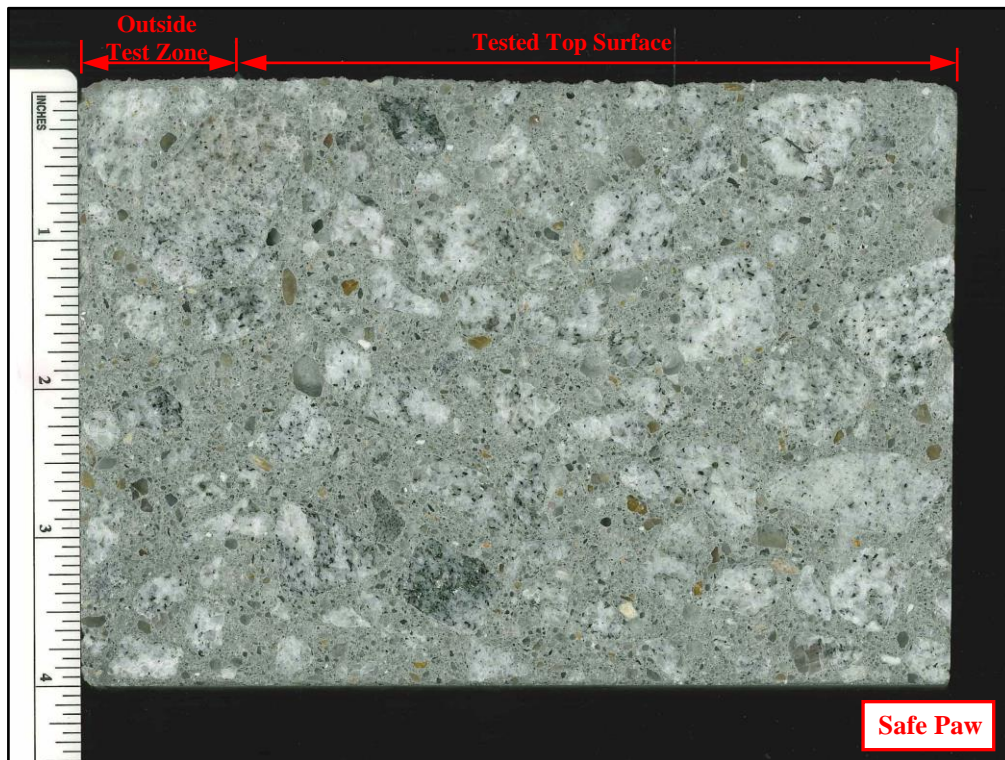
Figure 8. Scanned image of polished section of Safe Paw scaling resistance test slab.

(Figures 8 & 9). The polished sections had dimensions of approximately 4 inches tall by 6 inches wide. The prepared polished plane sections, polished billets and thin sections were examined in accordance with the applicable sections of ASTM C856, *Standard Practice for Petrographic Examination of Hardened Concrete*, using a digital microscope at magnifications of 20, 30, 50, 100 and 200X. The significant findings of the evaluations are discussed below.

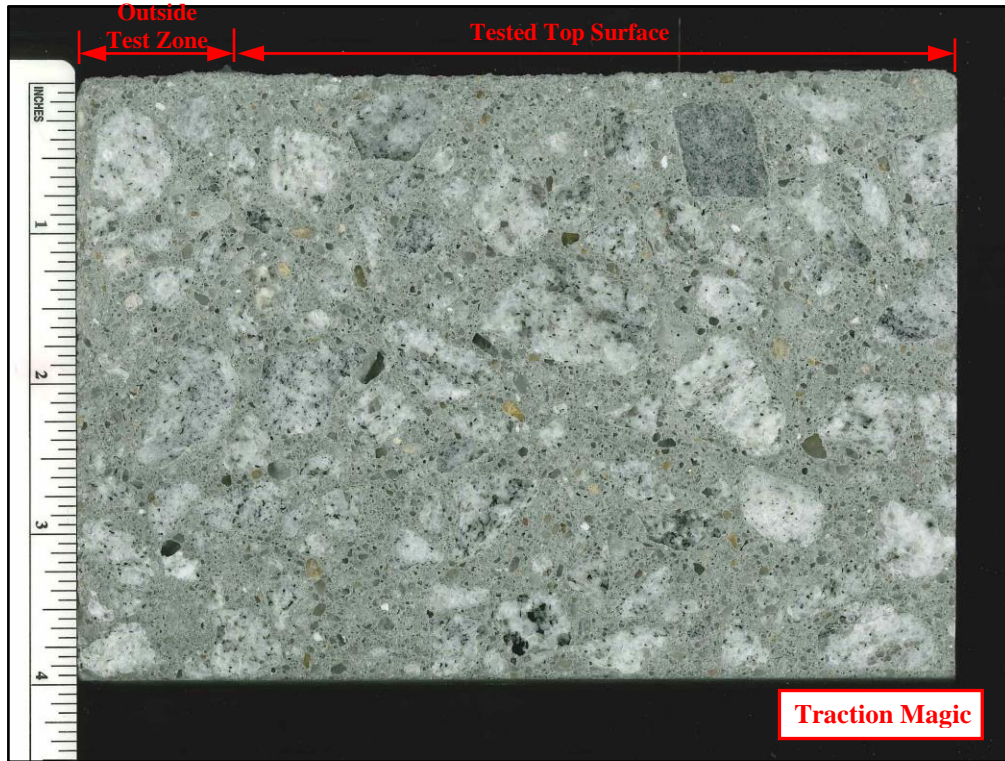
Figure 9. Scanned image of polished section of Traction Magic scaling resistance test slab.

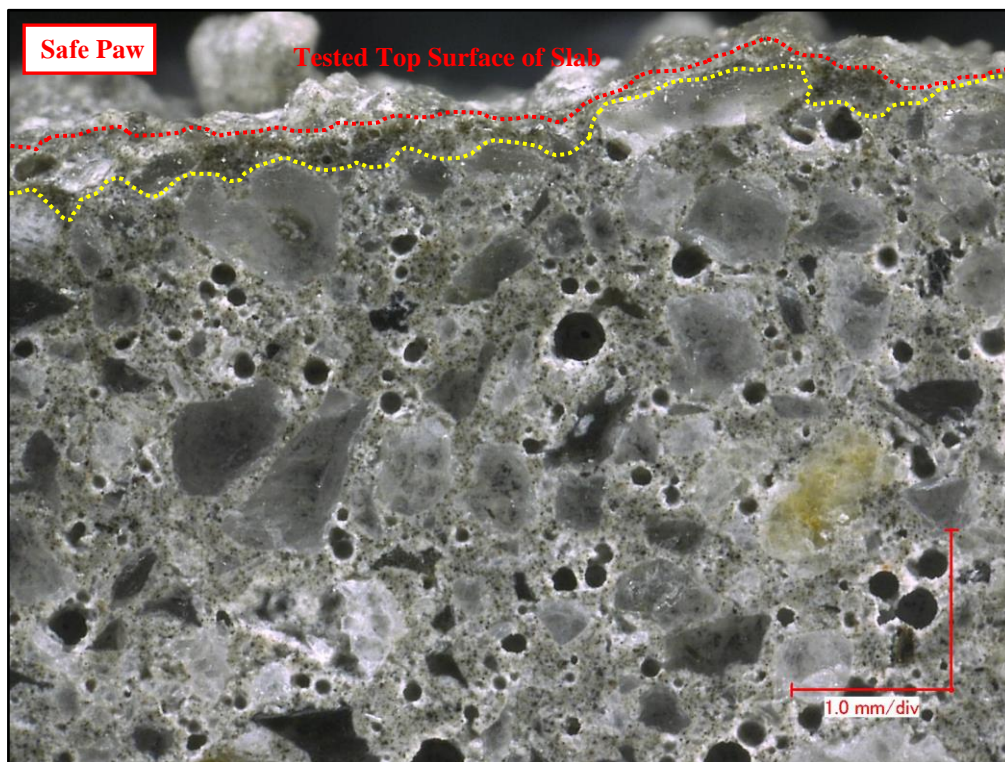
Figure 10. No cracks in concrete beneath the tested top surface (dotted red line) of the Soft Paw test slab. The yellow dotted line indicates the approximate absorption depth of the salt scaling solution.

- The concrete within both samples appears to have similar properties: air content, entrained air void quality, paste hardness, paste quality in upper zone of concrete. As a result comparing the test results for each sample is a fair assessment.
- No cracks, indications of freeze-thaw damage or salt scaling were observed beneath the surface of either test slab (Figures 10 – 13).

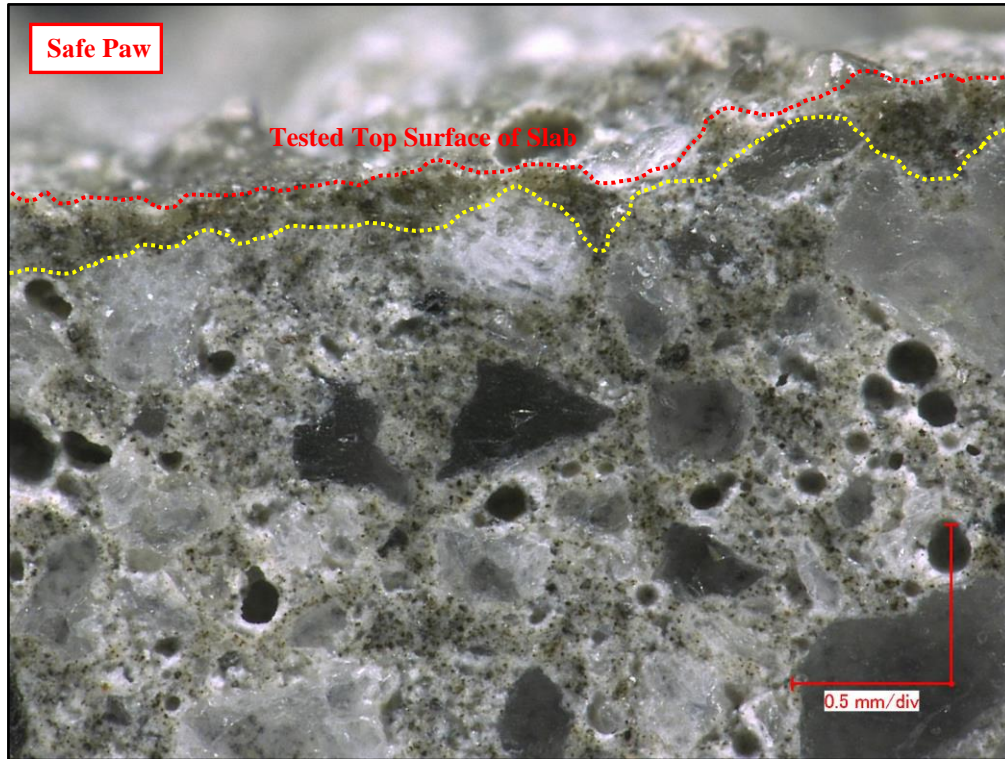
Figure 11. No cracks in concrete beneath the tested top surface (dotted red line) of the Safe Paw test slab. The yellow dotted line indicates the approximate absorption depth of the salt scaling solution.

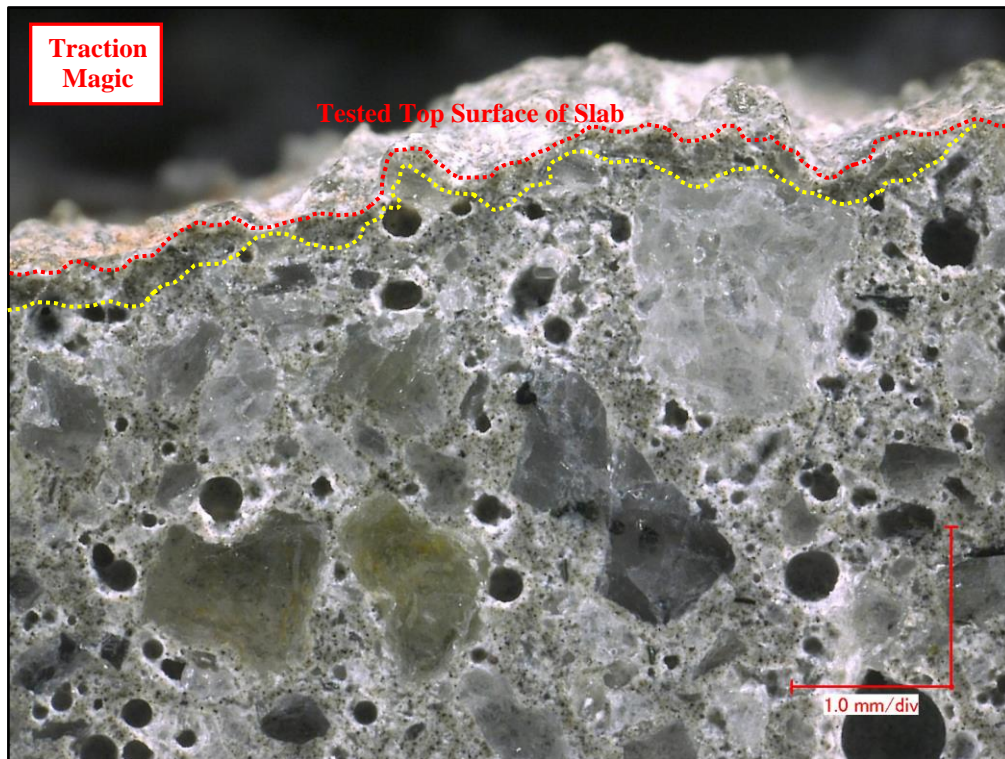
Figure 12. No cracks in concrete beneath the tested top surface (dotted red line) of the Traction Magic test slab. The yellow dotted line is the approximate absorption depth of the salt scaling solution.

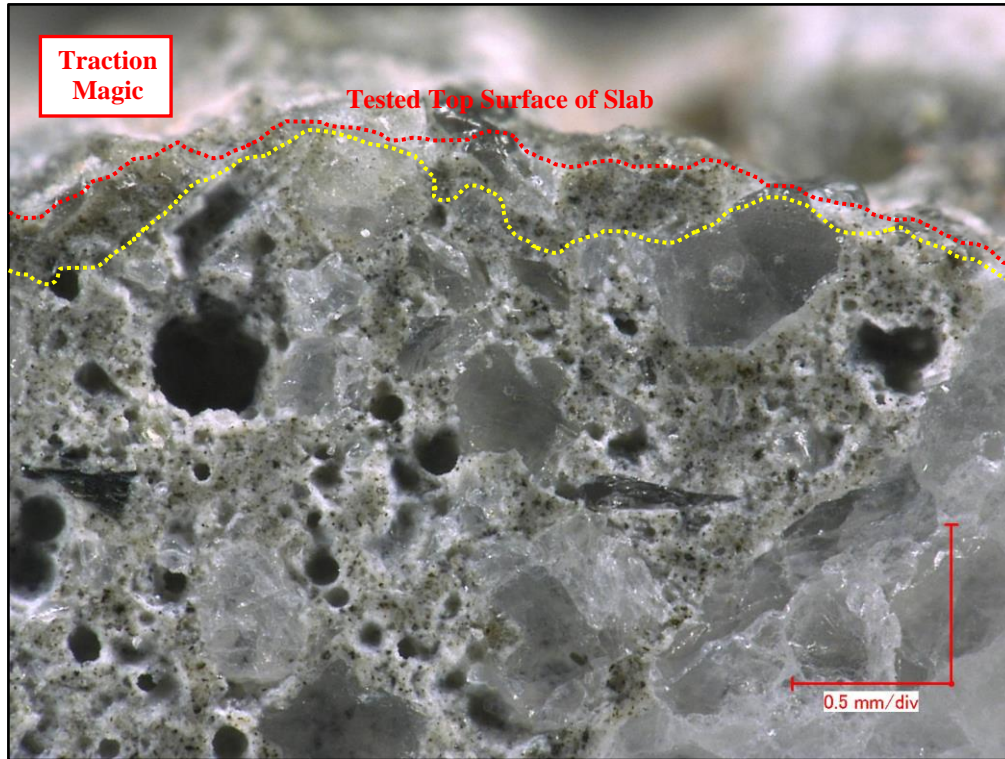
Figure 13. No cracks in concrete beneath the tested top surface (dotted red line) of the Traction Magic test slab. The yellow dotted line is the approximate absorption depth of the salt scaling solution.

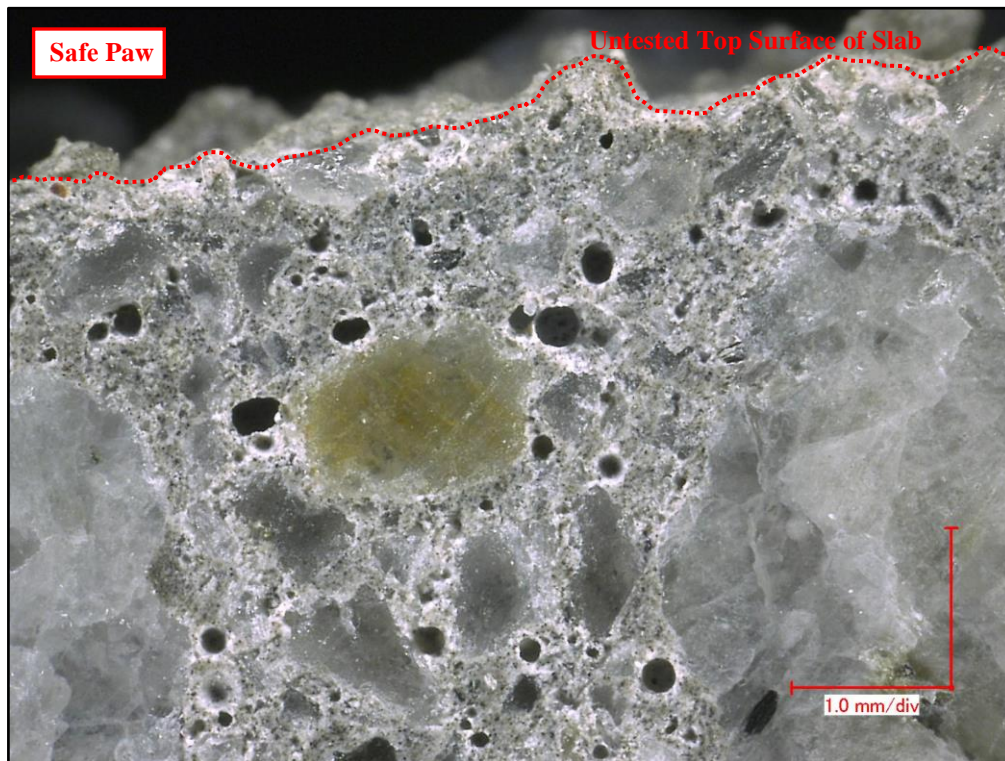
Figure 14. No cracks in concrete beneath the untested top surface (dotted red line) of the Safe Paw test slab. No relatively darker paste is present beneath top surface.

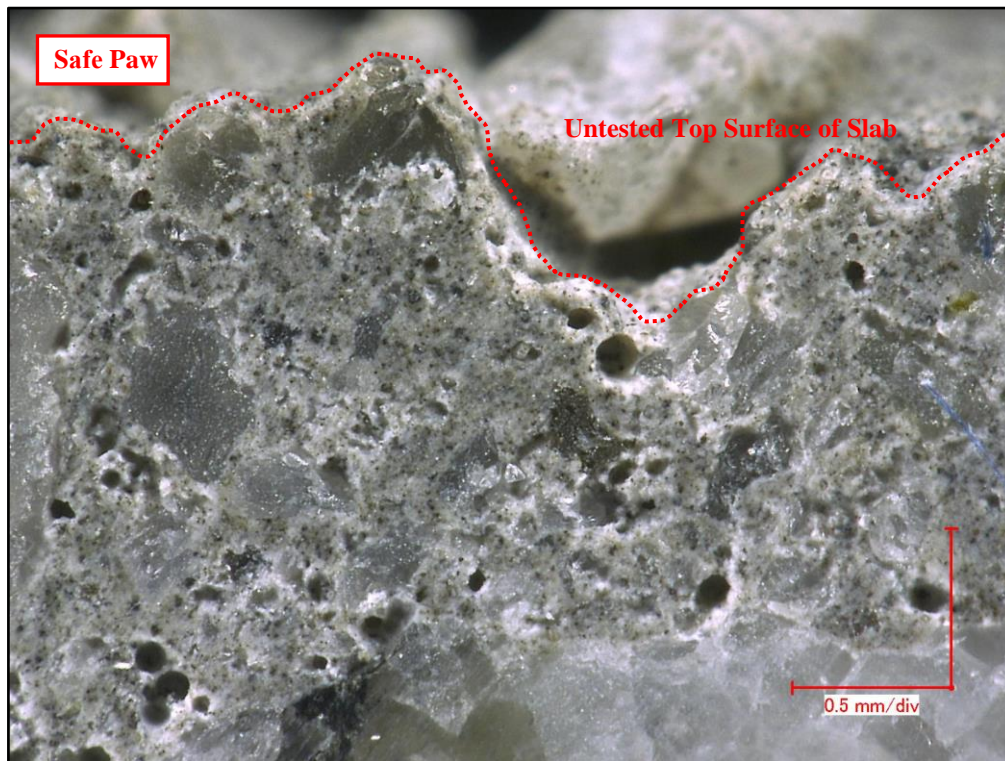
Figure 15. No cracks in concrete beneath the untested top surface (dotted red line) of the Safe Paw test slab. No relatively darker paste is present beneath top surface.

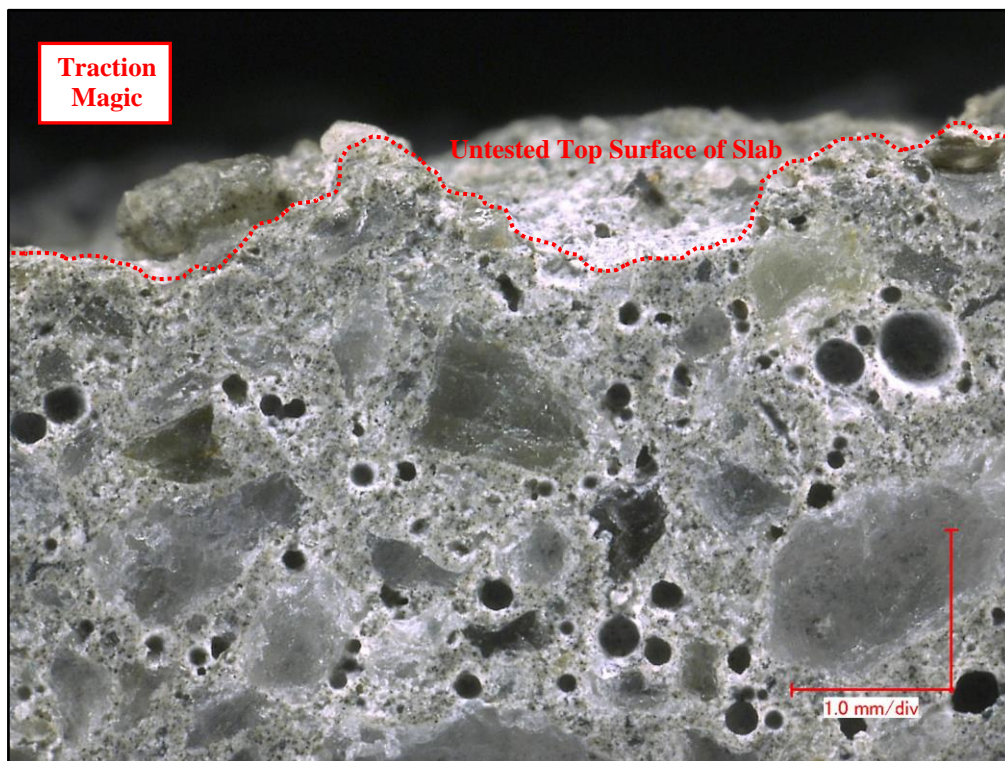
Figure 16. No cracks in concrete beneath the untested top surface (dotted red line) of the Traction Magic test slab. No relatively darker paste is present beneath top surface.

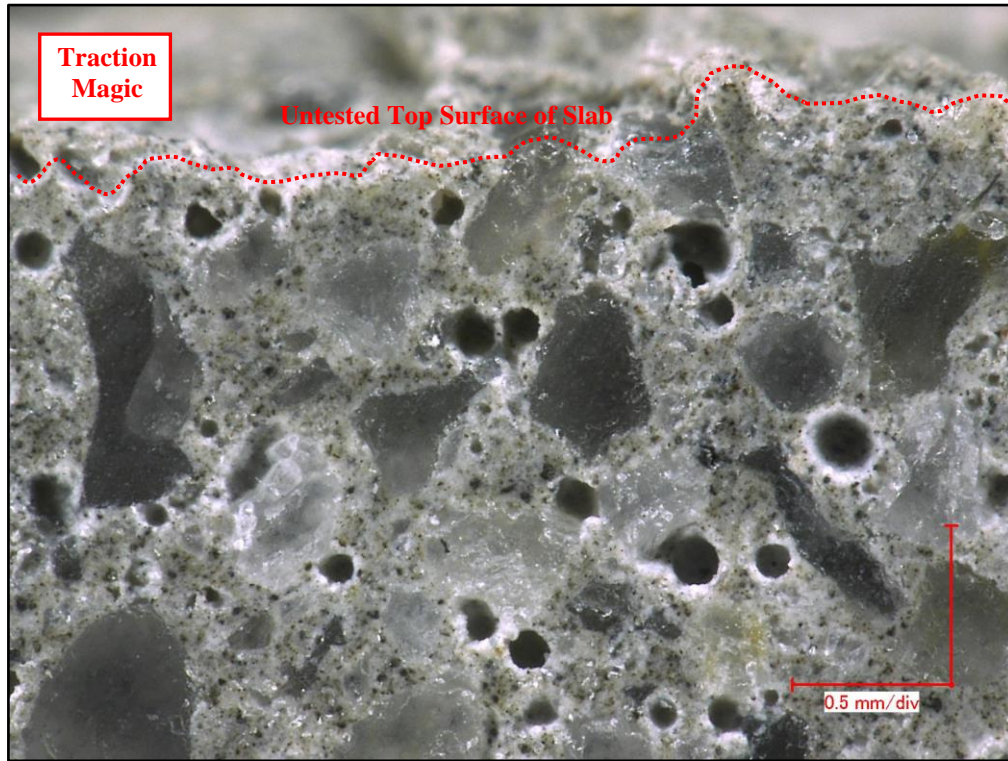
Figure 17. No cracks in concrete beneath the untested top surface (dotted red line) of the Traction Magic test slab. No relatively darker paste is present beneath top surface.
