## AUX-USB Plug Saver

Part #: AGA-A-U-PS

## AUX-USB Plug Saver Instructions

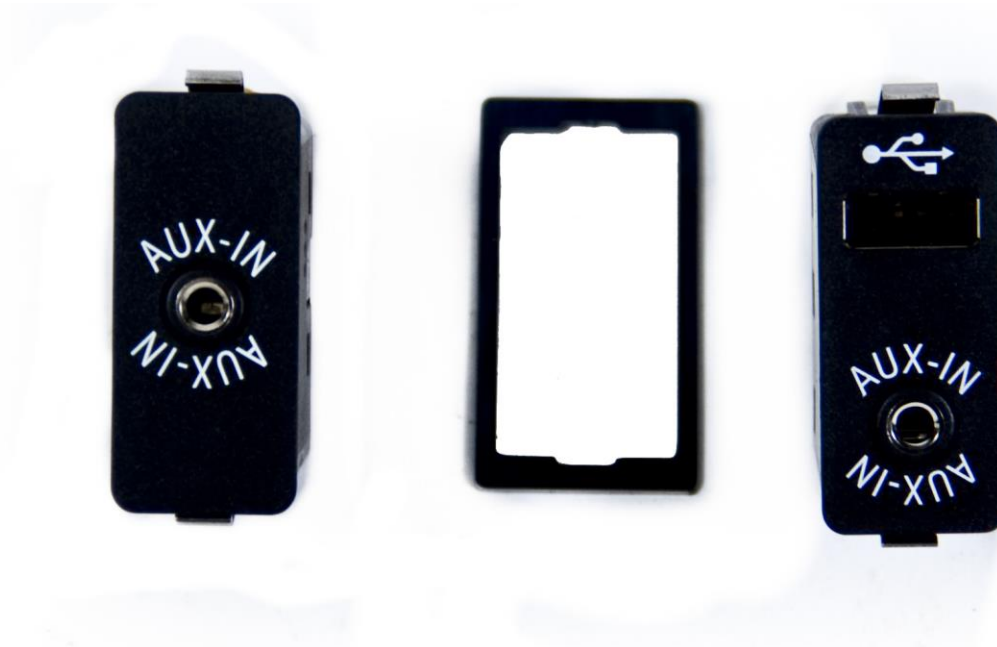
BMW E90 chassis, or any chassis with the same AUX-USB plug, has a broken aux connector in center console. This causes the USB and AUX connector to drop into the center console, making it impossible to plug in to the connector.

AGA's AUX-USB Plug Saver is manufactured from spring steel, heat treated and black oxide to match the interior color of the center console and AUX-USB switch.

The AUX-USB Plug Saver helps save time and money by providing an alternative to replacing the center console.

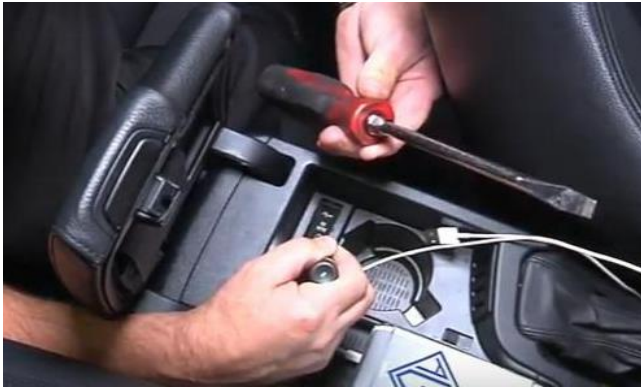
### Step 1:

Start by fishing the AUX connector out of the hole it has fallen into. Align with a pick on the inside and use a screw driver from down below.

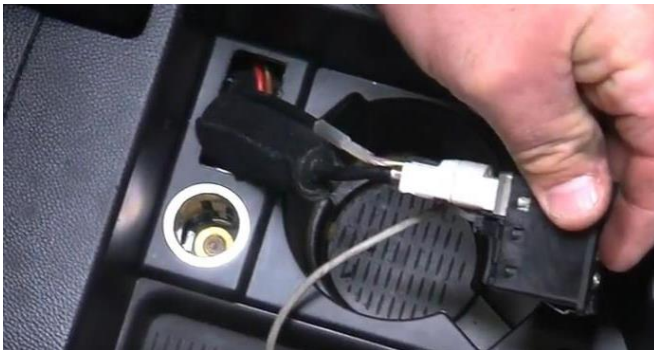
### Step 2:

Once the connector is out, make sure the wires don't fall back into the hole. Carefully push on the plastic tabs and disconnect the two connectors to the AUX-USB power.

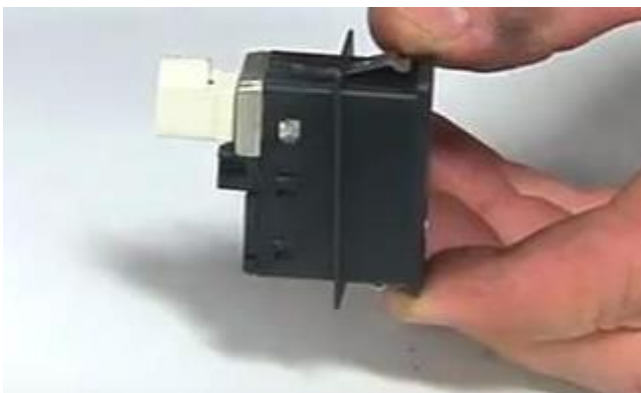
### Step 3:

To install the AUX-USB Plug Saver, slide it over the housing of the connector, until it clicks into place.

**NOTE: Push metal frame over the metal tabs at the same time to avoid bending the USB-AUX Plug Saver.**

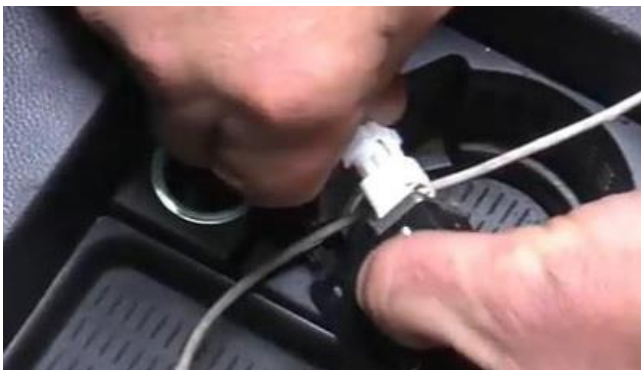
### Step 4:

Connect the USB power then connect the AUX connector back to the back of the switch. Push the wires in and push the switch back down.

**NOTE: If area where metal tabs make contact is damaged, it may be necessary to clean up center console with exacto knife or similar. Carefully bending the metal tabs outward on USB-AUX Connector to increase tension may also be needed.**
