## N62 & N62-TU Coolant Pipe

Part #: AGA-N62-6061

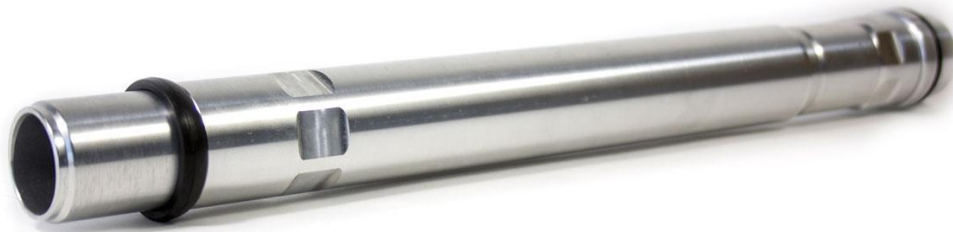
Rubber seal on aluminum cooling tube has failed. Coolant is leaking into back area of engine timing cover and out of hole.

Install an AGA collapsible cooling tube. We have designed a tube and seals that can be installed in under 10 hours.

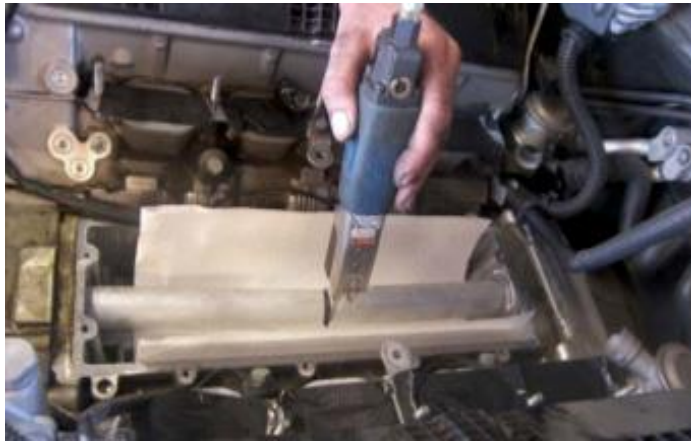
2. Cut cooling tube and remove rear part by hand.

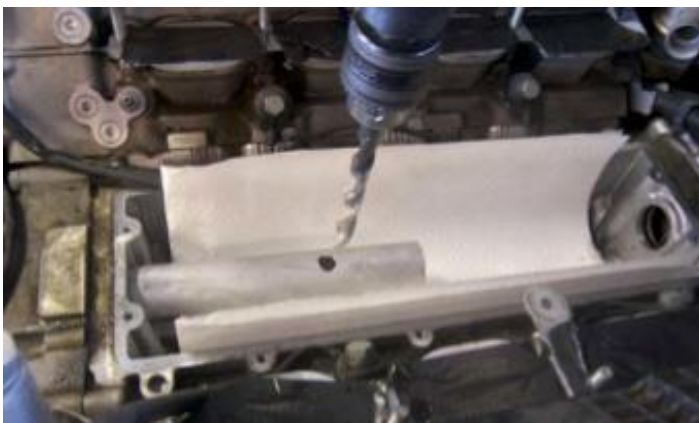
3. Drill hole in front part of tube.

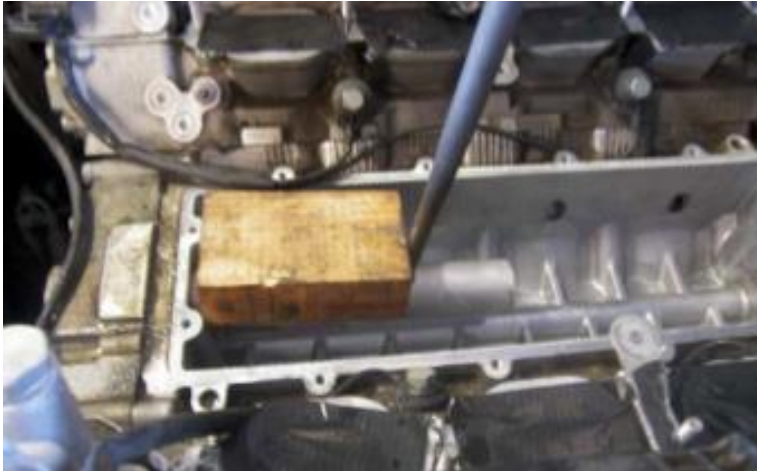
4. Pull tube out with lever bar.

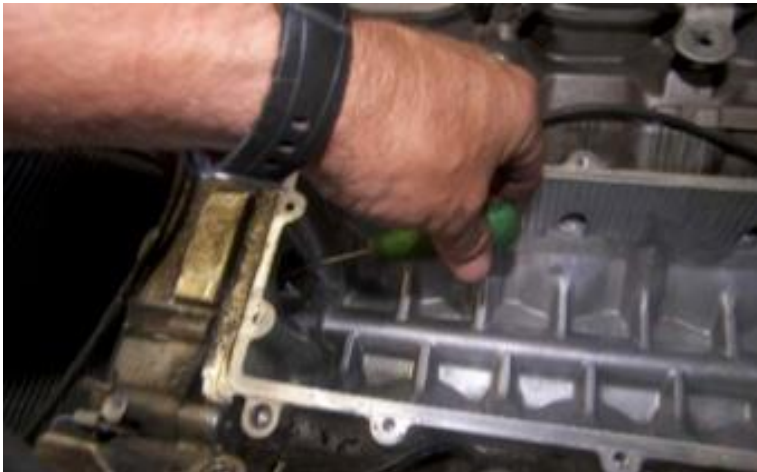
5. Remove old seal w/pick tool. Seal groove must be completely clean, use a small wire brush to remove ALL debris from old seal, inspect with mirror.

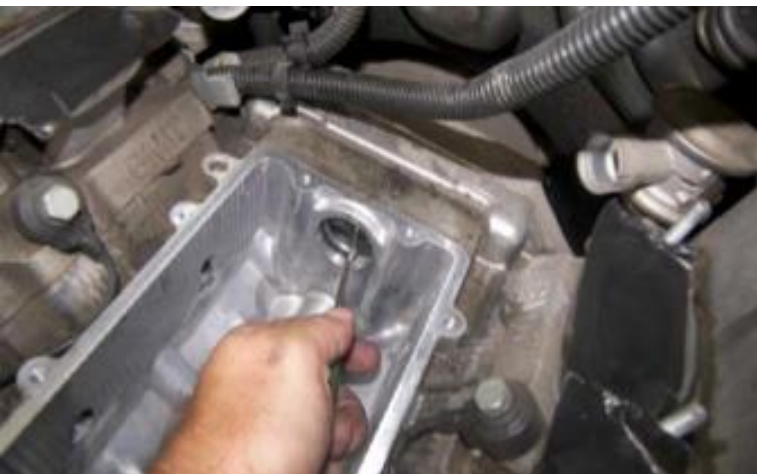
6. Remove rear o-ring in back of engine block.

Clean groove and install new o-ring. Part# 11-53-1-710-048 (do not install the o-ring that comes on the pipe. It must stay in place on the pipe).

Apply a little of the supplied grease to o-ring in rear of block.

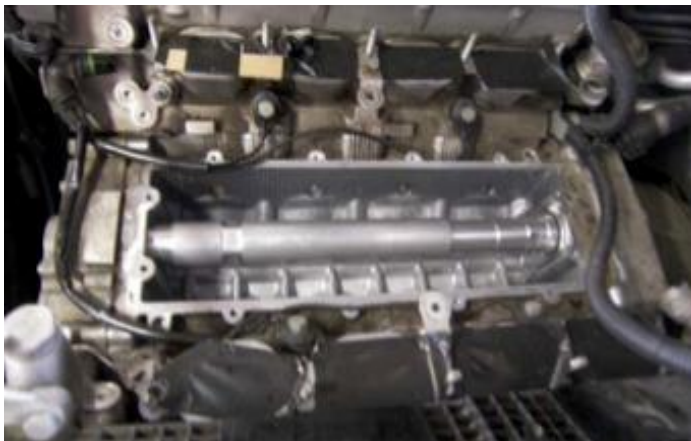
8. Start with the tube collapsed. Lube tube on both ends with white grease (supplied in kit). Hold tube into engine block. Insert tube into rear of engine block. Turn tube so it expands, as front of the tube enters seal; observe front seal with mirror from water pump side as the tube goes into seal. Seal cannot be pinched. If seal pushes out, collapse tube a bit, turn tube without expanding a few turns and then continue expanding until seal can no longer be seen from water pump side.

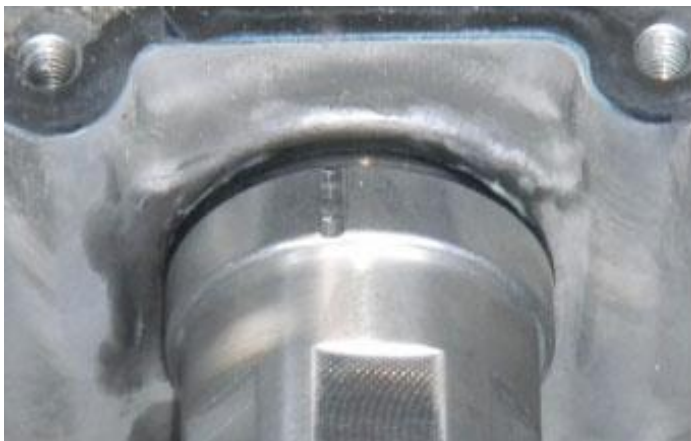
9. Rotate rear ring so the machine notch is straight up. Angled side is towards rear of engine block and o-ring. Tighten tube by hand until it has tension on front and on the rear o-ring.

**Note:** The back of the block is cast and will vary from car to car. It is normal for o-ring to have more contact on top or bottom. Do not over tighten!
