## Kit Contents PRN015485

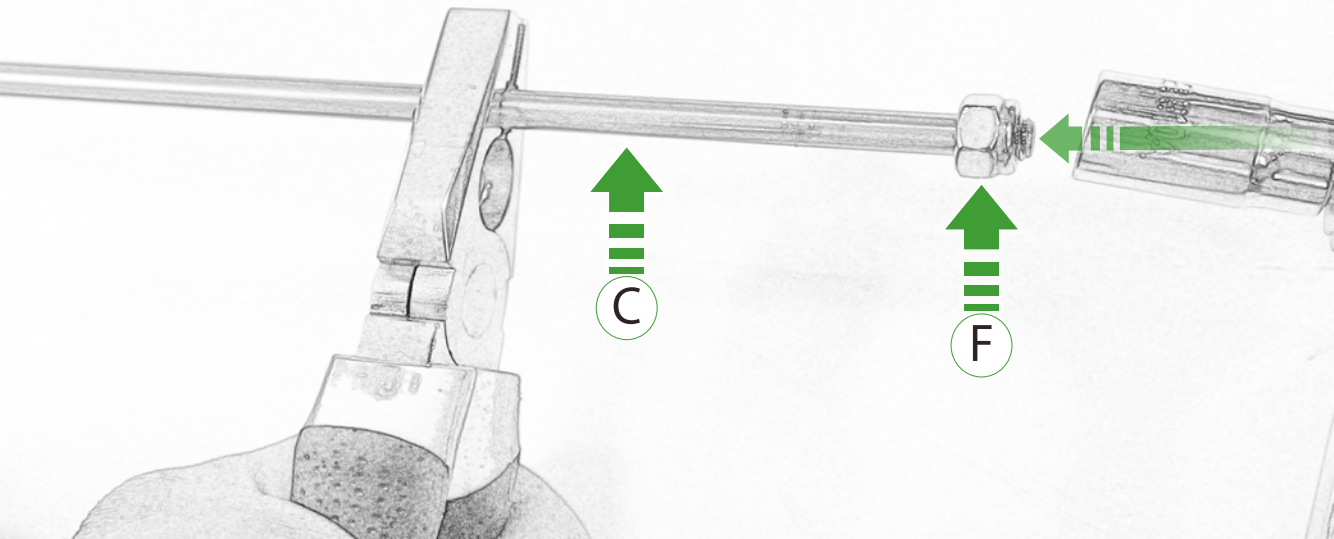
- (A) 1 x Hub Stop (Red)
- (B) 1 x Hub Stop (Silver)
- (C) 1 x Shaft
- (D) 1 x Bobbin Head
- (E) 1 x Washer
- (F) 2 x M8 Nylock

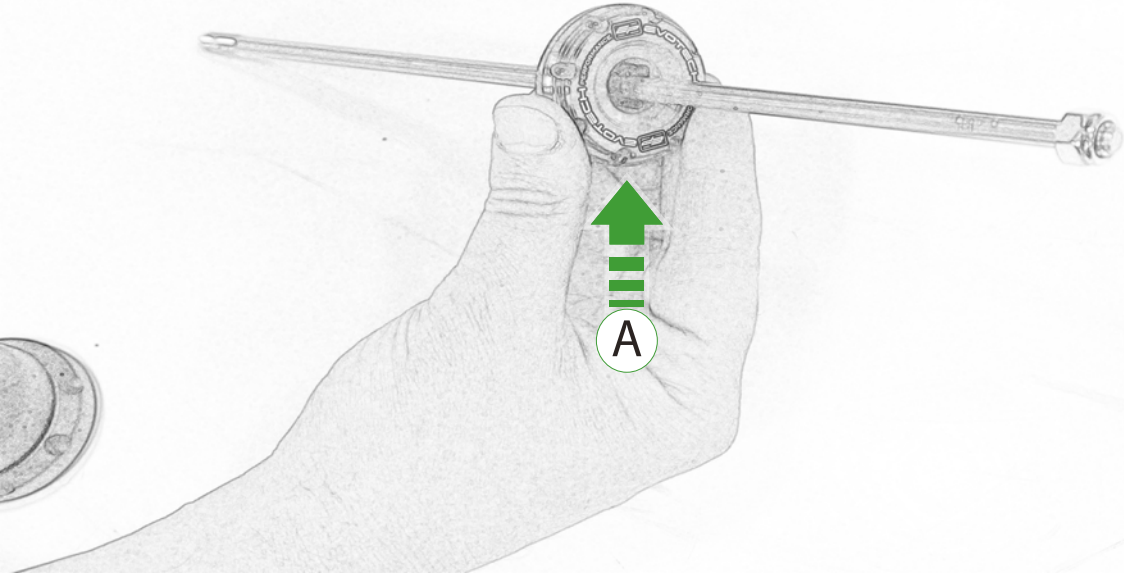
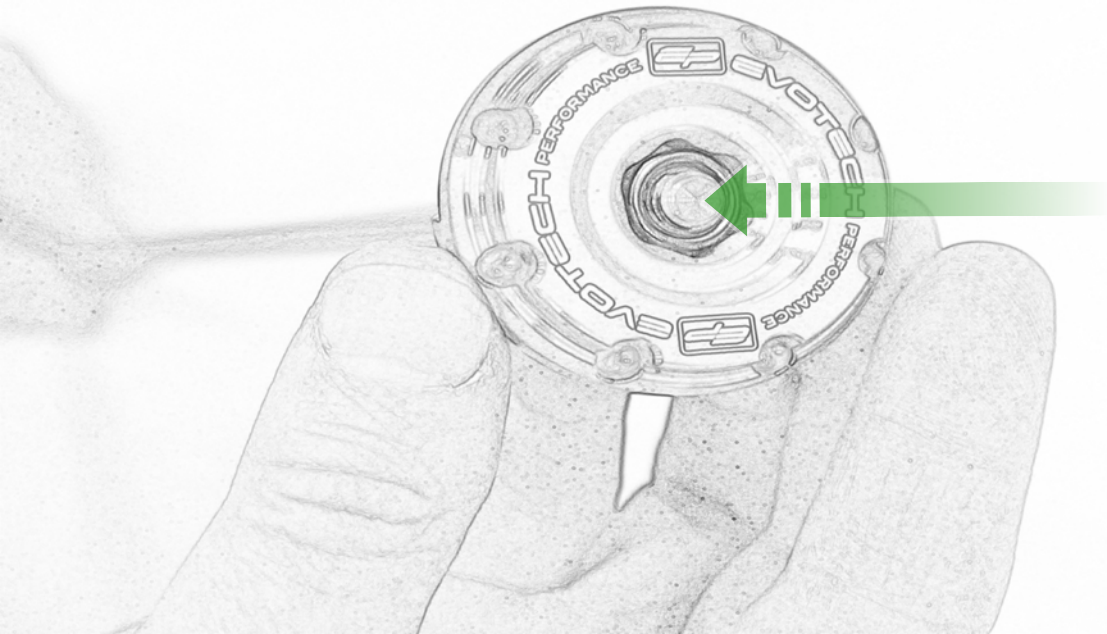
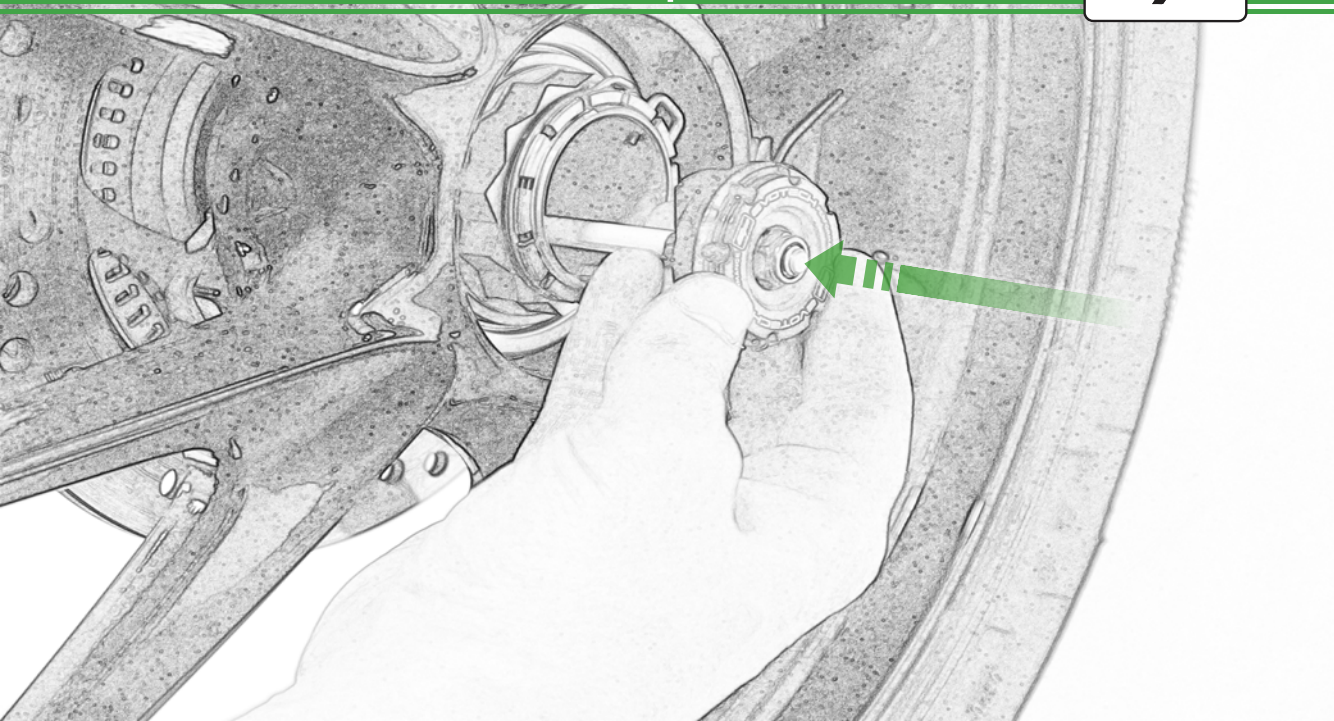
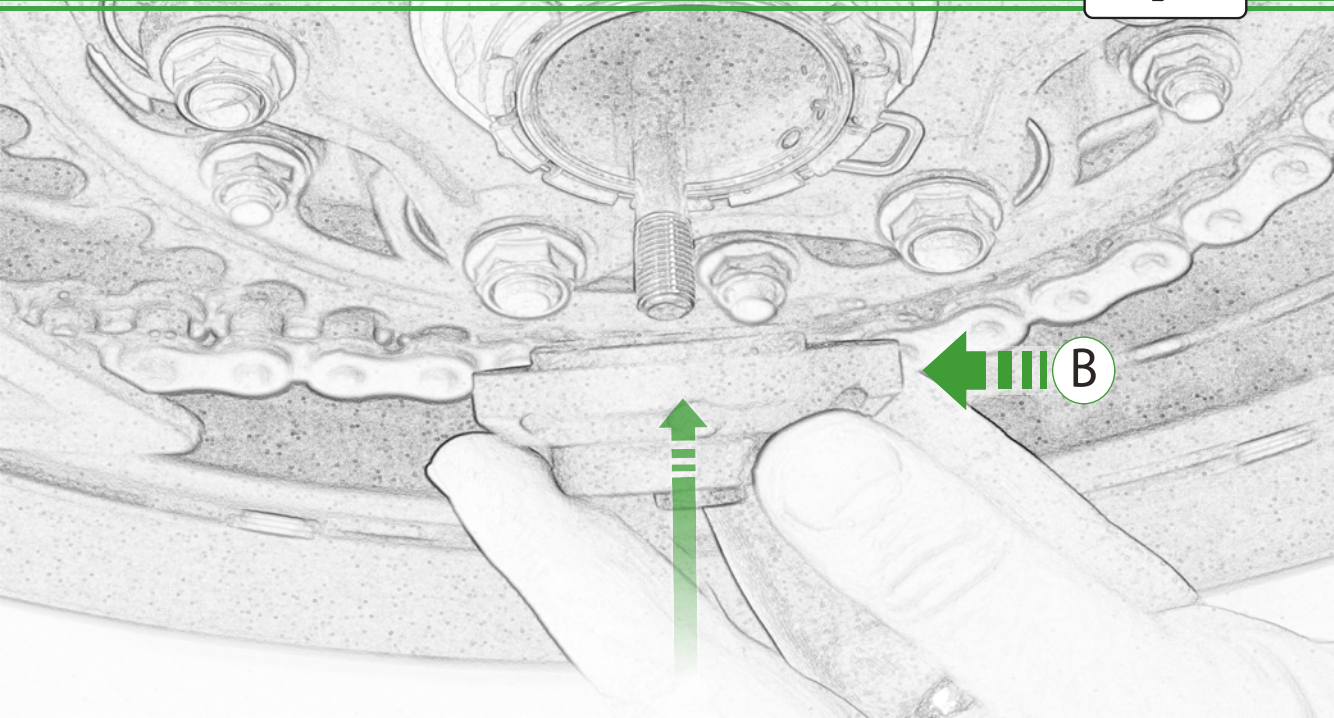
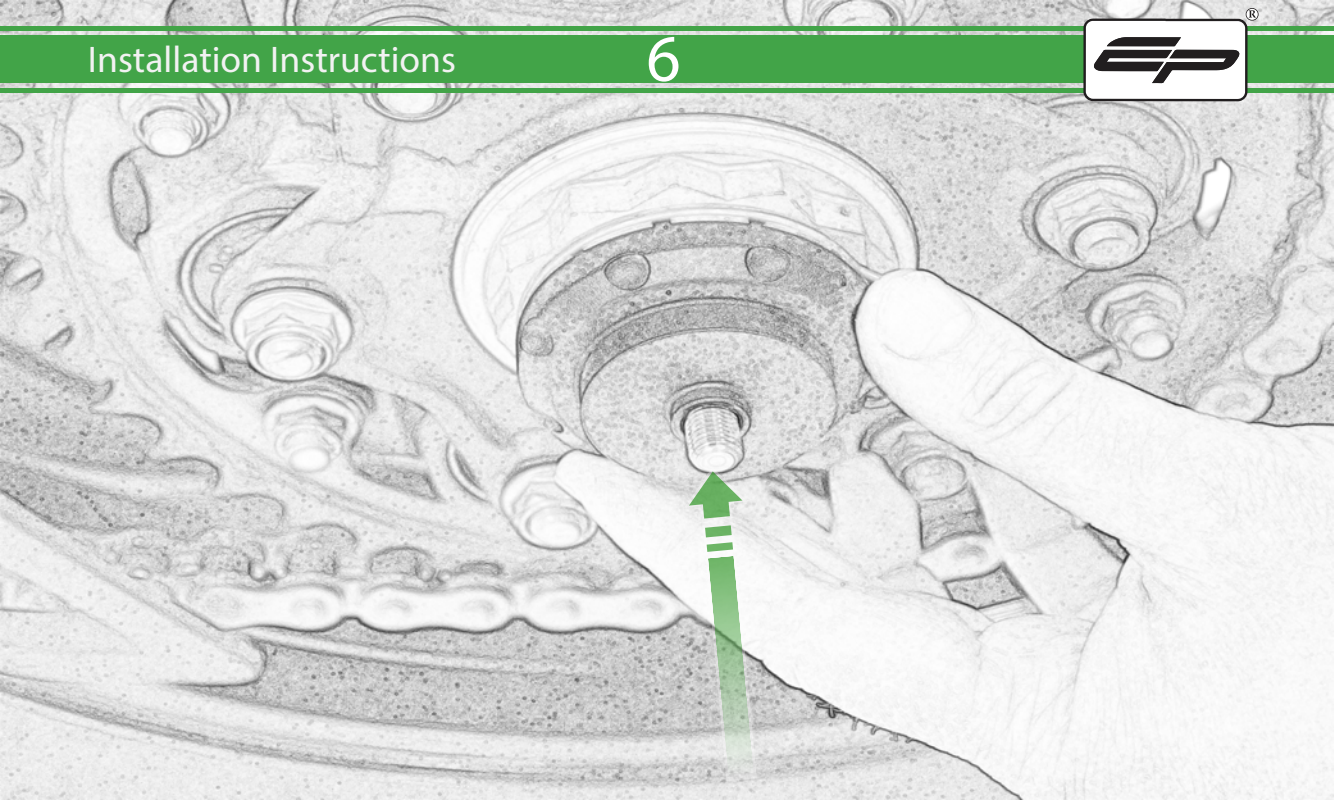
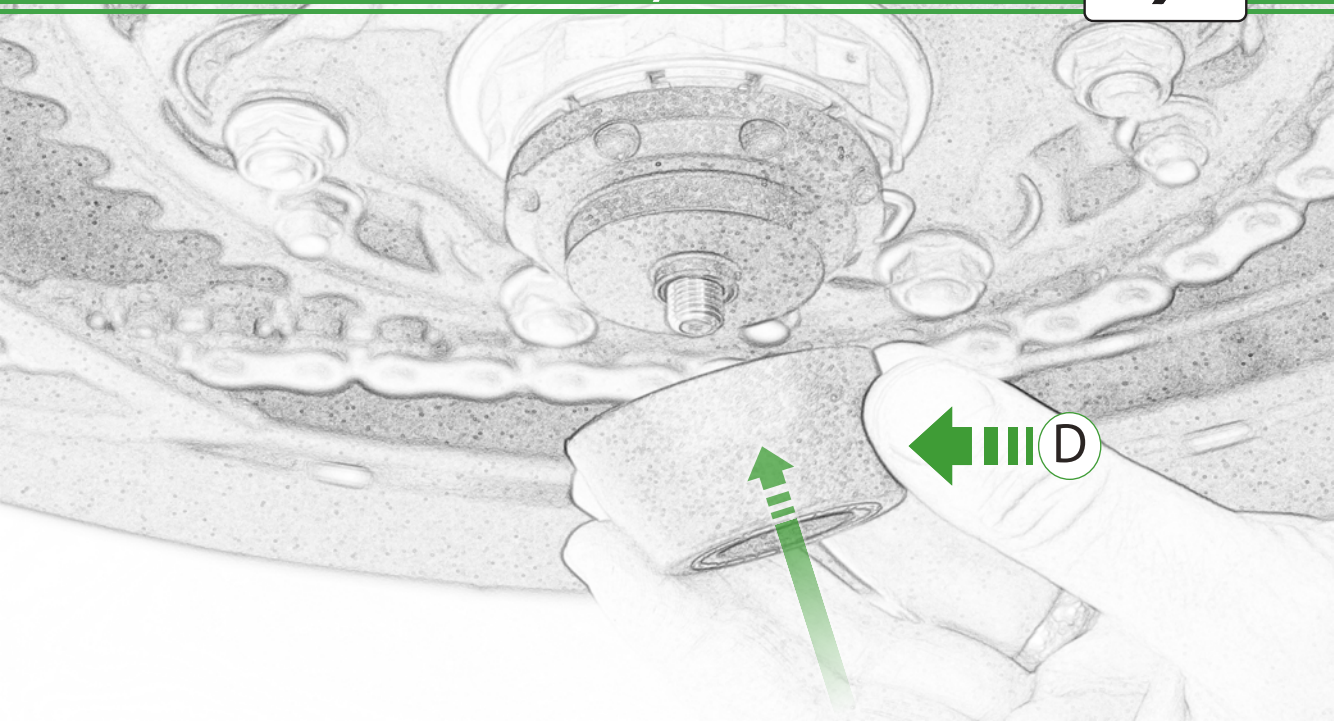
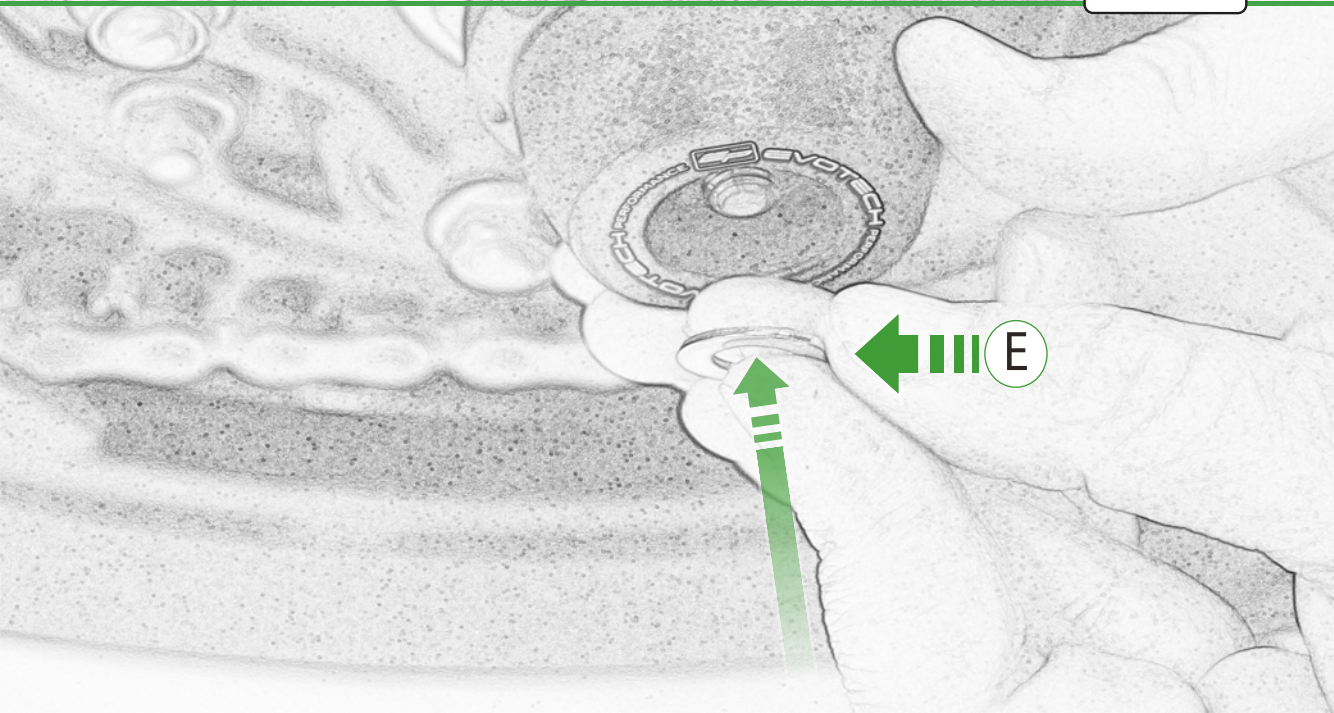
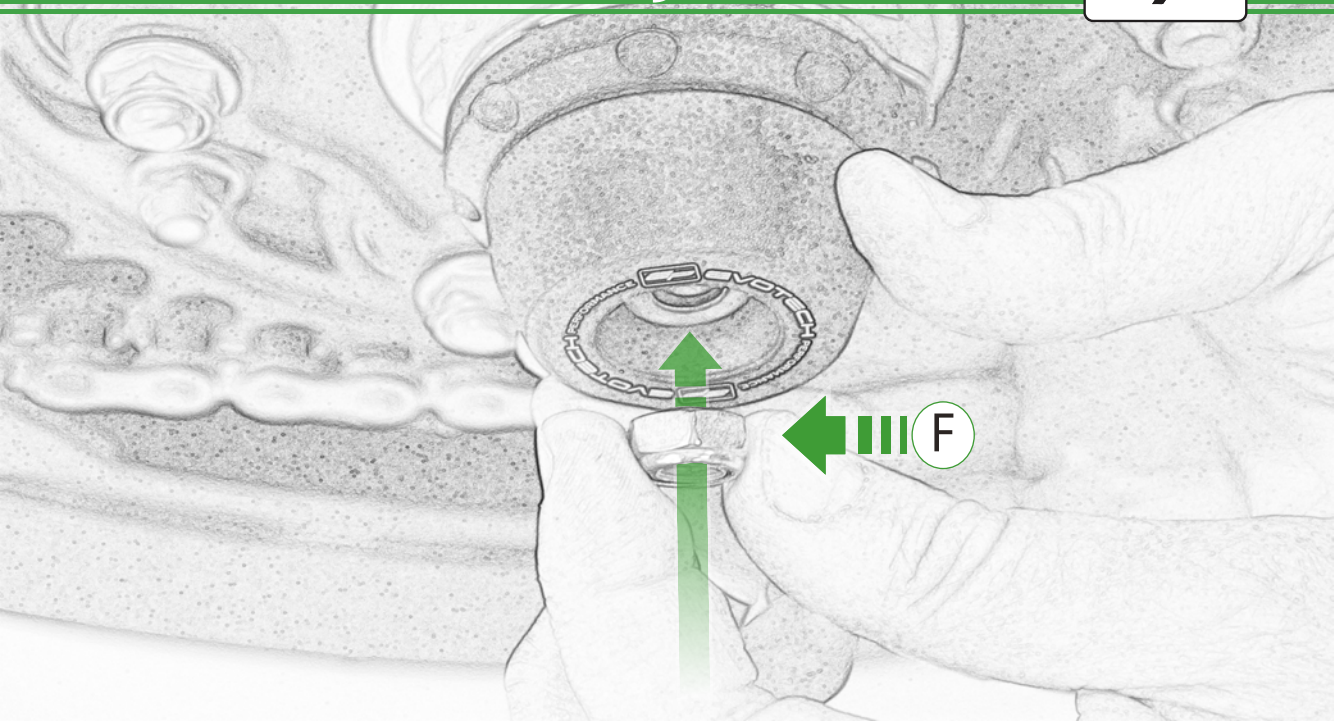
Fully Tighten  
8Nm

It is recommended that periodic inspections are made to ensure that all bolts are tightened to the specified torque settings.

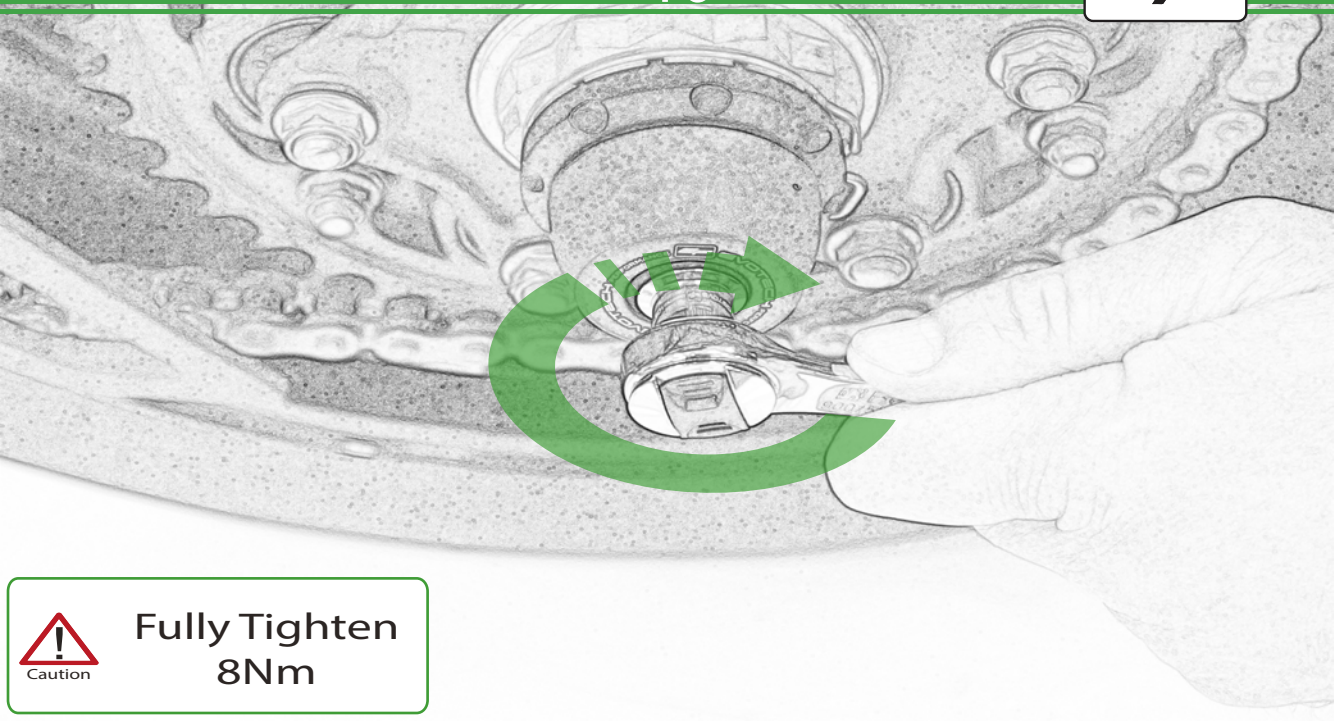
Caution
