INFORMATION REGARDING POSSIBLE CRACKS ON ASAP LOCK

APRIL 18 2016 • •

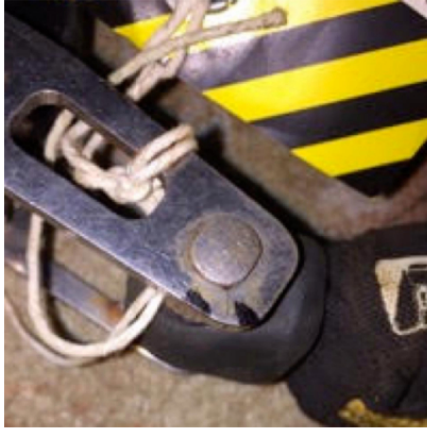
FACT: MARCH, 30 2016 - During routine equipment inspections one customer detected cracks on the stainless steel arms on three ASAP LOCK. These three defective products will be returned to Petzl for analysis.

- Regularly inspect your ASAP LOCK in accordance with [the ASAP LOCK PPE checking procedure](#)
- **A cracked arm presents no additional immediate risk to the user. However, as with any PPE, the presence of such a crack requires an immediate retirement of the product**
- In the unlikely event you find a cracked arm, retire your ASAP LOCK immediately and contact your local distributor for a replacement under warranty.
- ASAP (B71 AAA) is not concerned by these recommendations.

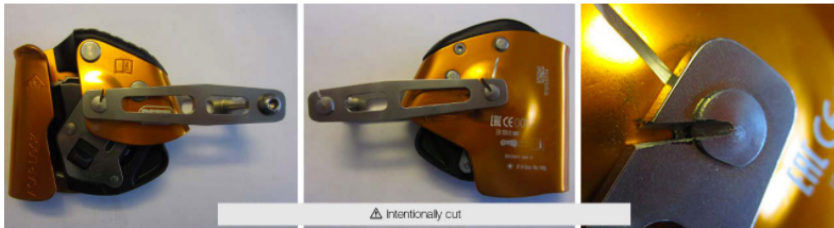
- We have intentionally cut both stainless arms at each rivet, to simulate potential cracks.

ASAP LOCK before test with multiple cuts to simulate cracks

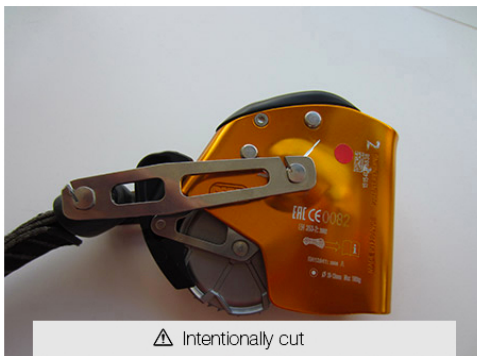
- The fall was arrested and the mass was not released.
- The ASAP'SORBER was deployed.
- No deformation of the cuts due to the dynamic test

ASAP LOCK prototype after dynamic test
