# Bioremediation Of Soils Contaminated With Transformer Oil In Brazil.

**Satya Ganti - Sarva Bio Remed, LLC Trenton, NJ, USA; Eduardo Trindade\*, LACTEC, Curitiba, Brazil\*; Paulo Fernandes, SDM do Brasil Ltda, Sao Paulo, Brazil**

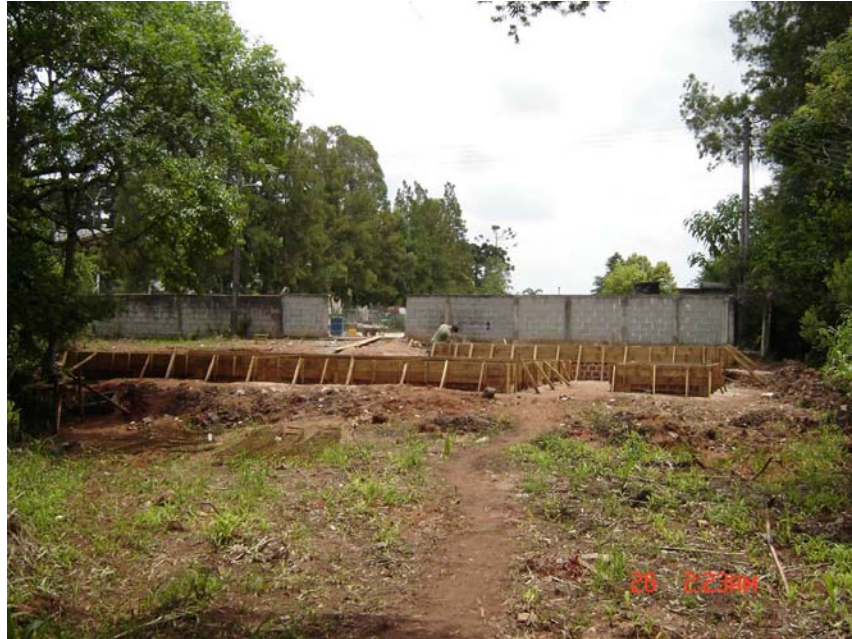
**Figure 2. Construction of irrigation canals**

employ pump and treat method of treatment. Rain water was channeled through pipes were laid below 1 meter BGS for collecting wash water from this depth. Following images show the construction of irrigation canals and their completion of the canals before the onset of rainy season.

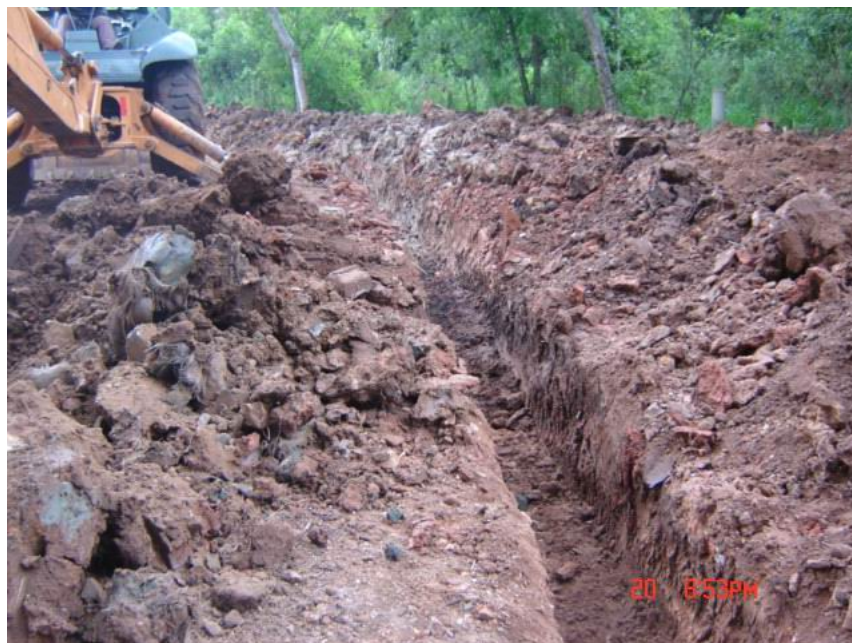
**Figure 3. Showing the construction of underground canals**

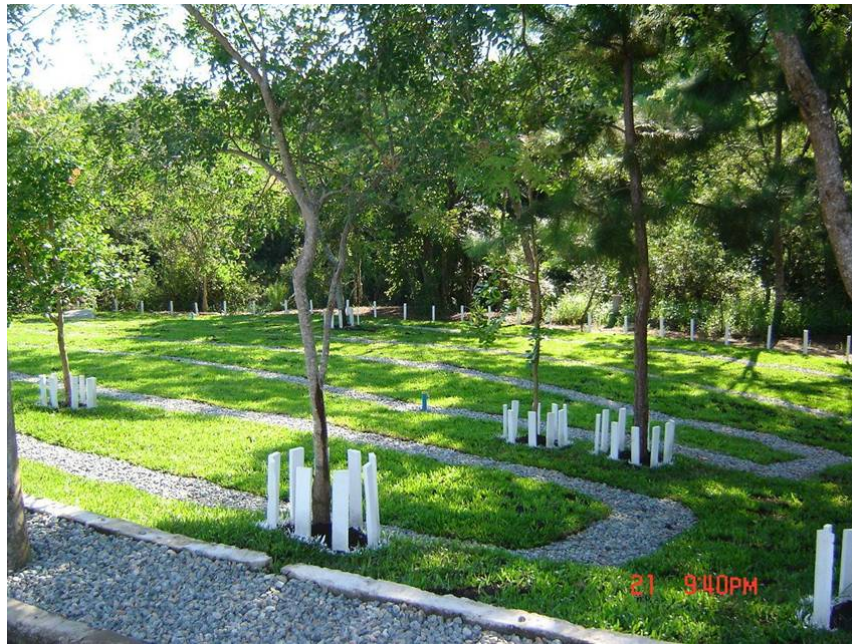
**Figure 4. The site after completion of irrigation canals**

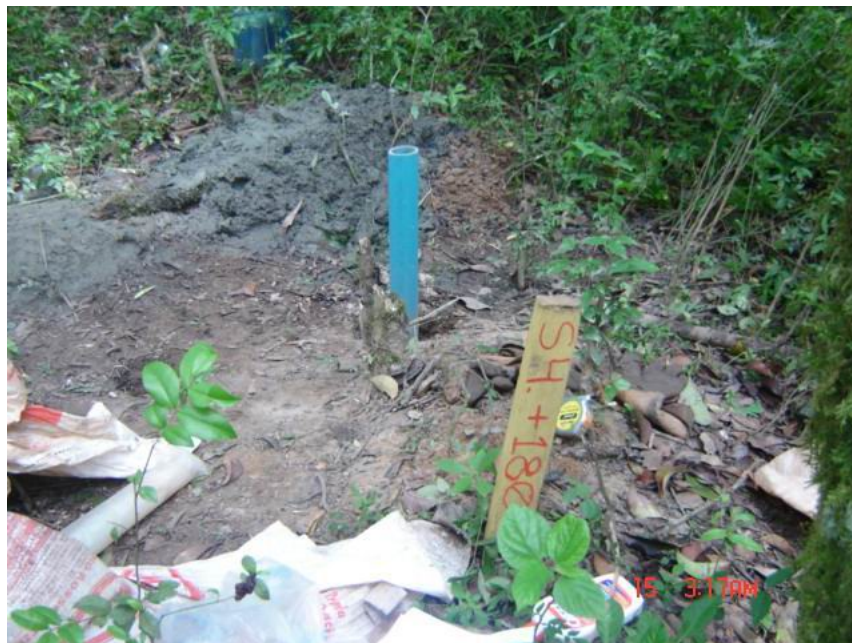
**Figure 4. Location of monitoring wells at each sampling points**

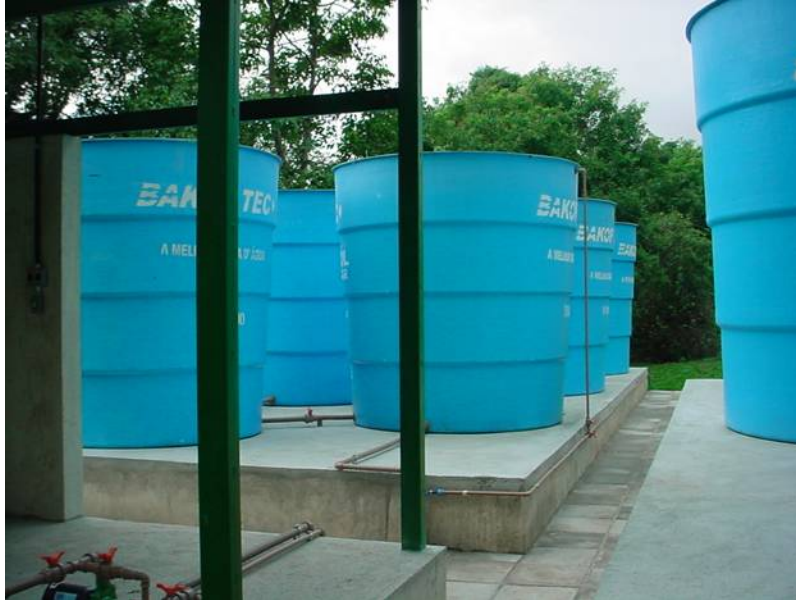
**Figure 6. An array of treatment tanks**

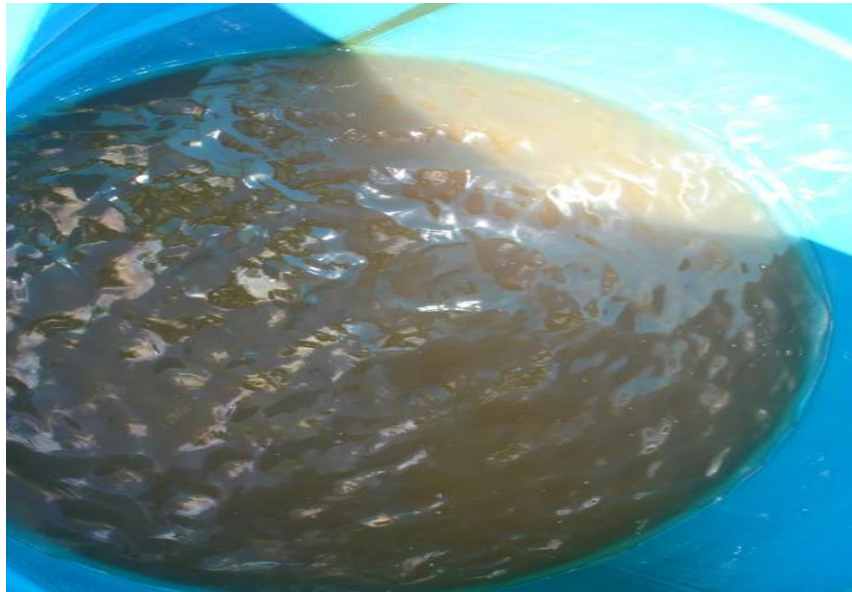
**Figure 7. Rain water with oil treated with AgroRemed**

The pump and treat method of cleaning the soil using the natural resources of rain water was found to be very effective and it was found that the adsorbed transformer oil was effectively removed due to good rain fall. This was evident from the analysis of the soil from the previously sampled areas. Results of the analysis are given in Table II below. It is observed that there was a considerably reduction in the TPH of the treated water and the water was then discharged after treating with bleach to remove any bacteria escaping into the river water.

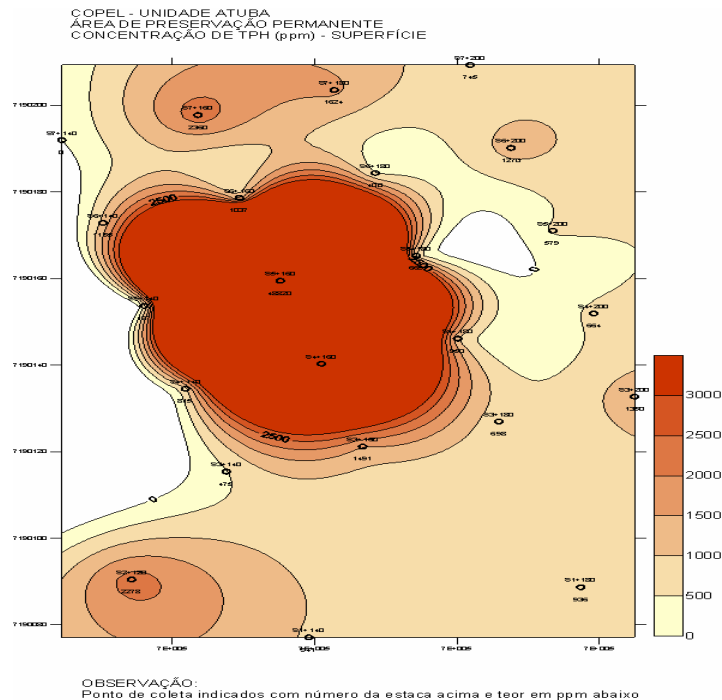
Figure 8. Contour map of the area at Atuba after Phase I

Based on the new values, a new contour map has been prepared as shown above to indicate the current levels of pollution in the area. The next phase of action is to focus on new hot spots and sites of concern and treat the identified areas. It is interesting to note that the project that was considered to last for more than 5 years because of the large area and high values of contamination is almost near completion using AgroRemed in less than five years and the site is expected to be cleaned up within the timelines as stipulated by the regulators.

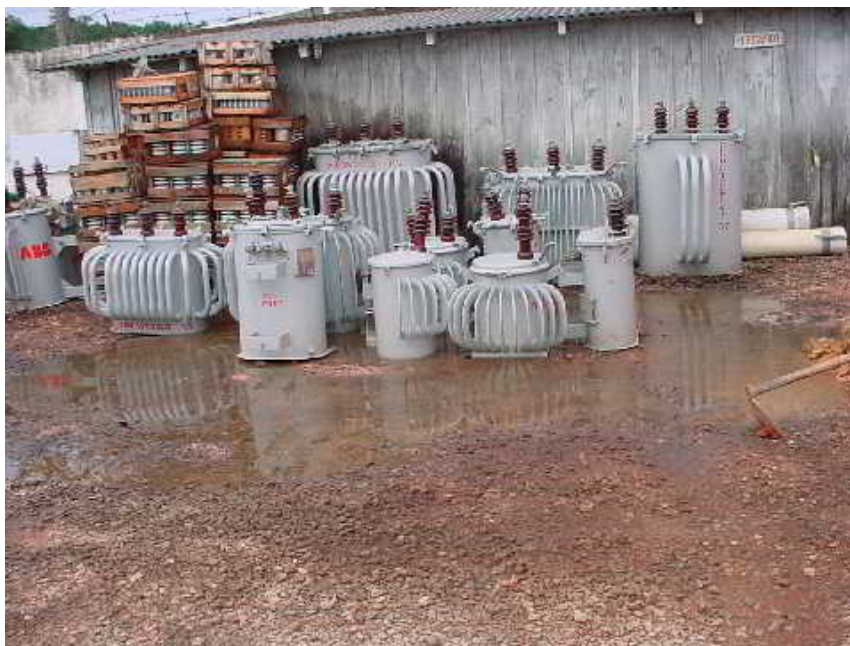
**Figure 9. A substation in Mandarituba with transformers and spills**

Photograph above shows one of the many substations with spills near the outdoor transformer storage location where direct application of AgroRemed is considered more suitable. Cost of excavation and transportation of the dirt is very high in Brazil particularly since many of these sites are remotely located. AgroRemed prepared in the US using the local bacteria is not acceptable to the regulators.

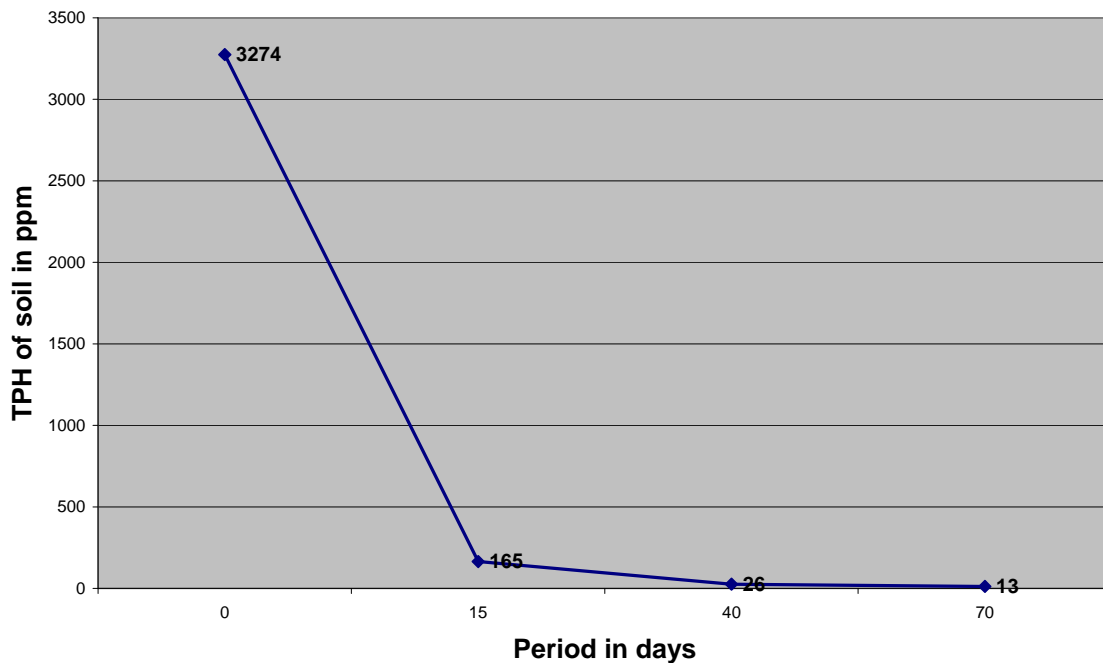
In one of the trial evaluation, diesel contaminated from another utility plant was used to evaluate the performance of AgroRemed BR. TPH of the soil contaminated with diesel and No. 2 fuel oil has been found to be reduced by more than 90 % in 20 days time and in this case, evaluation was done on 15<sup>th</sup> day, 40<sup>th</sup> day and 70<sup>th</sup> day after a single application. The graph below shows the effectiveness of the new AgroRemed BR.

**Reduction in TPH of diesel contaminated soil using AgroRemed BR**

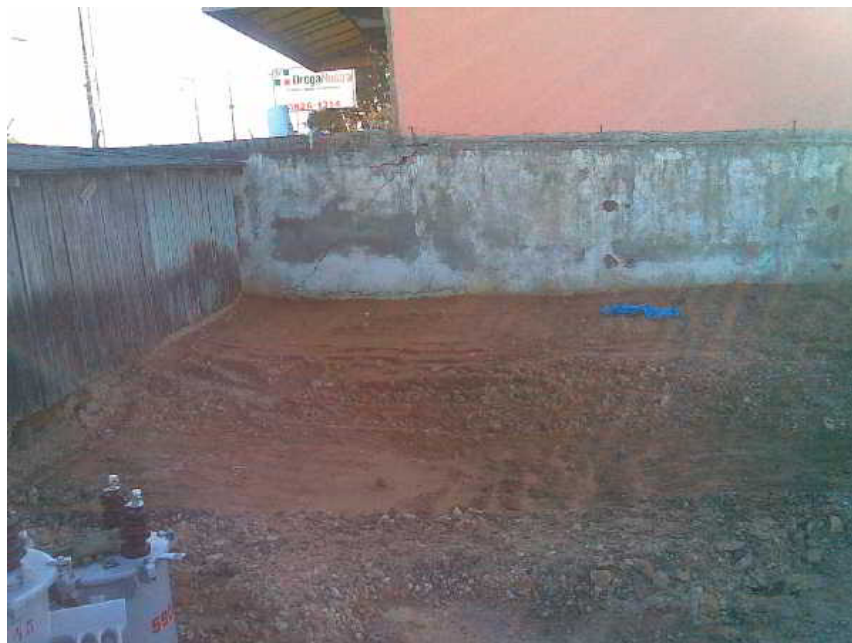
**Figure 10. Site preparation**

At one of the substation site the soil was contaminated with the transformer oil due to vandalism and unsafe storage practices. Local regulators required COPEL to cleanup the site and since excavation of the soil and replacing with clean fill was quite expensive, it was decided to treat the soil as Biopile with AgroRemed BR. The photographs show the preparation of the site before excavation and treatment of Biopile.

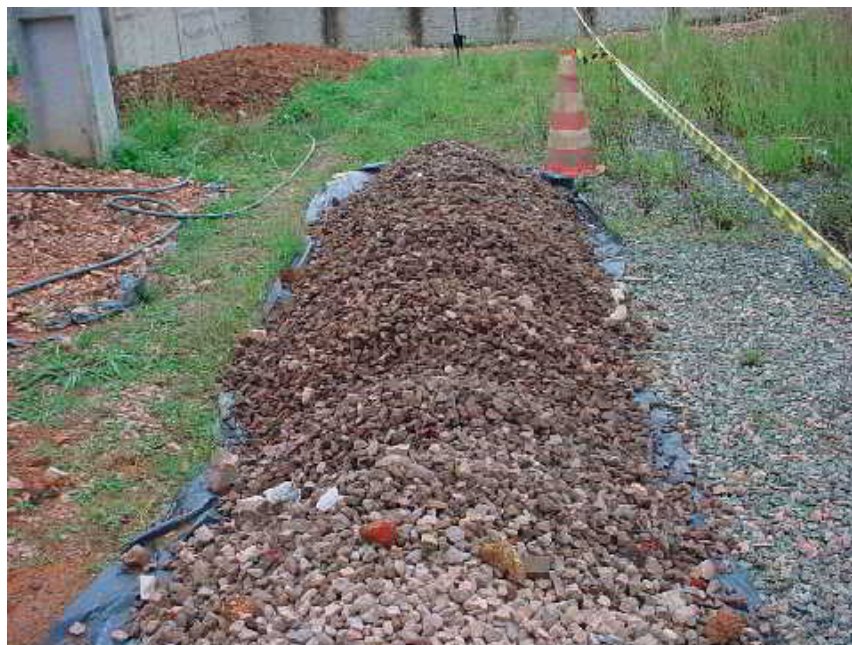
**Figure 11. Biopile prepared from soil excavated to 1 meter deep**

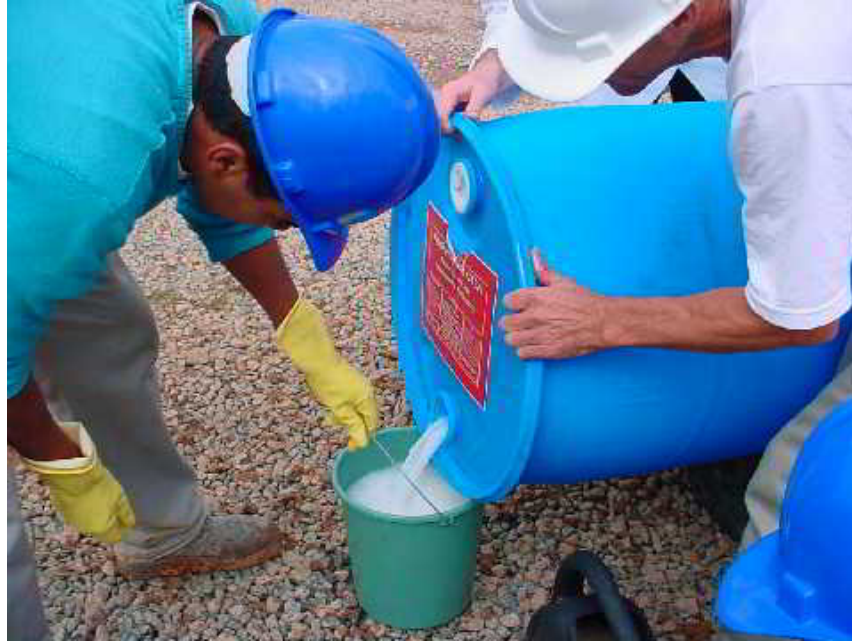
**Figure 12. AgroRemed BR being transferred into a bucket**

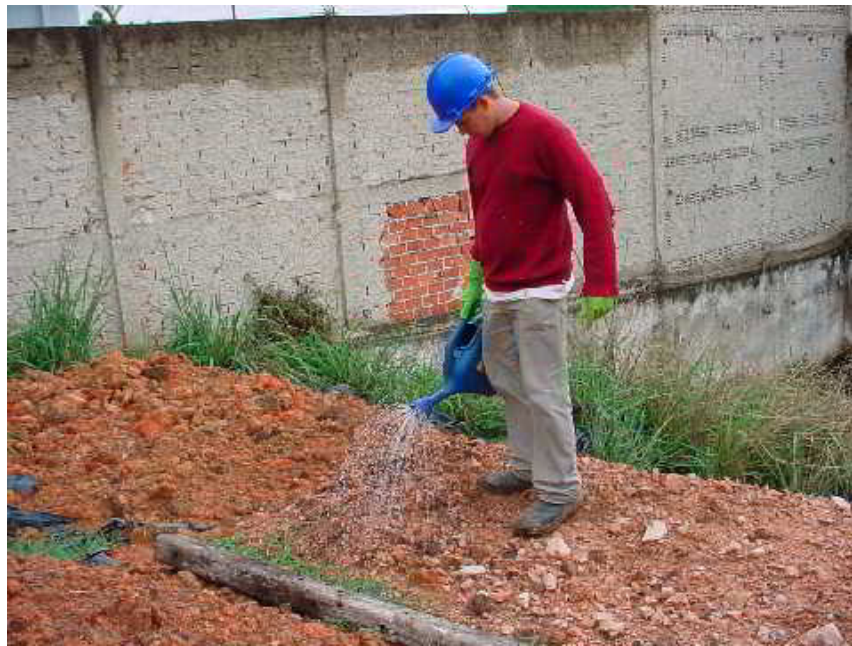
**Figure 13. AgroRemed BR being sprayed with a garden sprayer**
