ENHANCED AEROBIC BIOREMEDIATION OF CHLORINATED SOLVENTS AT A STRIP MALL IN YORK, PA

Enhanced Bioremediation of Chlorinated Solvents at a Strip Mall in York, PA

1 Enhanced Aerobic Bioremediation Report

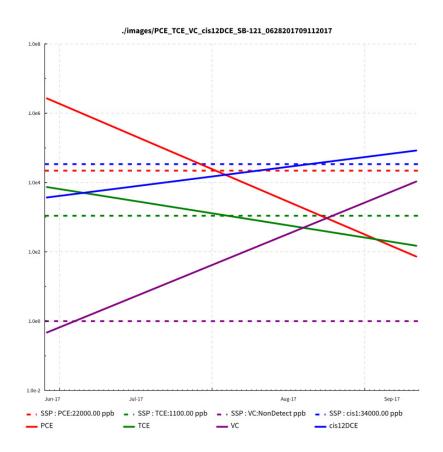
Figure 2: Contamination levels at SB 121, results in ppb*

Table 1 shows that in 70 days both PCE and TCE reduced by more than 90 % in soil. AgroRemed is commercially available to help reduce TPH levels in soil, groundwater by 90 % for over a decade. However, this is the *first* project where AgroRemed is being applied to reduction of PCE/TCE levels in soil.

This reduction is significant and also provides the first clear evidence of aerobic bioremediation of PCE/TCE at the site. Further, a significant increase in the values of cis-1,2-Dichloroethene (cis12DCE) and Vinyl Chloride (VC) by 2167 % and 2127 % respectively confirms the evidence of active aerobic bioremediation as reported in the literature. The significant reduction in the values of PCE and TCE supports our hypothesis that remediation of both these contaminants is being accomplished under aerobic conditions.

Computed first order decay for SB-121

- PCE = -14.00 %
- TCE = -0.005 %

Some more notes about the plot

Assuming a first order decay of PCE in the plot above, one can estimate the PCE levels at any point between 6/28 and 9/11. For example, it can be seen that the site specific levels for PCE were reached at the site in the first week of August, 2017.

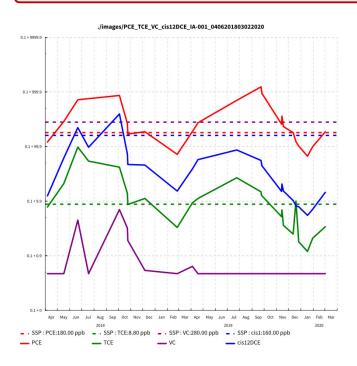
Figure 3: Values of PCE/TCE at IA-001

• IA 001: Basement: Just outside VP 3 sub-slab sampling point The location was measured at a greater frequency than the other locations as this location is closest to VP 3. It was observed that after summer of 2019 the results for Vinyl Chloride were non-detect. This degradation can be attributed to the bioremediation of Vinyl Chloride by VaporRemed. This confirms the results of an earlier project wherein biodegradation of poly vinyl chloride (PVC) was evaluated both under laboratory and semi-industrial scale and it was observed that the bacterial consortium in VaporRemed were effective in biodegradation of PVC.

Table 4: Documented reduction of TCE/PCE in IA-001

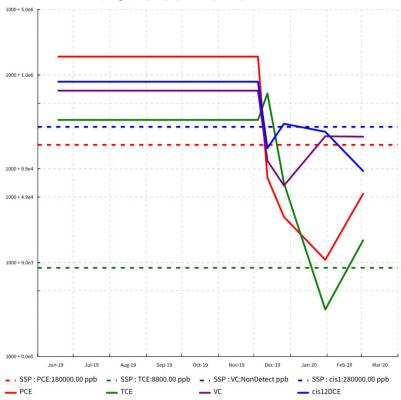
Figure 4: Values of COCs between 2019 - 2020

We decided to introduce VaporRemed at three new injection points drilled near SG 101 and SG 106. The holes at SG 101 were shallow less than 1' as standing water was recorded at this depth. At SG 106, these injection points were drilled to 6' below surface.

UTCTime	PCE	TCE	VC	cis12DCE
06/18/2019 09:00	1570000.00	332000.00	681000.00	848000.00
12/04/2019 11:25	1570000.00	332000.00	681000.00	848000.00
12/12/2019 11:25	80400.00	636000.00	122000.00	166000.00
12/26/2019 11:03	30700.00	70400.00	66300.00	302000.00
01/30/2020 11:01	10700.00	3160.00	222000.00	248000.00
03/02/2020 11:50	54200.00	17300.00	220000.00	94700.00
