Impact of Irrigation Drainage Tile on Nutrient Loading in the Tri-County Agricultural Area, Northeast Florida

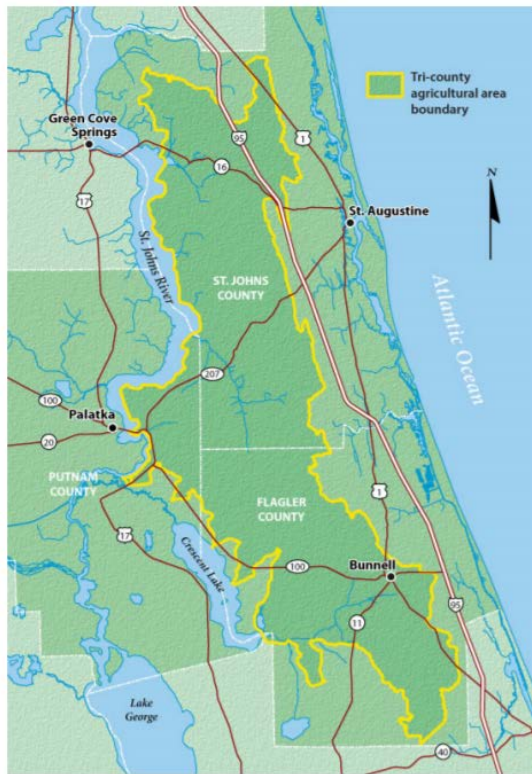
Figure 1 – Tri-County Agricultural Area (TCAA)

Agriculture in the Tri-County Agriculture Area (TCAA), **Figure 1**, was identified as a significant contributor to nutrient loads in the freshwater section of the LSJR and even with full implementation of BMPs by growers, agricultural load reduction requirements would not be completely met and will require regional treatment systems and other enhanced nutrient reduction techniques to achieve full load reduction requirements. The Tri-County Agricultural Area – Water Management Partnership (TCAA-WMP) is a cost share program that funds projects intended to reduce nutrient loads in the St. Johns River.

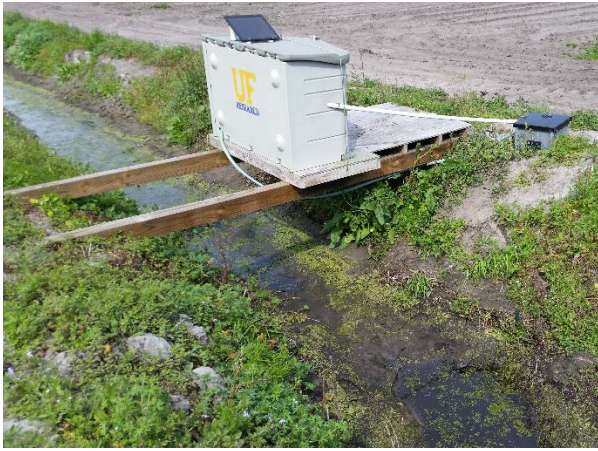
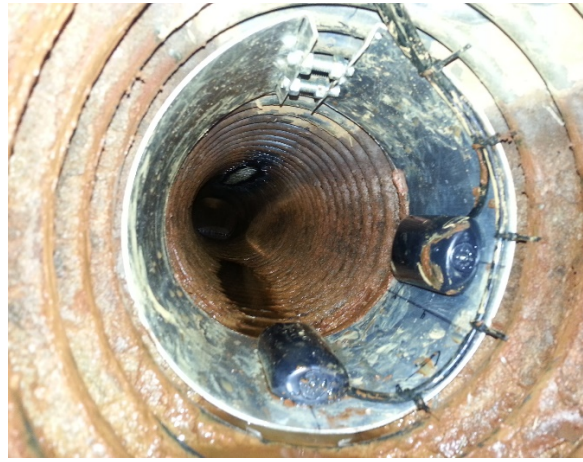
Figure 5 - Monitoring station at IDT field (left) and AV flow sensor within IDT discharge pipe (right)

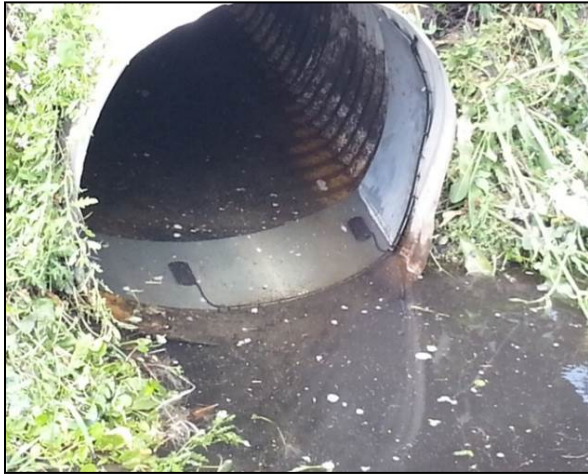
Figure 6 - AV sensors within surface water monitoring culver pipe (left), AV sensors installed within IDT discharge pipe (right)

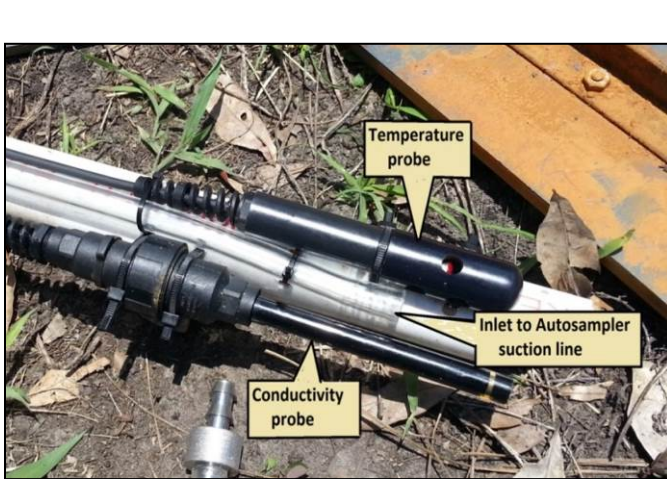
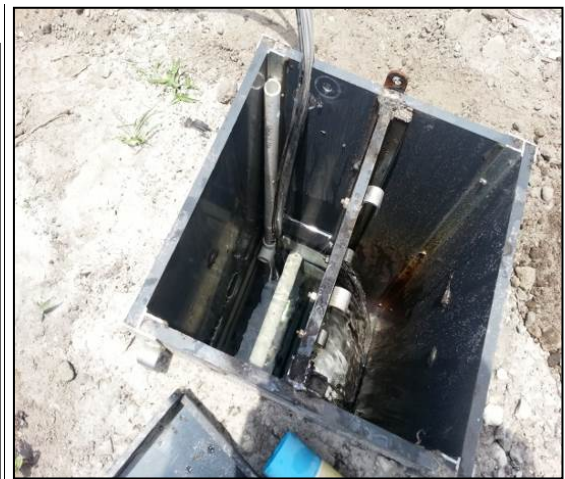
Figure 7 - Autosampler intake tube, conductivity, and temperature probe (left) prior to installation within IDT control box (right)

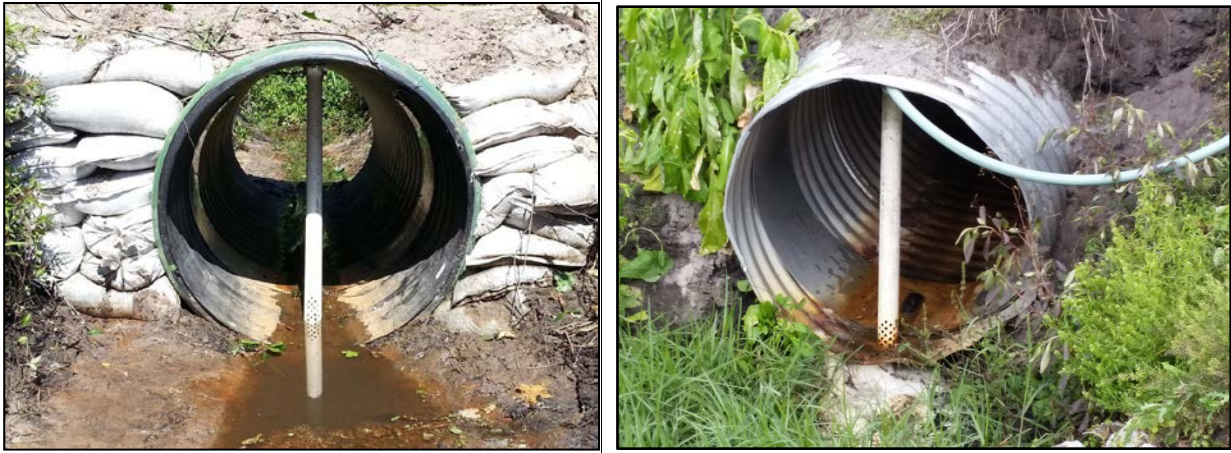
Figure 8 -Typical surface water collection within seepage ditch (left) and culvert (right). Autosampler intake tube, temperature and conductivity probes are located within PCV pipe attached via hinge to top of culvert to allow high flow events.

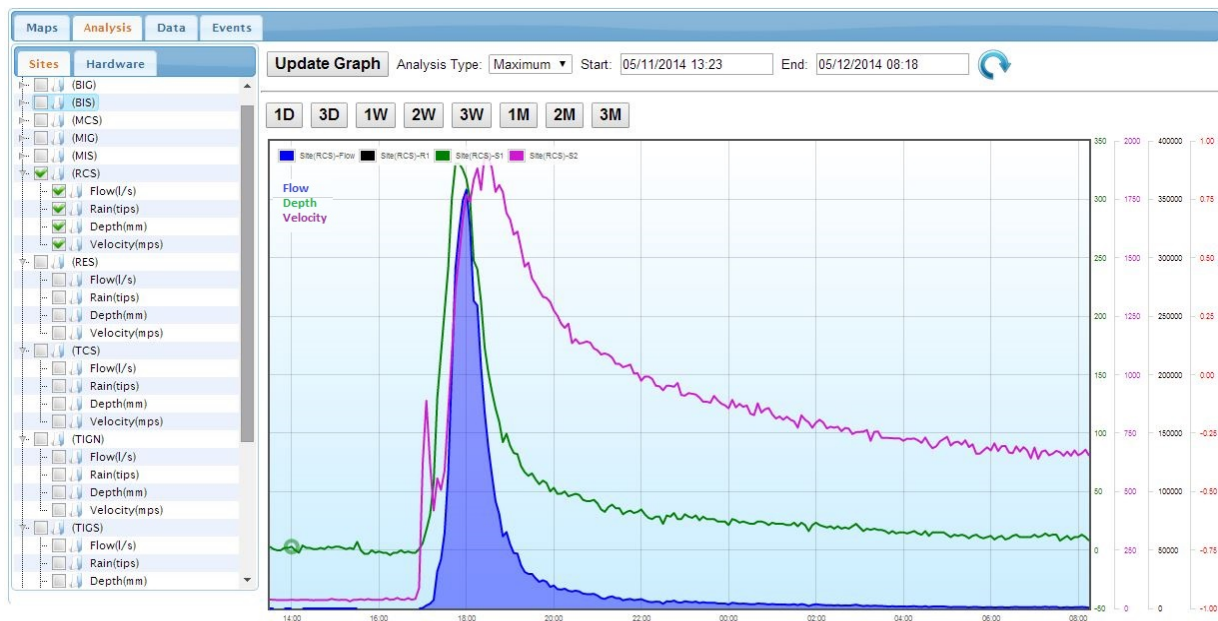
Along with measuring flow and triggering ISCO samples, each Blue-Siren flow meter/data logger was connected to water quality probes to collect temperature and conductivity at the sample collection point. These values, as well as the flow and depth volumes were collected by the datalogger at 5-minute intervals. The Blue-Siren datalogger was also connected to the internet via modem and uploaded data to a Blue-Live website on a 30-min basis so live data from samples sites could be monitored and stored. The real-time levels within the IDT control box as well as the drainage ditch culverts were shown on the Blue-Live website and changes, such as ISCO trigger volumes, could be made according to observed levels and weather forecasts. Stations were monitored via Blue-Live website for water levels, flow, depth, velocity, rain gauge tips and ISCO sample trigger times. This information was useful to view rain events and field irrigation response as well as illustrate sample collection volumes as well as potential problems prior to weekly visits. Real-time data acquisition and monitoring using the Blue-Siren flow sensors and Blue-Live virtual data server also facilitated assessment of monitoring sites and determination of any calibration, maintenance and repair that may need to be conducted.

Figure 9 – Blue-Live website showing increased depth, volume, and flow at a monitoring station

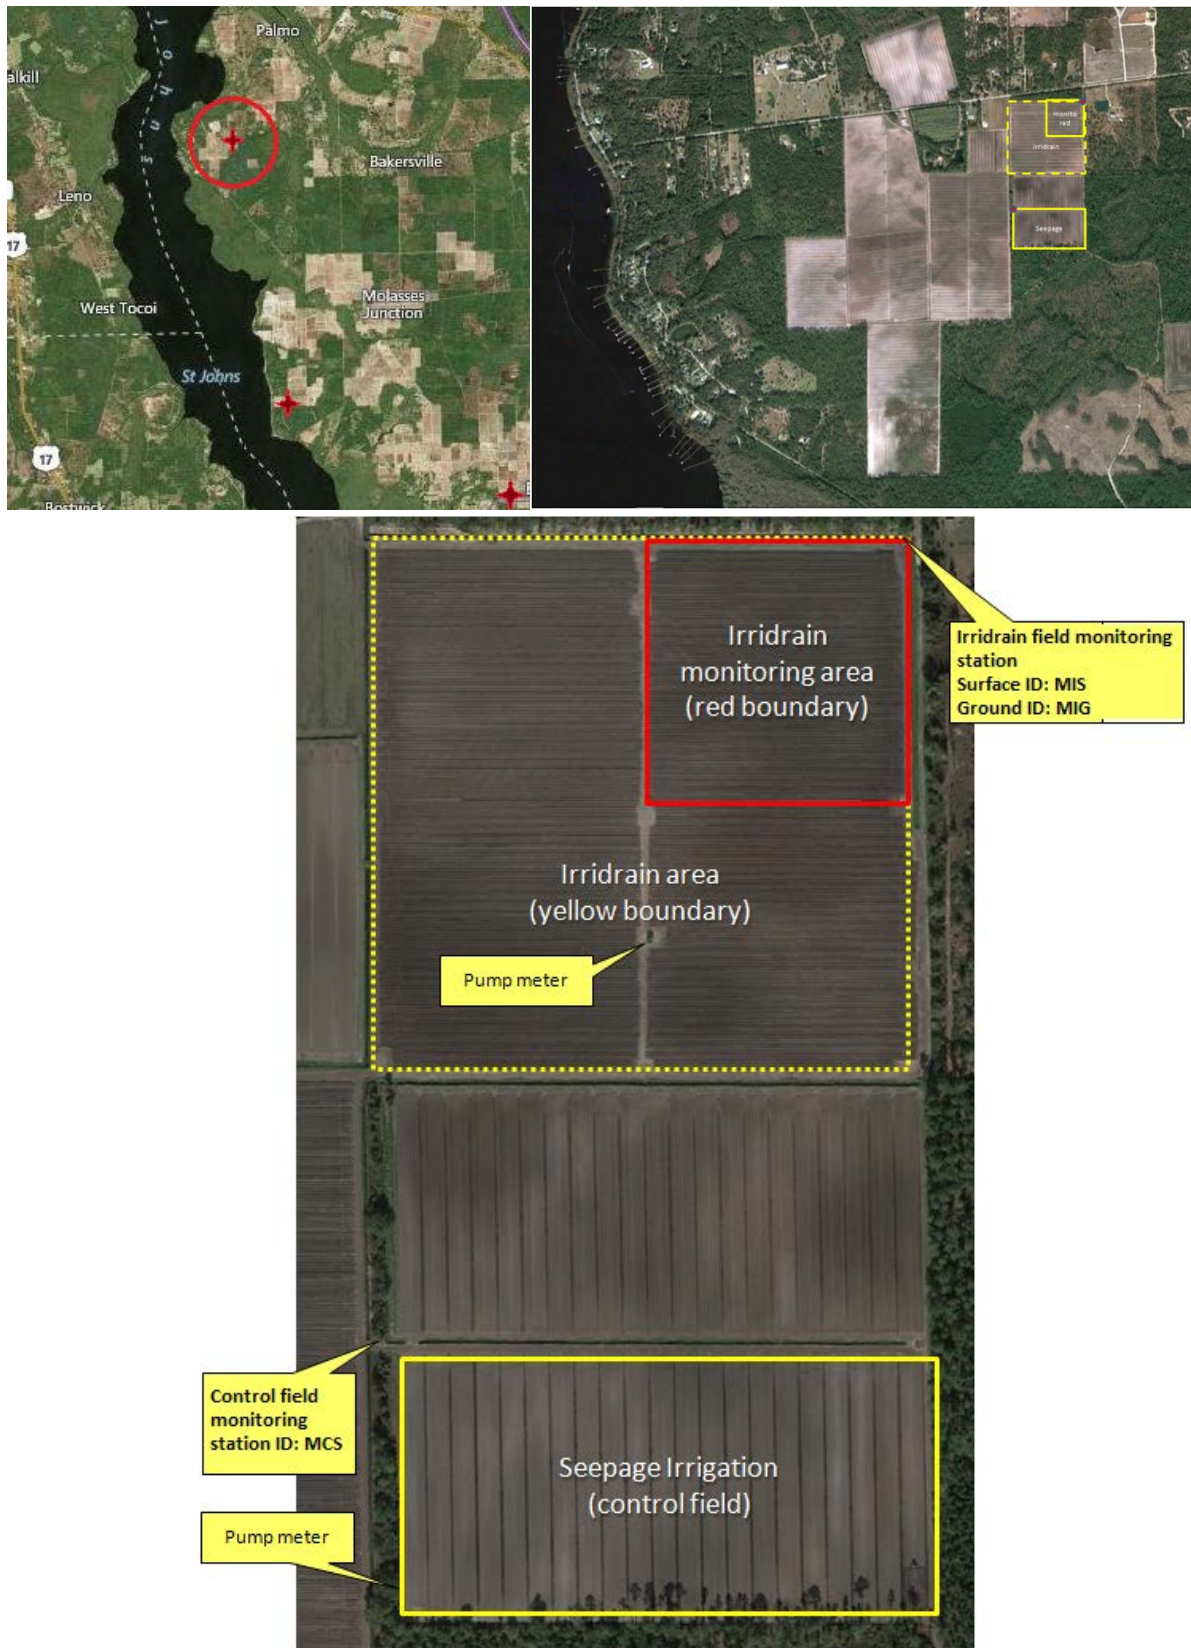
Figure 11 – Sykes & Cooper Farms

A total of 13 monitoring stations were installed on 9 fields within the 4 farms. At each IDT field one groundwater monitoring station and one surface water station was installed. This system allowed a comparison between groundwater drainage resulting from the IDT system within the field and the surface water leaving the field in the perimeter tailwater ditches. The monitoring station distribution is as follows: Picolata farms, one IDT field groundwater station (MIG) and surface water station (MIS), one seepage field surface water station (MIG) (Figure 10); Sykes & Cooper Farms, one seepage field surface water station (BCS), one IDT field groundwater station (BIG) and one surface water station (BIS) (Figure 11); Tater Farms, two IDT field groundwater monitoring stations (TIGS, and TIGN) and surface water station (TIS), one overhead irrigation field surface water station (TOS), and one seepage field surface water station (TCS) (Figure 12). Smith Farms one surface water station was installed on the farms seepage field (SCS), one surface water station (SIS), and one additional groundwater station (SIG2) was installed at the southern end of the IDT field. The northern IDT drainage was also monitored, but samples were not collected from this site (SIG1) – Figure 13.

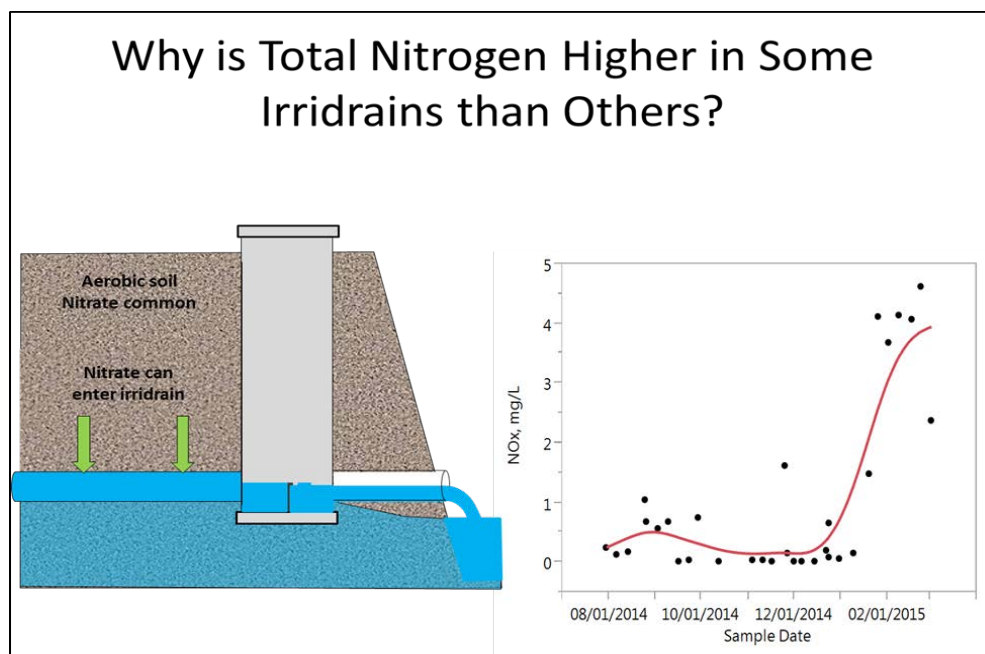
Nitrogen - Total Nitrogen (TN) concentrations generally showed the opposite trend to that of TP when comparing IDT fields to conventional seepage irrigated fields or showed that there is no significant difference between fields. Concentrations at Picolata and Tater Farms had slightly higher TN concentrations at the IDT (ground) monitoring station than at the IDT (surface) monitoring station indicating some assimilation or dilution of nitrogen in the tailwater ditch, but IDT fields at these farms were not found to be significantly different from conventional seepage irrigated fields. Sykes and Cooper Farm however, had significantly higher TN concentrations from the IDT field than from the conventional seepage field with most of this nitrogen being in the form of nitrate which differed from the dominant nitrogen form found at Tater and Picolata farms which was TKN and likely ammonium. These differences in nitrogen species and significant differences in total nitrogen concentrations found between farms may indicate how important water level management in IDT fields is to reducing nitrogen loss. Further evidence of the relationship between field groundwater level and nitrate concentration discharge through IDTs is illustrated in Figure 3. The graphic shows nitrate concentration at Picolata Farm IDT field between August 1, 2014 and February 28, 2015. Between August 1, 2014 and mid-January, 2015 water levels in the field were kept high and nitrate concentrations in runoff were relatively low (below 1 mg L⁻¹). In mid-January 2015 water levels were lowered in to allow equipment into the field for planting, which also appeared to cause a significant increase in nitrate nitrogen concentrations (approximately 4 mg L⁻¹). This was also a time when fertilizer was applied so specifically which factor (fertilizer or water level) resulted in the significant increase in nitrate concentrations is uncertain and it is likely that both contributed to the increase in concentration to some extent. But lowering the water table in the field and allowing “free drainage” of the IDT system would have removed any potential for an anaerobic zone in the soil that nitrate leached through the profile would have to encounter before entering the IDT system. Holding at least some water in the soil profile above the IDT system would likely be beneficial to reduce nitrate losses.

Figure 3. Water level management as likely mechanism explaining differences in nitrogen concentration between IDT and conventional seepage irrigation fields. Graph inset shows nitrate concentration at Picolata Farm IDT field with high water table from August 1, 2014 through mid-January 2015 and then lowering of water level for the rest of the monitoring period. Slide presented to TCAA growers during a field day updating them on findings of the project.

Management of IDT fields by via control box boards to retain a high water level within the soil may be a way to enhance the denitrification potential within IDT fields. Minimum height of 24 inches may be the minimum target height of control box stoplogs to see beneficial denitrification while still maintaining an aerobic zone above the saturated zone to reduce nitrate loss in the upper soil profile.
