East Coast Filter, Inc.

ANTI-STATIC VARNISH REMOVAL FILTER ELEMENTS

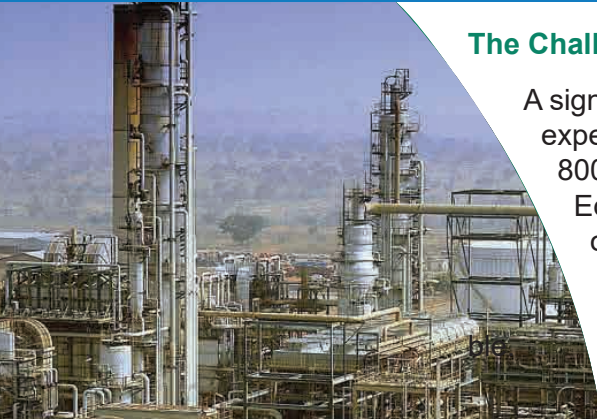
With a further detailed inspection of the previously installed OEM Lube Oil Filter Elements, a large amount of varnish had been deposited on the inner core of the element after only one month in operation, indicating a severe issue with static discharge. The conductivity levels of the Lube Oil were evaluated at 4 pS/m which reflects a high possibility of static discharge.

It was also discovered during the inspection, that a noticeable sound could be heard within the Main Lube Oil Filter Vessels which was believed to be caused by the static discharge being produced by the generated varnish coupled with the velocity of Oil flowing through the filter. Finding a solution that could improve the noise as well as the appearance of varnish would be the ultimate goal.

By working diligently with Hilco Engineering as well as the Gas Turbine OEM, it was determined that the best solution for the varnish and sound issue would be to install the Hilco PH-CGJ Style Anti-Static Filter Elements within the existing Lube Oil Vessels.

These Filter Elements are designed with a proprietary Anti-Static media that helps disperse any static charge build up that could have occurred before it could be discharged, thus eliminating the chance for sparking potential as well as exceptional particulate removal.

With the installation of the Hilco PH-CGJ Anti Static Filter Elements, the sound associated with the old Elements within the filter Vessel had been eliminated completely.
