A quick update regarding some concerns with the Hoyt St Puck remote control. Nothing lasts forever and the Hoyt Puck is no anomaly. Plastic fatigues and breaks, solder joints atrophy when exposed to repeated stresses. It is important to regularly inspect your Puck to ensure it is flight ready.

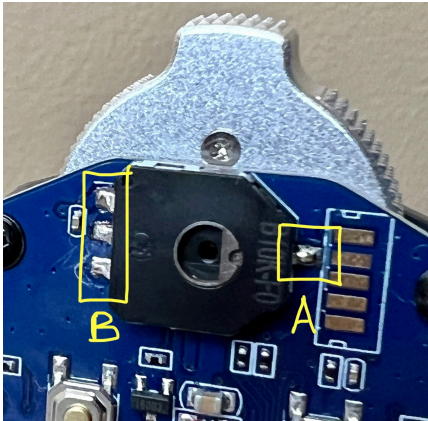
Particularly after a fall but also after aggressive longterm use, these solder joints can fail resulting in a full throttle incident.

Primarily solder joint A but also solder joints B can see wear and stress.

A quick solder top off on these joints is all that is necessary for repair. If you're not confident with your soldering skills, feel free to mail to Hoyt for free repair:

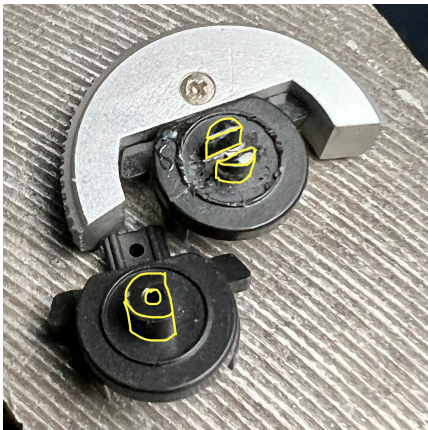
Additionally, Hoyt has reinforced the throttle pin to address the pin breaks we experienced with the first batch of remotes. Anybody with the original two pin configuration was offered a replacement pin on the house. While this modification has immensely improved the durability, a hard fall can still shear this component. This generally results in a non-functional throttle rather than a full throttle event.
