Load testing of PP
Itip™ wheelbarrow handles

Job No: J4921

Introduction

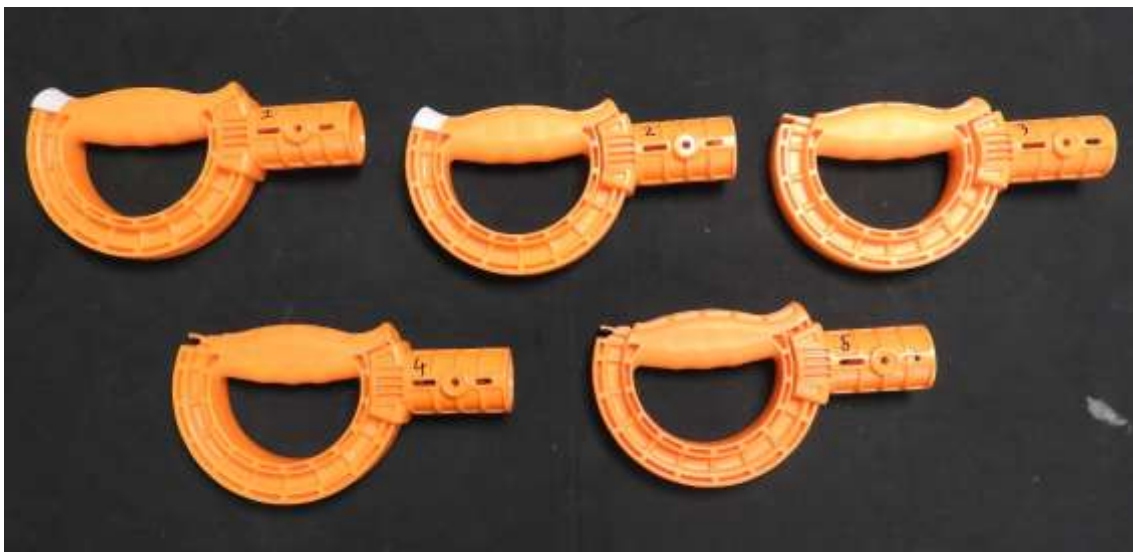
Image 1: Samples as received

The samples delivered consisted of 5 of articulated wheelbarrow handles. Each of the samples were initially inspected for any evidence of defects. No difference between any of the handles was observed apart from the presence of a clip on 2 handles and not on the other 3. An example image of the delivered samples is shown below. In each case the handle element was manufactured from PP whilst the support stub was manufactured from POM.

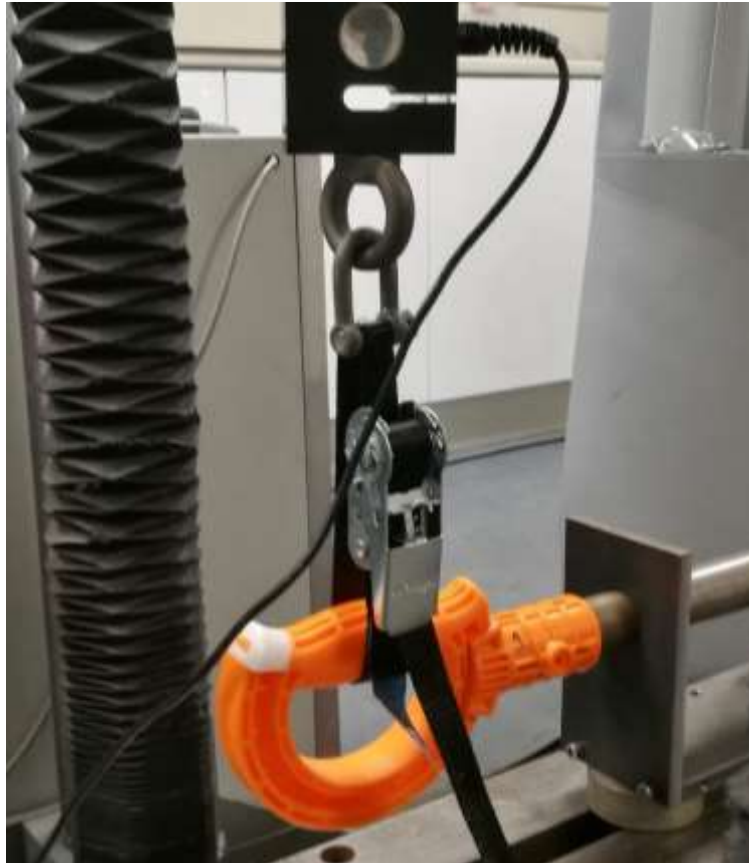
Image 2: Test setup showing vertical loading

In the absence of a published standard, a bespoke load test was agreed with the client. Load testing was conducted in 1 orientation on the 5 samples. A steel mandrel used for mounting and testing the handles. An image of the final test setup is shown below. For this testing a tensile tester was used with a crosshead speed of 12mm per minute, and the load on the handle was recorded digitally. The load was increased in approximately 250N steps and then held for 10 seconds at each interval.

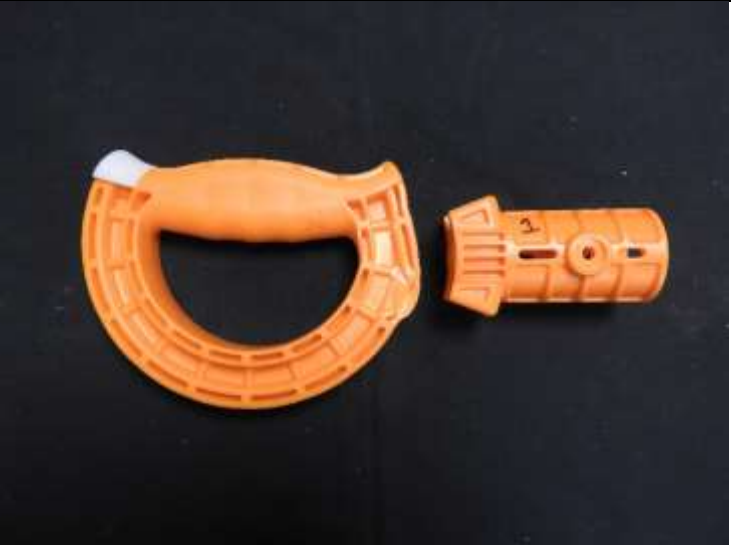
Sample	Failure description	Image
1	Failed following deformation of the handle allowing it to slip out of the joint.

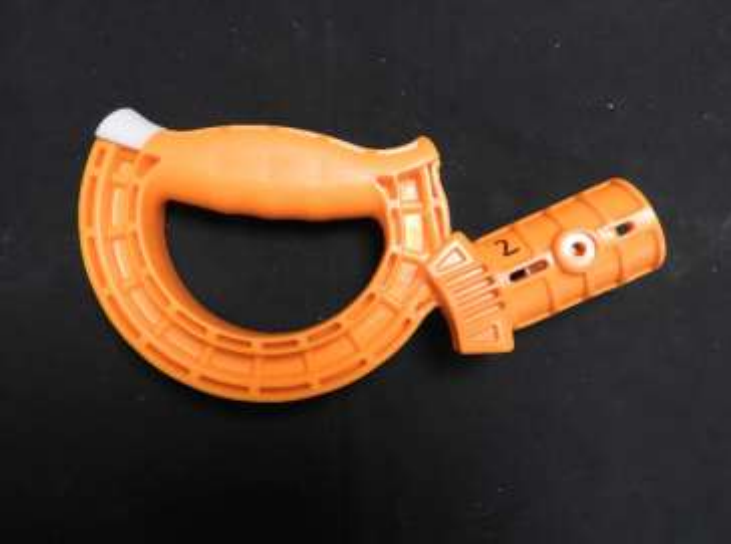
2	Failed following deformation of the handle allowing it to partially slip out of the joint.

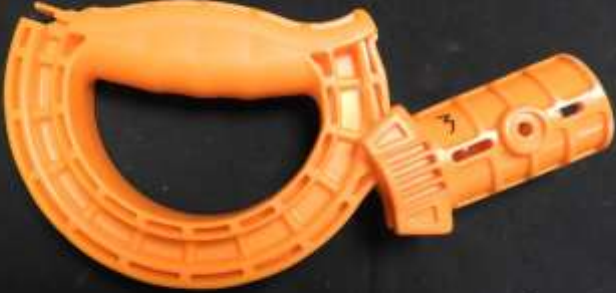
3	Failed following deformation of the handle allowing it to partially slip out of the joint.

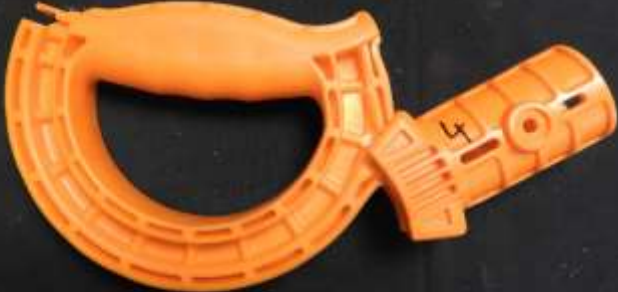
4	Failed following deformation of the handle allowing it to partially slip out of the joint.

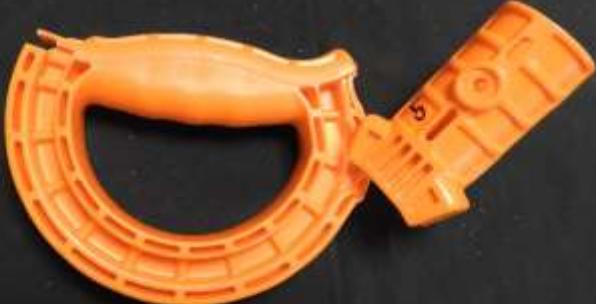
5	Failed following deformation of the handle allowing it to partially slip out of the joint.

Table 3 shows images and descriptions of how each sample failed during testing. All samples failed due to deformation of the handles that allowed the sample to slip out of the top of the joint. Image 3 (below) shows sample 2 just prior to failure.

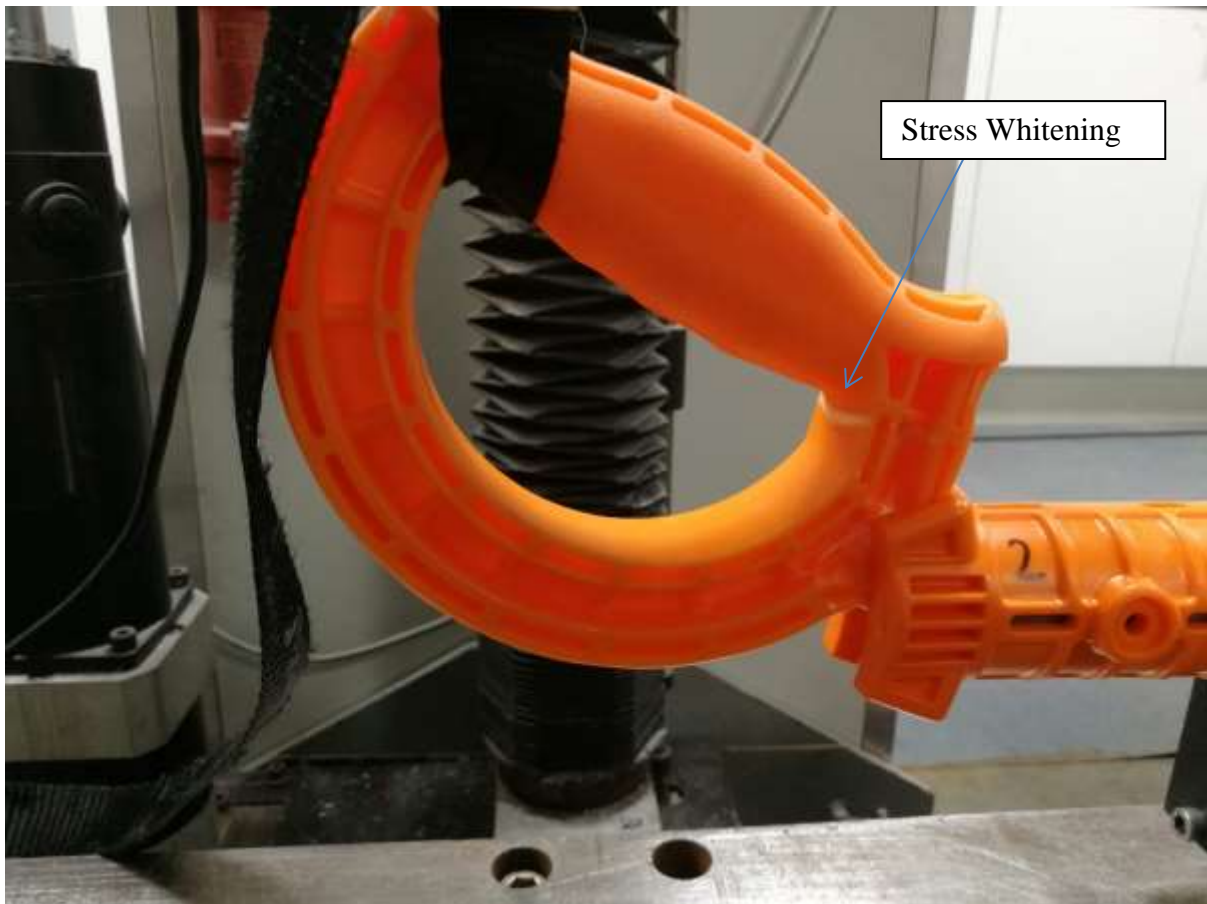
Image 3: Image of sample at failure

In each case, visible deformation of the handle began to occur between 1000 and 1200N. Some stress whitening was visible on the inner radius of the handle (see image 3).

1. Load testing of the PP/POM variant shows a different failure mode to the POM variant.
2. No cracking or fracturing of the components occurred with the PP/POM variant.
3. Deformation of the handle begins to occur at around 1000 to 1200N.
4. Final failure occurs 1543N. The final failure mode is deformation of the PP track causing the handle to slip out of the POM retainer.
