SEM surface analyses of 120 sterile-packed implants

Final report of the BDIZ EDI implant study | 2014/15

DR DIRK DUDDECK^{1,2}, DR HASSAN MAGHAIREH³, DR FRANZ-JOSEF FABER⁴ AND DR JÖRG NEUGEBAUER^{1,5}

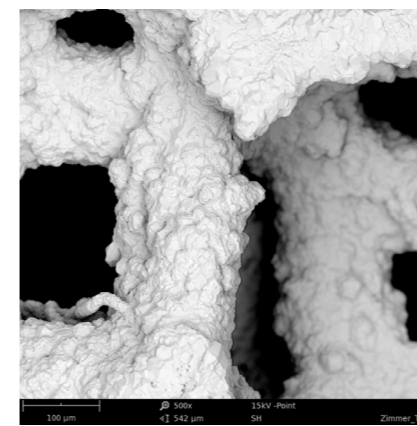
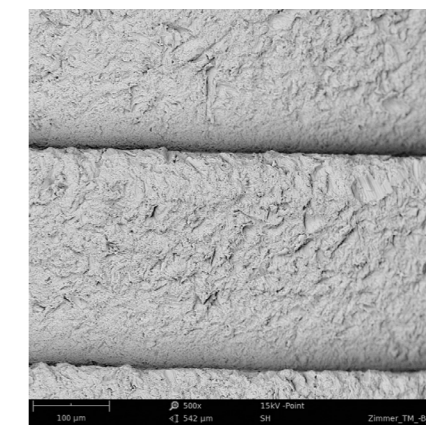
17 | Trabecular midsection made of tantalum (Zimmer Trabecular Metal implant, x500).

18 | The shoulder and apex of the same implant are made of titanium (Zimmer Trabecular Metal implant, x500).

One tantalum-titanium hybrid implant in this study exhibited a rather particular surface topography. While the titanium surface of the implant shoulder and its apical region had been blasted with hydroxyapatite, the middle segment of the implant, marketed by the manufacturer as “trabecular metal”, had a porous structure not unlike cancellous bone. This three-dimensional structure is based on a glassy carbon framework completely coated with tantalum. The corrosion-resistant tantalum [11] has been successfully used as an orthopaedic implant material for many years. Now also used in dental implants, the special surface texture is designed to allow the ingrowth of bone cells into the depth of the structure [12,13]. The term “osseointegration” has been coined in the literature in an attempt to add a third dimension to Brånemark’s definition of osseointegration [14]. Prospective multicentre studies at 22 locations in five European countries have shown that the clinical success rates of hybrid implants made of titanium and tantalum were similar to those of pure titanium implants [15]. The only representative of this class of materials in the current study was the tantalum-titanium hybrid implant by Zimmer (Figs. 17 and 18).

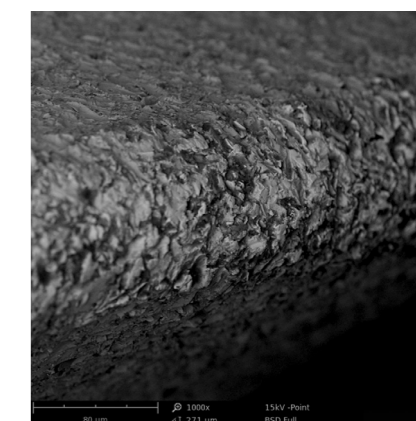
22 | Circumferential organic residue on a titanium implant (x500).

23 | Organic residue on the outer thread structures (zirconia, x500).

24 | Superficial organic particles (zirconia, x500).

Minor amounts of carbonaceous residue remaining on the implant after the cleaning process are a not infrequent finding. Organic residue appears darker in the material contrast image than titanium or zirconia because carbon atoms have fewer electrons and therefore create fewer backscattered electrons in a SEM than atoms of higher atomic numbers. Soft, sometimes jagged edges are typical of organic contaminants. If there are only a few isolated spots like that, they will make up only a very small part of the total area, being of little consequence and no clinical relevance (Fig. 21). The figure shows a single organic impurity 10 to 20 µm in size on an otherwise largely residue-free implant. More conspicuous were systematically distributed organic residues on several implants that are in contact with their outer packaging. These typically featured circumferential organic contamination occurring only at the outer edge of the thread (Figs. 22 to 24), which suggests that con-

tact with the packaging could be responsible.

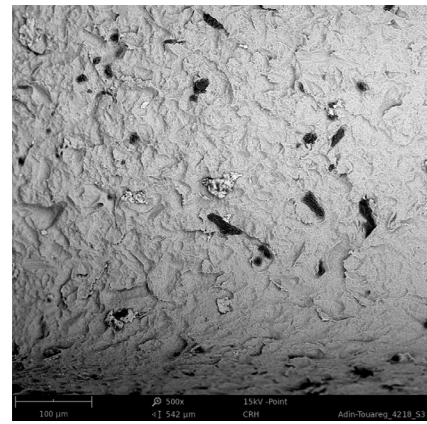
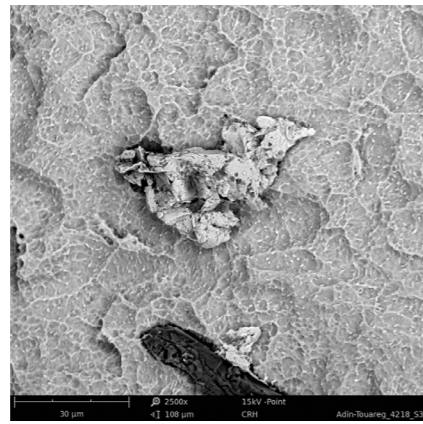
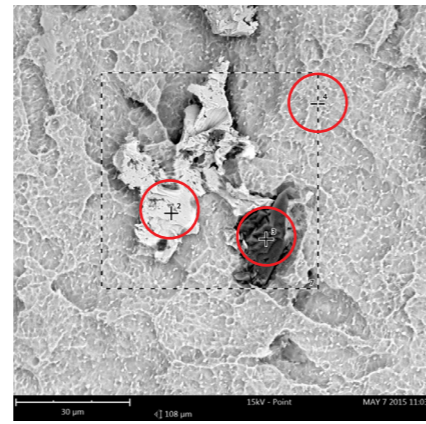
Unexpected inorganic residue findings included, in addition to the iron-copper-chromium particles described in the first part of the report, larger areas with intermittent chromium-nickel-steel particles 4 to 30 µm in size on one of the implants studied. The material contrast image had already presented them as strikingly bright and well-defined structures. These metallic particles might have originated as impurities within the blasting material or as abrasion residue from the CNC cutting tools that were subsequently embedded in the implant surface to the point where cleaning could not remove them (Figs. 26 and 27). Three spot analyses were carried out as part of the qualitative and quantitative elemental analysis (Fig. 28). The analysis of the chromium-nickel-steel particle

26 | Implant surface (Adin Toureg) with notable light and dark particles (x500).

27 | Same implant surface (Adin Toureg): bright chromium-nickel-iron particle, dark aluminium oxide particle (x2,500).

28 | Marks for EDX spot analysis and EDX mapping area (Adin Toureg; x2,500).

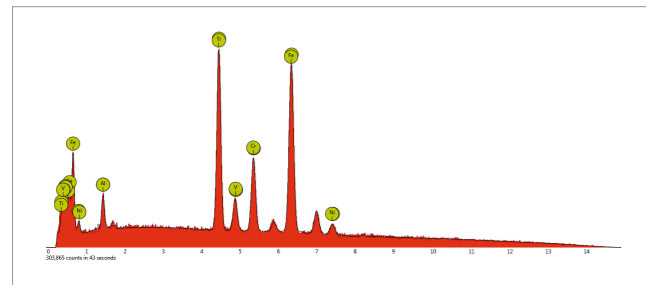
29 | Qualitative elemental analysis, spot no. 2 (bright chromium-nickel-iron particle).

Element	Atomic percentage	Certainty
Fe	49.8%	0.99
Ti	24.5%	0.99
Cr	13.6%	0.99
Al	5.6%	0.97
Ni	5.2%	0.96
V	1.3%	0.94

(spot no. 2) has typical “fingerprints” for the elements iron, nickel and chromium (Fig. 29 and Table 2). As expected, the dark particle turns out to be alumina (Fig. 30 and Table 3), while the control area outside

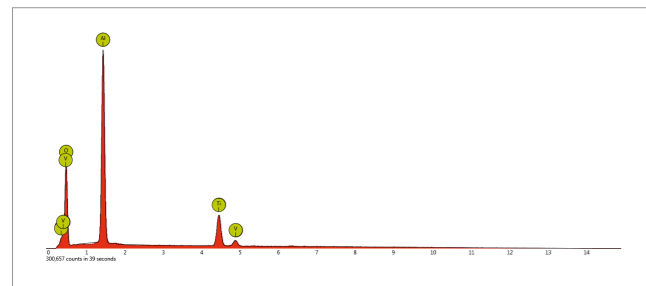
30 | Qualitative elemental analysis, spot no. 3 (bright aluminium oxide particle; sandblasting residue).

Element	Atomic percentage	Certainty
O	68.2%	0.99
Al	25.3%	1.00
Ti	6.1%	0.99
V	0.4%	0.93

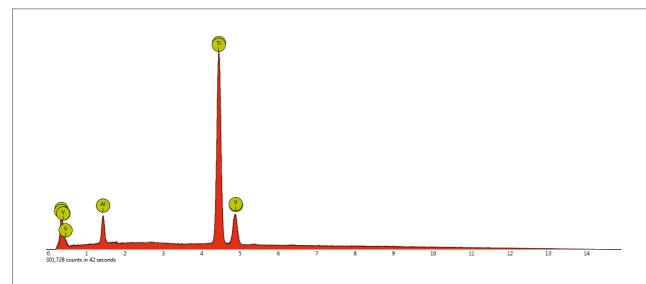
31 | Qualitative elemental analysis, spot no. 4 (particle-free implant surface, grade 5 titanium).

Element	Atomic percentage	Certainty
Ti	85.7%	1.00
Al	11.5%	0.99
V	2.8%	0.94

the two particles (spot no. 4) shows only the typical signs for grade 5 titanium (titanium, aluminium and vanadium) (Fig. 31 and Table 4).

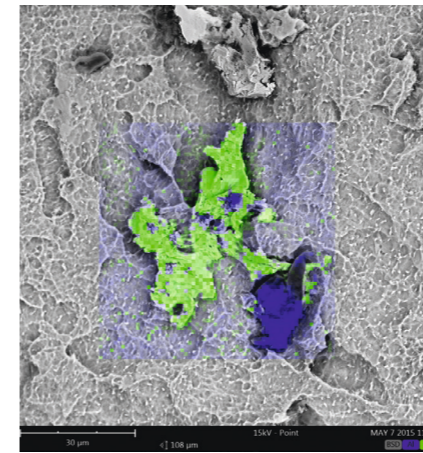
32 | Example of EDX mapping: green = chromium; blue = aluminium (Adin Toureg; x2,500).

tal signal its own colour, which can then be superimposed on the SEM image as a coloured overlay. Figure 32 shows the detected chromium and aluminium in blue.

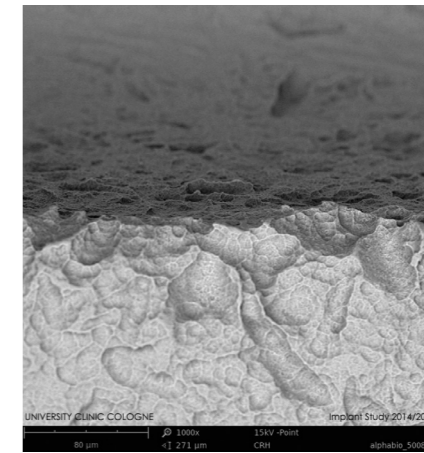
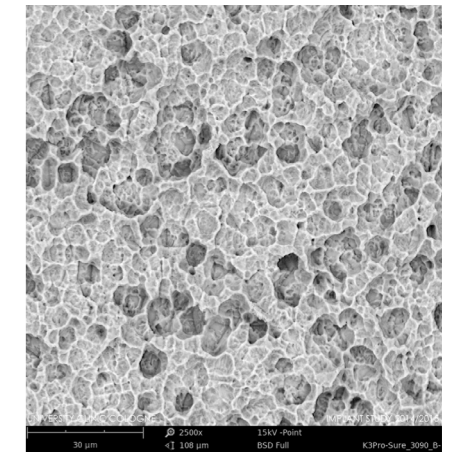
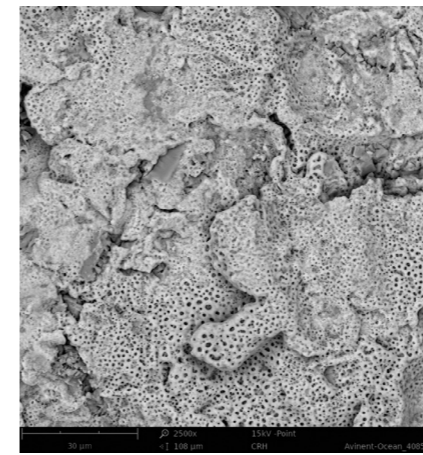
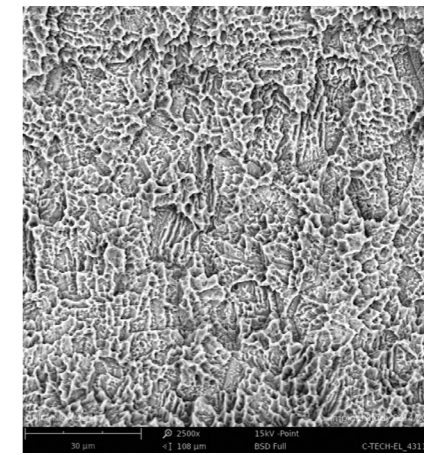
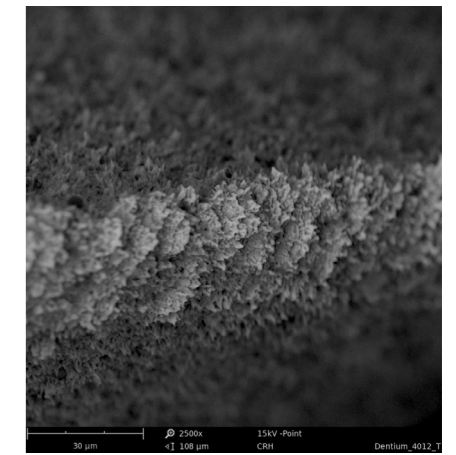
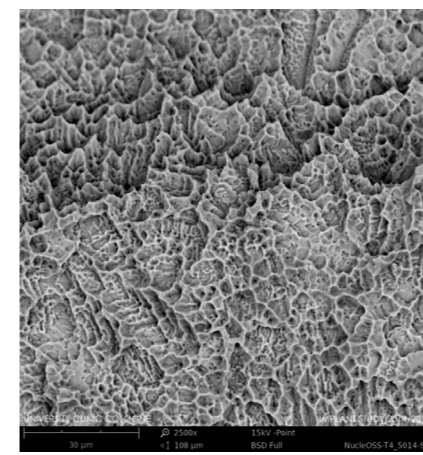
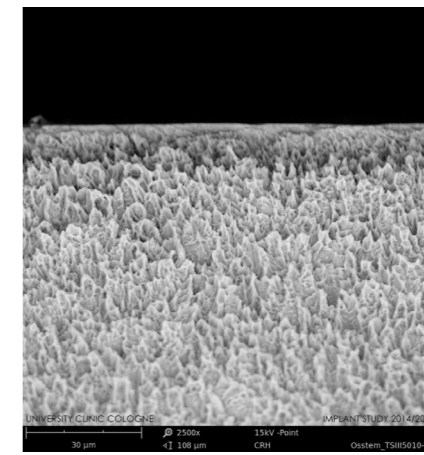
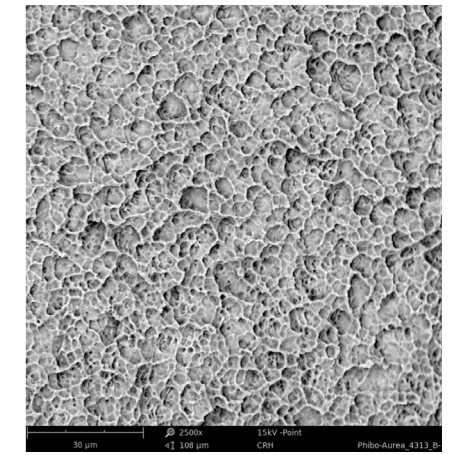
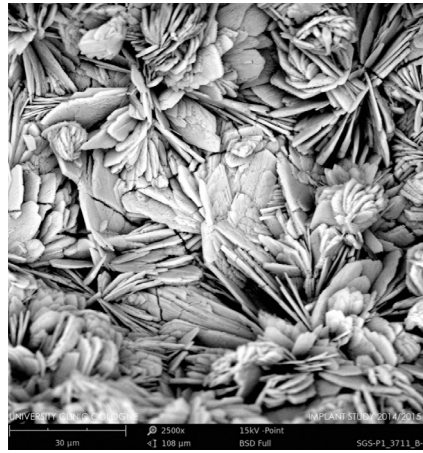
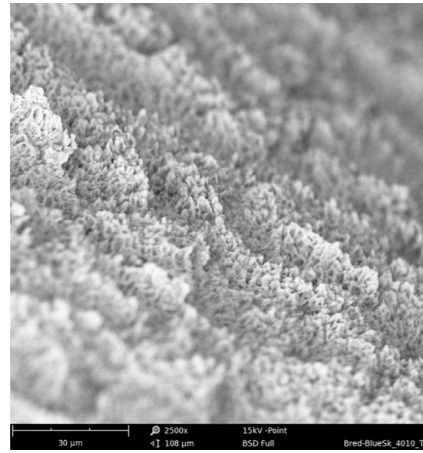
33 | AlphaBio – SPI Spiral Implant (x2,500).

34 | Argon Medical – K3Pro Sure (x2,500).

35 | Avinent – Ocean (x2,500).

36 | C-Tech – Esthetic Line (x2,500).

37 | Dentium – Superline (x2,500).

38 | Nucleoss – T4 Implant (x2,500).

39 | Osstem – TS III (x2,500).

40 | Phibo – Aurea (x2,500).

plants exhibited no significant contamination. By way of example, the surfaces of titanium implants by some manufacturers (Alpha-Bio, Argon Medical, Avinent, C-Tech, Dentium, Nucleoss, Osstem, Phibo, SGS and Bredent) are presented at comparable

41 | SGS - Pi (x2,500).

42 | Bredent - BlueSky (x2,500).

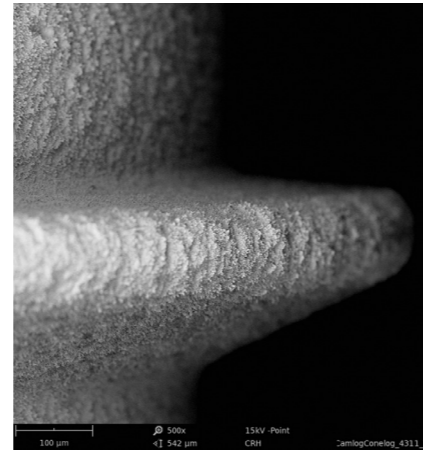
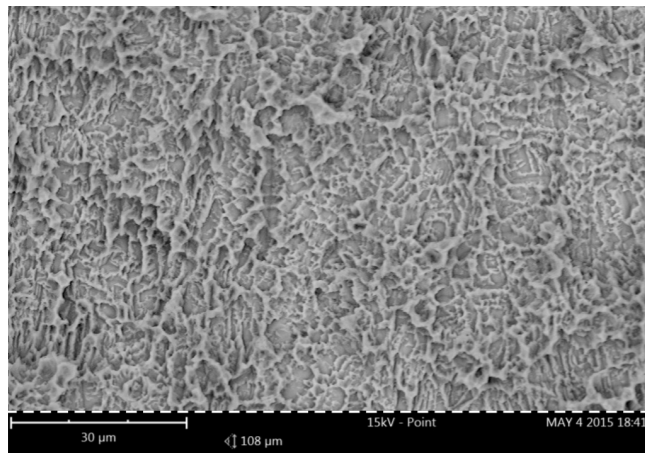
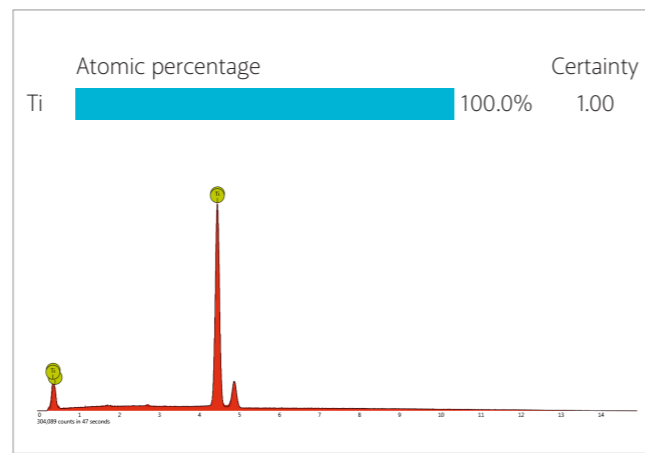
43 | Camlog - Conelog (x500).

44 | Camlog - Conelog, EDX area analysis (x2,500).

45 | Quantitative and qualitative elemental analysis of the Camlog Conelog implant surface (pure titanium).

magnification in Figures 33 to 42. The continuous improvement process in Camlog implants deserves special mention. While the samples analyzed in 2008 showed residues of blasting material on up to ten per cent of the total surface, the figure for 2011 was less than three per cent for the same implant type. In the current study, all three implant models (Camlog, Conelog and iSy) exhibited completely residue-free surfaces in the elemental analysis. Thus, the spectrum of the EDX analysis of the Conelog implant surface indicates only titanium (Figs. 43 to 45).

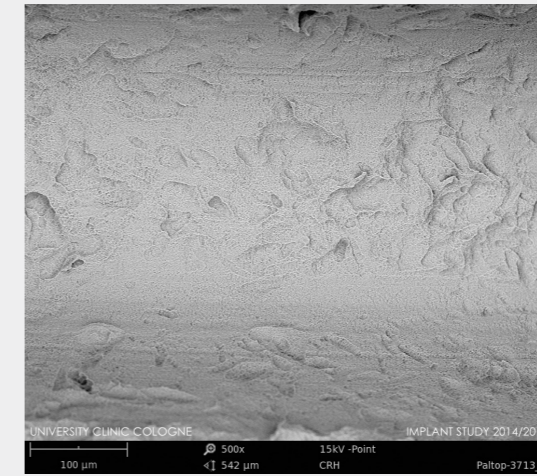
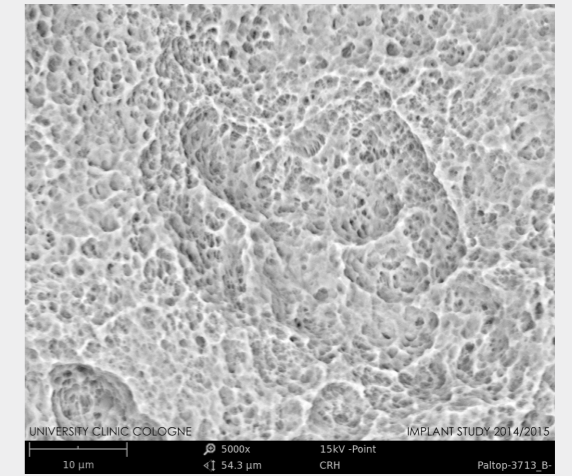
46 | Paltop Advanced Dental Implant (x500).

47 | Paltop Advanced Dental Implant (x5,000).

An Israeli manufacturer (Paltop) has decided to consistently clean their products with ultra-pure water (UPW), which is rather expensive to produce compared to regular demineralized water and is otherwise mostly employed by the semiconductor industry. XPS analyses of the implant surfaces thus cleaned show no traces of sulphur, silicon, zinc or chlorine, inorganic impurities not infrequently found in the XPS analyses of the sandblasted and acid-etched surfaces of implants by other manufacturers investigated in 2014 as the corresponding ISIS identification cards were prepared [22]. The material contrast image showed no residue on the Ti-6AL-4V ELI implant (Figs. 46 and 47). The corresponding EDX analysis shows only the typical elements for grade 5 titanium (Fig. 48 and Table 5).

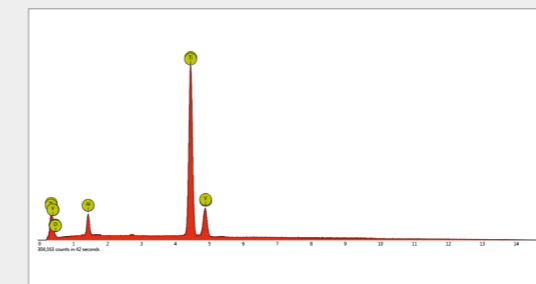
48 | EDX spectrum for the Paltop implant.

Element	Atomic percentage	Certainty
Ti	65.6%	1.00
O	24.4%	0.96
Al	7.3%	0.99
V	2.7%	0.96

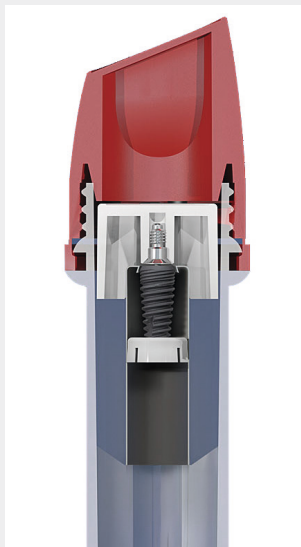
On the one hand, there are uncompromising elaborate constructions that offer safe handling and are sure to eat into the manufacturer's profit margin (Fig. 49). The illustration shows a complex packaging design where the implant is inserted in a separate sleeve made of the same material (grade 5 titanium) as the implant itself to reduce the influence of other materials to a minimum.

49 | Example of elaborate sterile packaging, longitudinal section (Paltop).

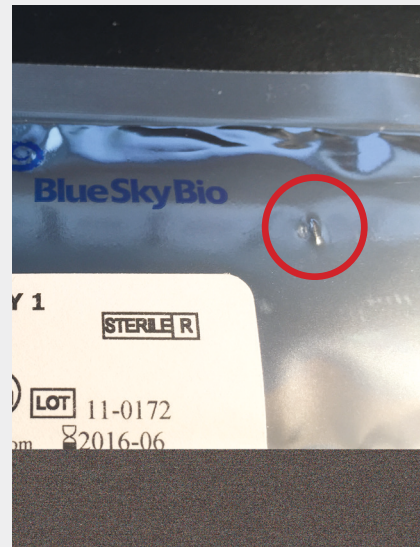
On the other hand, there are simple packaging solutions where the implant is simply sealed in a double plastic bag and the manufacturer seems to have deemed even a stabilizing outer wrapper such as a blister pack to be too costly. Figure 50 shows a sterile package compromised by a sharp-edged cover screw.

50 | Sterile packaging compromised by a sharp-edged cover screw (BlueSkyBio).
