BRITANNIA'S ENVIRONMENT

A look into the 20th century environmental legacy of the Britannia Mine and its 21st century clean up

The Britannia Mine

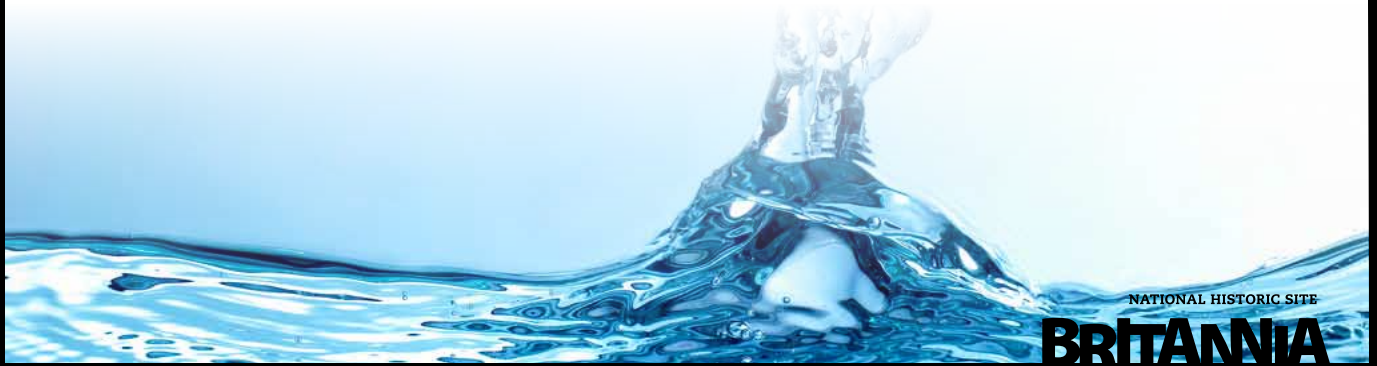
ARD production is a very complicated process, but the main reaction is:

play a big part in ARD production. The biggest ARD producer is pyrite (iron sulphide), though at Britannia, others include chalcopyrite (the copper ore), galena (lead) and sphalerite (zinc). A chemical reaction happens that produces sulphuric acid and dissolves metals, both of which pollute the local environment when they get into the groundwater and local water sources.

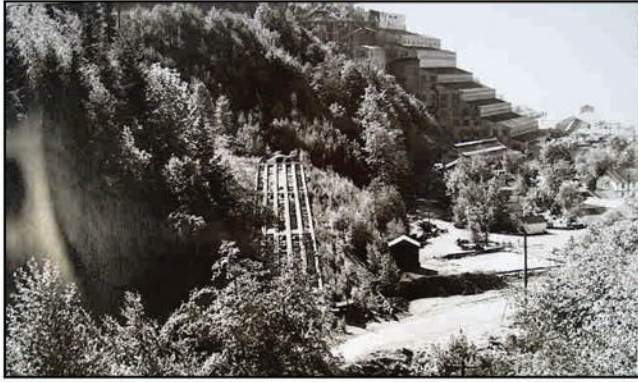
The Beach launders, constructed in the 1950s, were part of the initial water treatment process put in place.

environmental impacts. From the 1930's to the 1970's, copper launders helped, but these were for economic, not environmental reasons. The launders were long timber or concrete troughs containing iron scraps. The mine water was fed through these before being discharged. An iron-copper exchange happened; copper coated the iron scraps and dissolved, relatively non-toxic iron flowed with the water out of the troughs. The copper flaked off from the scraps and was collected to be sold. So it did help reduce the amount of copper entering Howe Sound, but after the mine closed in 1974, the use of the launders soon stopped.

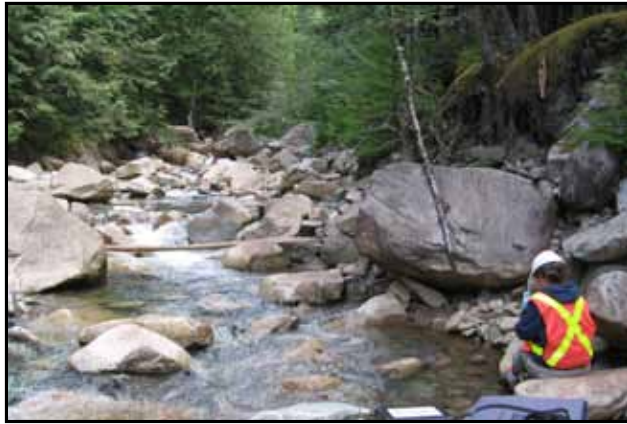
Water sampling from Britannia Creek

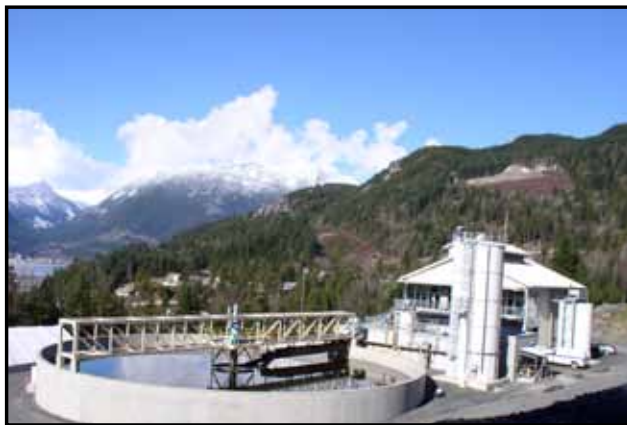
EPCOR Britannia Mine Water Treatment Plant

On arrival at the facility, the water is first treated with lime slurry (a mixture of lime and water) in two reactor tanks. The alkaline lime neutralizes the acidic water, quickly raising the pH from 3.8 (ARD) to 9.3. At pH 8.5, the dissolved metals naturally come out of

solution and precipitate as tiny particles. The most amount of metals precipitate at pH 9.3. The water is then fed into a large 'clarifier' tank where a customized, man-made polymer is added. This electrostatically attracts the metal particles, forming clumps that sink through their own weight, creating a dense sludge at the bottom of the tank. This is removed, and the clean water is discharged into Howe Sound. By the time the water reaches the sea, its pH has naturally decreased to around neutral. Some of the metal-rich sludge is added back into the lime and ARD mix. The sludge particles are a catalyst, encouraging the newly precipitated metals to stick to them – speeding up the precipitation/ clumping process. The rest of the sludge is dewatered in a large filter press (to 45% dry), then stored until it is taken back up to the original mining pit (Jane Basin) high on the mountain.

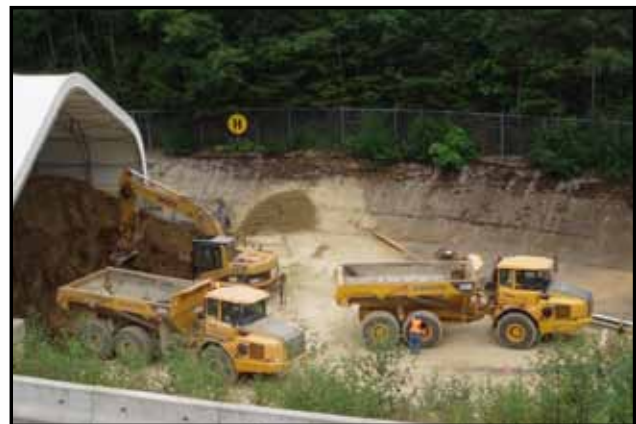
Storing the metal sludge before transport to the Jane Basin pit

The water treatment process removes around 600 – 700 kg of metal sludge every day. The main metals removed are aluminum, zinc, copper, manganese, iron and cadmium. This is around 95% of the metal in the water.

The sludge is stored on site until it can be taken up to the Jane Basin mining pit, where it helps cap the pit. As the metals are no longer in the form of a metal sulphide, they won't react with air and water to form ARD. Also, as the pH is now slightly alkaline, any water runoff into the mine will help to neutralize the acidic water in the mine.

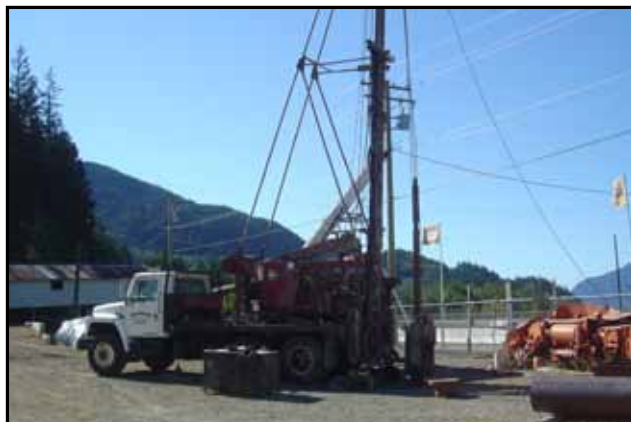
Drilling groundwater pumping wells at the Museum

The soils around the 2200 Level portal at the old Mount Sheer townsite and on the fan at Britannia Beach, have been badly contaminated by mining operations. The alluvial fan area at Britannia Beach is largely overlain by tailings (waste rock) from the Mill operations. This has contributed to the contamination of the ground here. The worst of the soil has been removed to the original Jane Basin mining pit. Here, any ARD it generates will be captured in the mine and then cleaned by the water treatment plant. Currently about 50% of the ARD generated by the remaining contaminated soils is captured by the wells on the foreshore and pumped to the water treatment plant. Ongoing work aims to take this to over 90%.

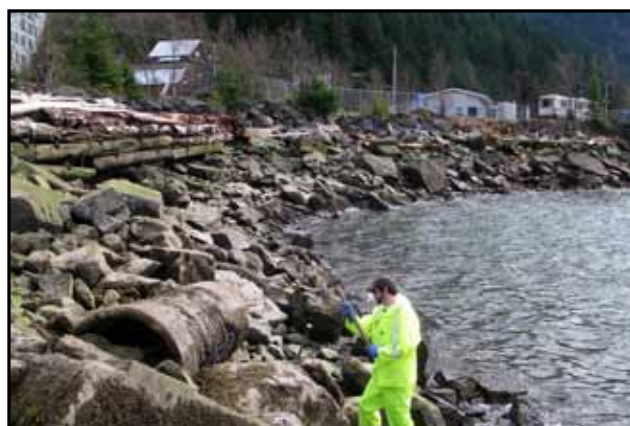
Monitoring life on the shores of Howe Sound

In the few short years that the remediation campaign has been taking place, Golder Associates have been monitoring the shoreline at Britannia for dissolved metal levels and for its ecology. There are currently still some hot-spots - the focus for future work, but the shoreline and sea water quality has improved greatly and life has returned. In 2011, both Pink and Coho salmon were also found to be swimming in the lower reaches of Britannia Creek.
