Spray Gun Maintenance Guide

Instructions

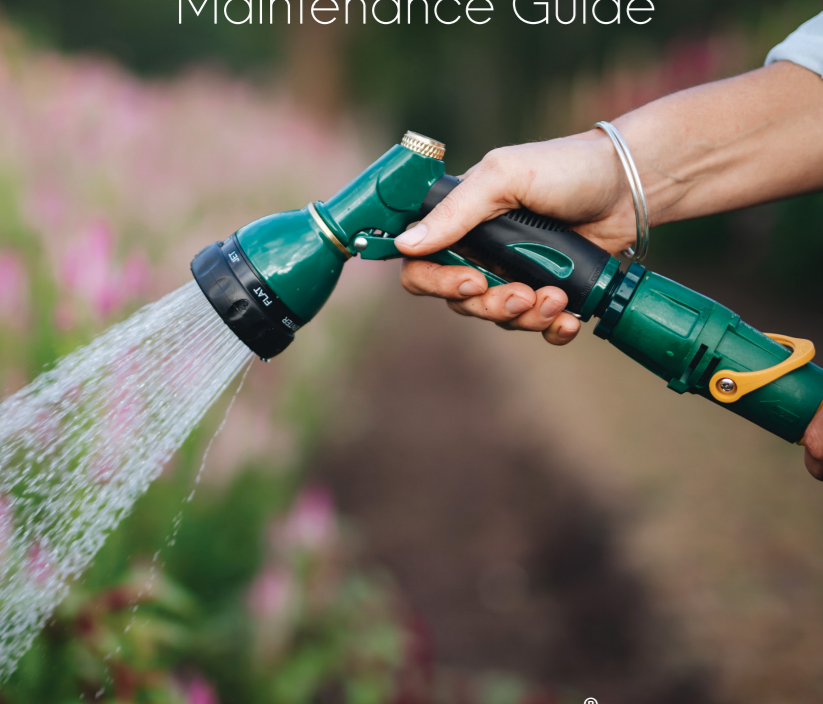
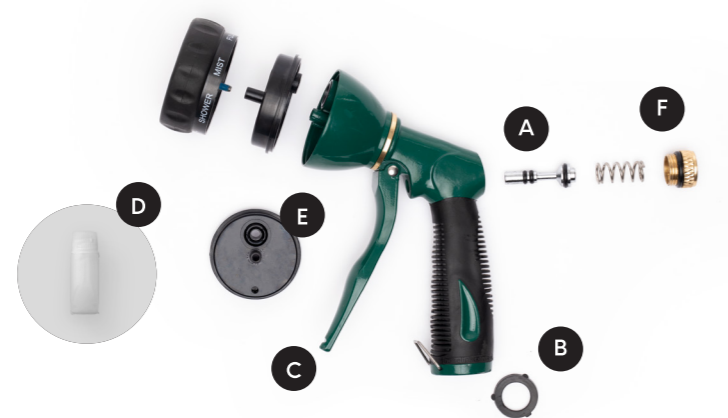
Kit Contents

- A Plunger x 1
- B 3/4" Washer x 1
- C Trigger Lock x 1
- D Spray Gun Lubricant Tube x 1
- E Spray Head O-ring x 1
- F Brass cap and O-ring x 1

Problem	Cause	Fix
Trigger not shutting water off.	O-rings on the plunger have dried out and need lubricating.	<p>STEP ONE: Using a pair of pliers unscrew the brass cap, remove the spring and plunger then apply lubricant to the o-rings on the plunger.</p> <p>STEP TWO: Reassemble putting the plunger, spring and brass cap back in place. Then, pump the trigger to distribute the lubricant.</p> <p>Tip: Repeat occasionally to keep the trigger functioning properly.</p>
Leaking from behind the trigger, where silver plunger is exposed.	Worn or damaged o-rings on the plunger.	<p>STEP ONE: Unscrew the brass cap on the back of the spray gun and replace the plunger.</p>
Leaking between metal body and pattern selector dial.	The pattern selector dial is loose, or there is damage to the O-ring.	<p>STEP ONE: Try tightening the face with a Phillips head screwdriver.</p> <p>STEP TWO: If leaking persists, remove the face of the spray gun. Be careful not to lose the small spring. Use a pin to unseat the O-ring and replace with a new one.</p>

Leaking between the bottom of the spray gun and the Hoselink Accessory Connector.	Accessory Connector is cross-threaded or washer in spray gun is damaged.	<p>STEP ONE: First, try screwing in the Accessory Connector again, ensuring it follows the thread correctly.</p> <p>STEP TWO: Check the washer and, if damaged, replace with the new 3/4" washer.</p>
Leaking from brass cap	O-ring has become damaged	<p>STEP ONE: Remove brass cap and exchange for replacement</p>
