Spray Gun Maintenance Guide

Instructions

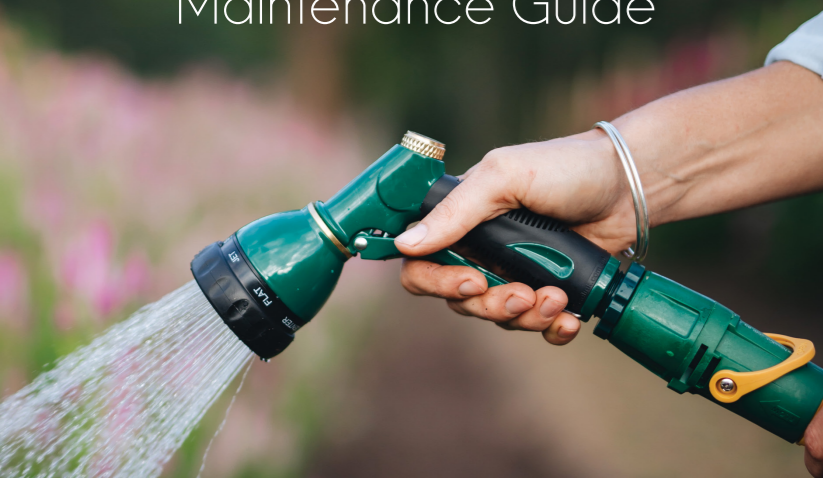
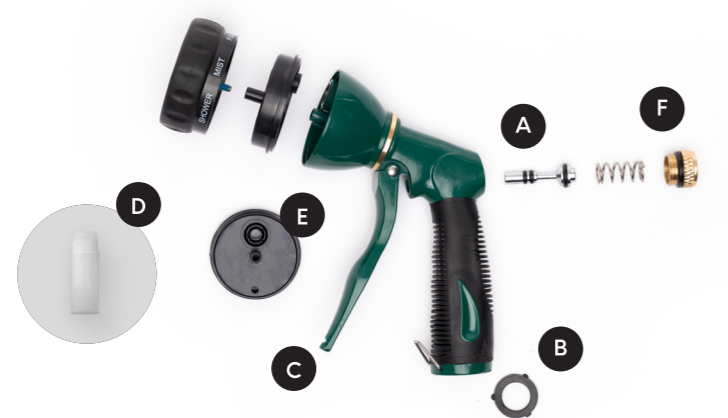
Kit Contents

- A Plunger x 1
- B 3/4" Washer x 1
- C Trigger Lock x 1
- D Spray Gun Lubricant Tube x 1
- E Spray Head O-ring x 1
- F Brass cap and O-ring x 1

Problem	Cause	Fix
Trigger not shutting water off.	O-rings on the plunger have dried out and need lubricating.	<p>STEP ONE: Using a pair of pliers unscrew the brass cap, remove the spring and plunger then apply lubricant to the o-rings on the plunger.</p> <p>STEP TWO: Reassemble putting the plunger, spring and brass cap back in place. Then, pump the trigger to distribute the lubricant.</p> <p>Tip: Repeat occasionally to keep the trigger functioning properly.</p>
Leaking from behind the trigger, where silver plunger is exposed.	Worn or damaged o-rings on the plunger.	<p>STEP ONE: Unscrew the brass cap on the back of the spray gun and replace the plunger. Lubricate plunger as per above steps.</p>
Leaking between metal body and pattern selector dial.	The pattern selector dial is loose, or there is damage to the O-ring.	<p>STEP ONE: Try tightening the face with a Phillips head screwdriver.</p> <p>STEP TWO: If leaking persists, remove the face of the spray gun. Be careful not to lose the small spring. Use a pin to unseat the O-ring and replace with a new one.</p>

Leaking between the bottom of the spray gun and the Hoselink Accessory Connector.	Accessory Connector is cross-threaded or washer in spray gun is damaged.	<p>STEP ONE: First, try screwing in the Accessory Connector again, ensuring it follows the thread correctly.</p> <p>STEP TWO: Check the washer and, if damaged, replace with the new 3/4" washer.</p>
Leaking from brass cap	O-ring has become damaged	<p>STEP ONE: Remove brass cap and exchange for replacement</p>
