## 7.4 Ridge and Hip Caps

### 7.5 Wall and Chimney Flashing

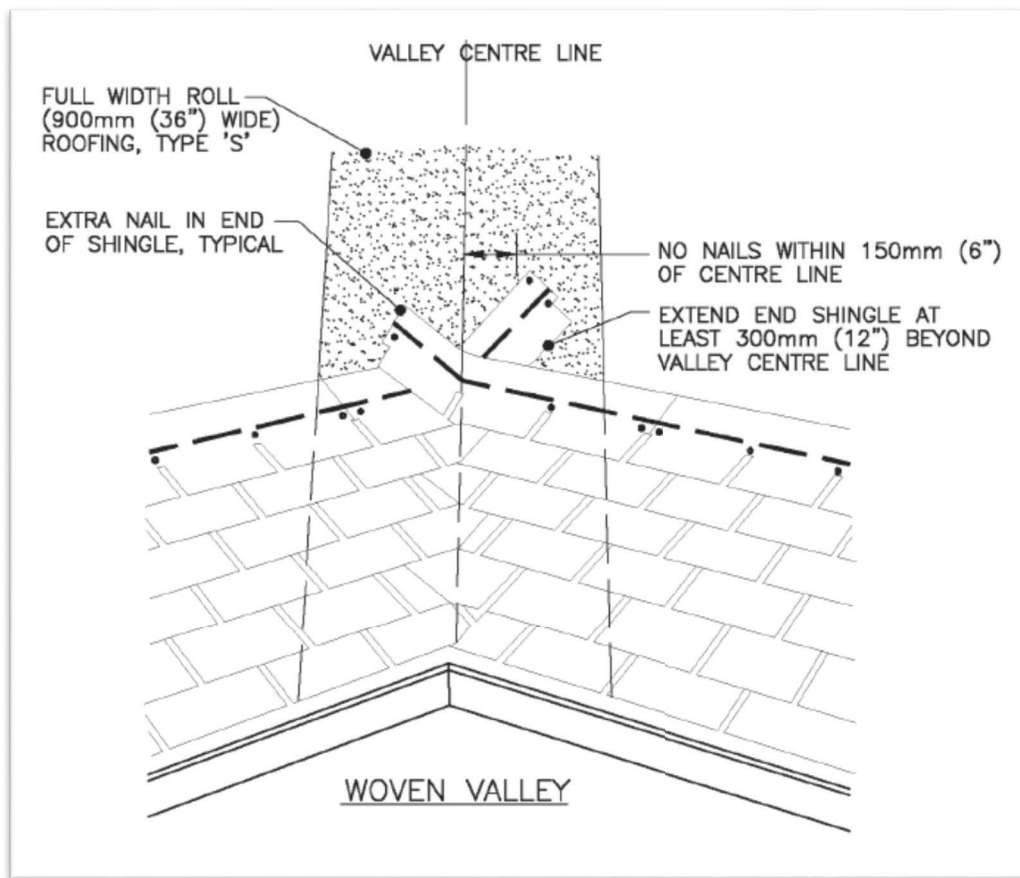
Fig. 7-6 Woven Style Closed Valley

Whatever the style, the lower end of valley flashing should not be cut short to expose the drip edge or the fascia, but it should also not extend too far as it encourages water running down the valley to overshoot the eaves trough. A water diverter is often installed in the trough to prevent this.

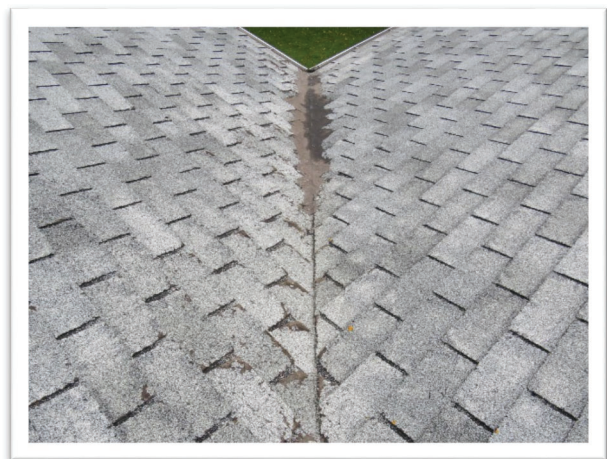
Valleys merit close inspection due to the factors previously mentioned. Roofs that are shingled with asphalt will often wear more quickly in the valley, particularly at the low end, than the rest of the roof.

Image 7-7 Lower Valley Deterioration

followed by the roofer. This includes sealing down the shingles along the valley, keeping nails away from the centre of the valley, and clipping the pointed ends of the shingles in the valley. If the shingles appear worn or brittle, no attempt should be made to lift them. The lower end of the valley should be properly terminated as described. The cut line of shingles at the valley should be clean and straight, with no ragged cuts or shingle ends showing from underlying courses. A carelessly cut valley may indicate hidden deficiencies and is more prone to catching debris and allowing water to seep past the valley flashing.

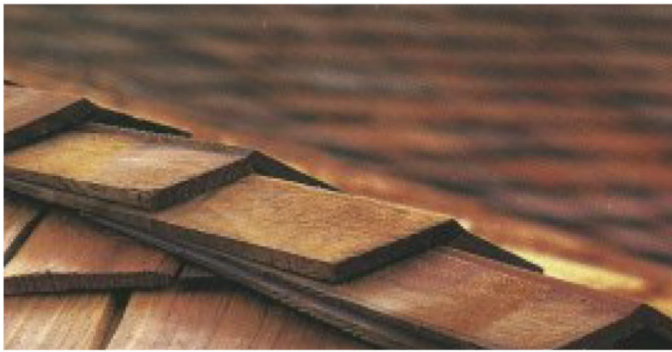
and the lap should conform to the exposures for each length and grade of shingle as listed in the **NBCC** and on manufacturer's labels. Prior to capping the ridge or hips of a wood-shingled roof, a strip of breather-type moisture barrier should be laid over the intersection of the roof planes. Capping must be bevelled to suit the adjacent roof slope, with laps alternating. This may be done on-site, or by purchasing premade cap shingle pairs.

Fig. 7-8 Cedar Shingle Hip Capping

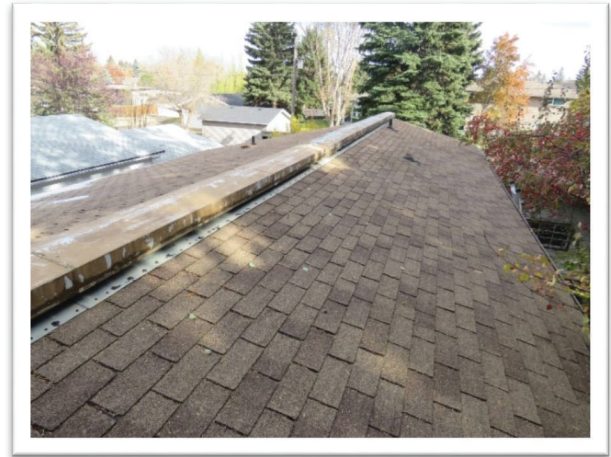
If the ridge is equipped with a continuous vent, the roof sheathing and shingles are held back from the ridge board to create a continuous opening which is then covered by a vent. The vent may take the form of a plain or painted aluminum or steel section or a plastic vent that can be capped with shingles.

Fig. 7-9 Continuous Metal Ridge Vent

Vents of this type may be found on any roof, but are the norm for metal sheet roofing and on roofs with cathedral ceilings.

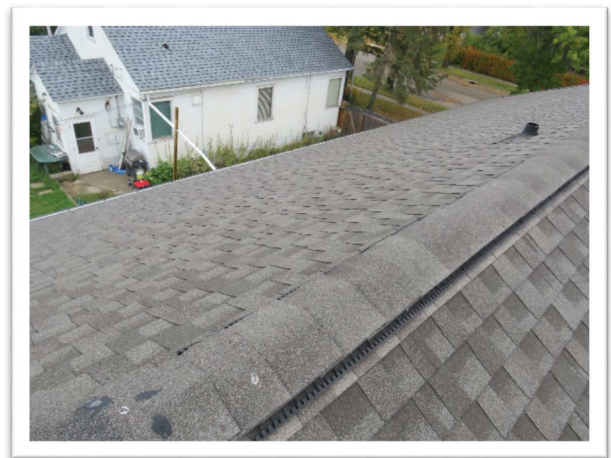
Fig. 7-10 Shingled Continuous Plastic Ridge Vent

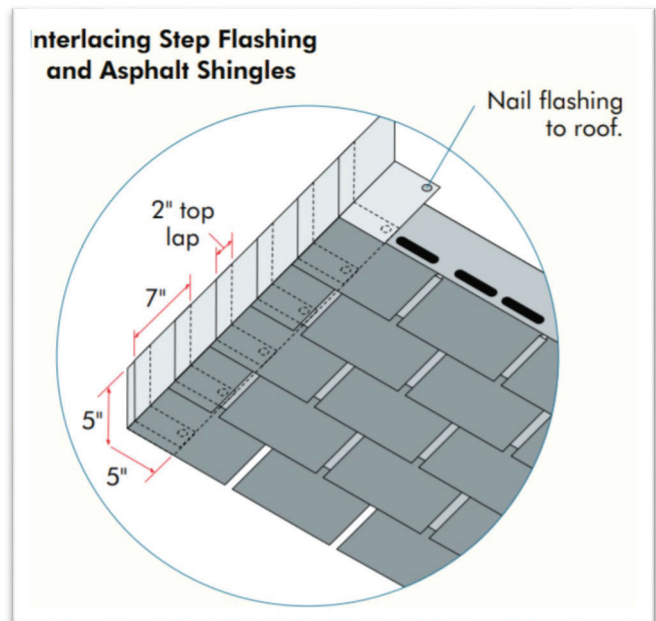
base flashing. The two flashings work together to remain weather-tight while allowing a degree of movement. There must be enough overlap to maintain a shingle effect after movement has stopped. The most common form of this type of base flashing is step flashing, used with shingles. The base flashing is installed with the shingles.

Fig. 7-11 Step Flashing Installation

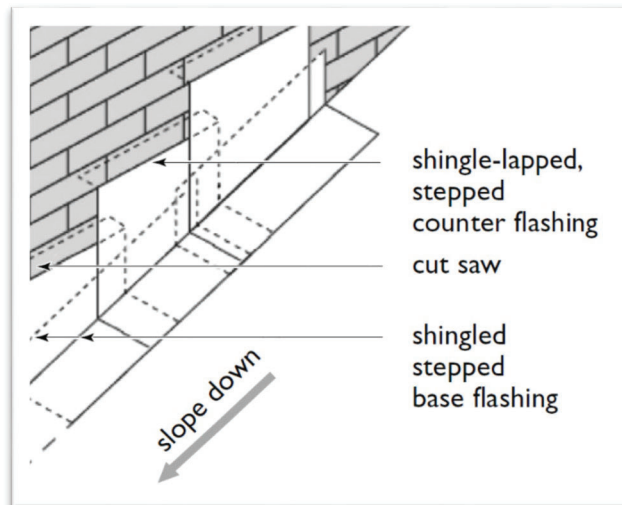
Counter flashing is embedded in masonry as in the next image. This may be done by making a saw cut in the mortar joint to receive the counter flashing, or by placing the counter flashing as the masonry is laid. The requirements for lapping and embedment of this type of flashing are contained in **NBCC Article 9.26.4.4.**

Fig. 7-12 Counter Flashing at Masonry Wall

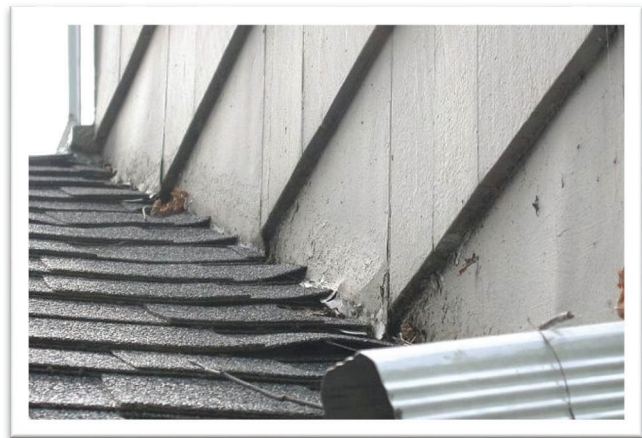
If the wall is a framed wall with an exterior finish such as siding; the function of the counter flashing is replaced by lapping the moisture barrier and siding of the wall system over the step flashing a minimum of 3"/75mm, per **NBCC Article 9.26.4.5**. To prevent damage to siding or sheathing made from wood or a wood product, such materials must be kept a minimum of 2"/50mm above the finished roof surface, per **NBCC Sentence 9.27.2.4.(2)**. This clearance requirement is a frequent area of concern with older homes that are likely to have more than one layer of roofing applied – the extra thickness of roofing brings the roof surface too close to wood or wood-based siding or concealed wall sheathing.

Fig. 7-13 Faulty Intersection at Wall

The step flashing is nailed only to the roof surface and should be entirely covered by the shingles. Shingles should be held back from the bend in the step flashing to prevent their buckling in the event of expansion. Failure to allow proper clearance between roofing and wood sheathing can be disastrous.

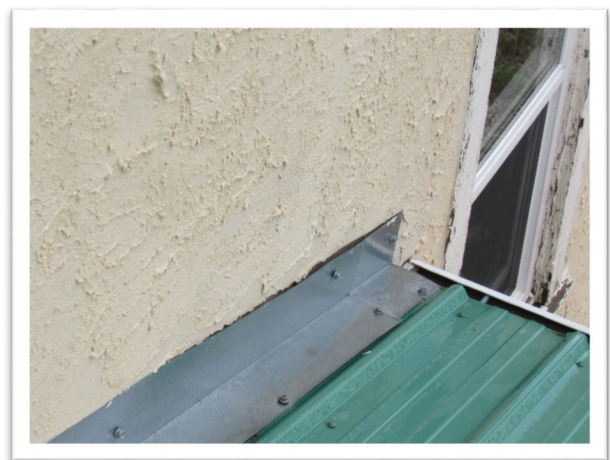
Fig. 7-14 Improper Wall Flashing Installation
