## 1.7 Slab on Grade Foundations and Floors

## 1.8 Pier (Pile) Foundations

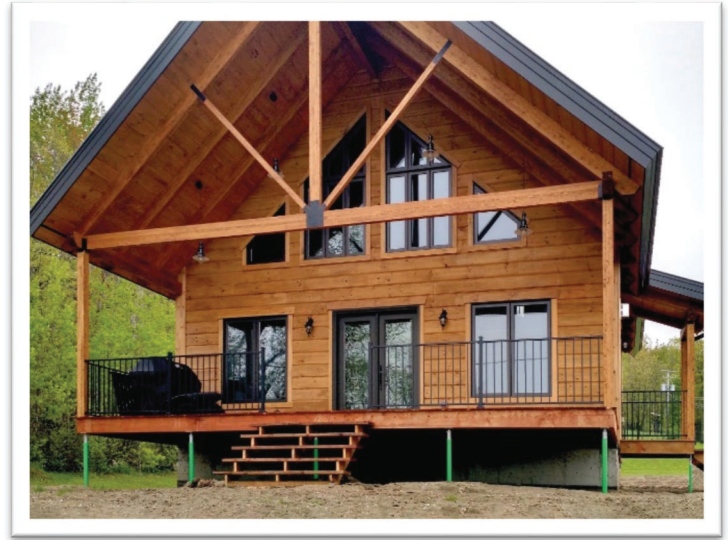
Fig. 1-20 Green Helical Piers Supporting Deck

A helical pier is an oversized steel screw that is drilled into the ground, using hydraulic equipment, until it reaches the required bearing capacity. The size of the helix and the depth of the pier depends on the structure, the soil type, and on the required bearing capacity. Once installed, pier caps are used to attach the pier to the framing system. Pier caps come in many sizes and varieties, depending on the structure's frame.
