SIX-LITER REVIVAL

BULLETPROOF DIESEL BRINGS NEW LIFE TO THE PROBLEM-RIDDLED 6.0-LITER POWERSTROKE

BY ADAM BLATTENBERG

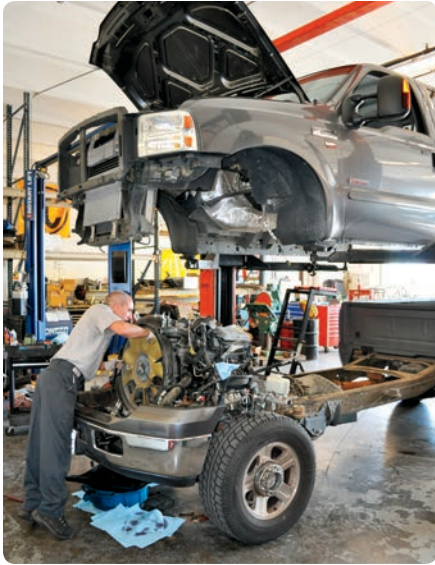
1 Accessing the motor for a repair like this one requires removing the cab. It's really not as bad as it looks, and only takes a couple hours to complete.

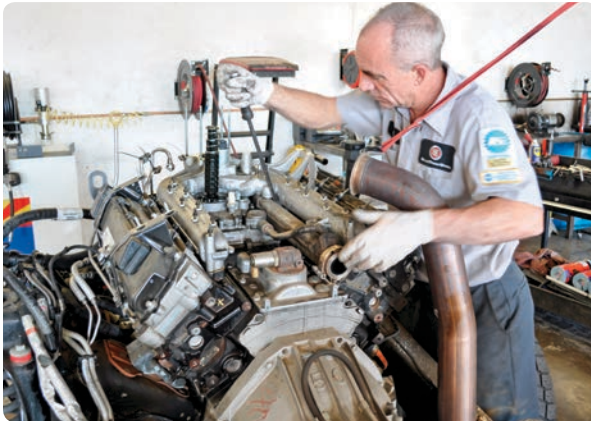
2 With the cab off, Bulletproof Diesel's Del Wamsley removed the turbo, intake manifold, EGR cooler, wiring, and more to gain access to the valley.

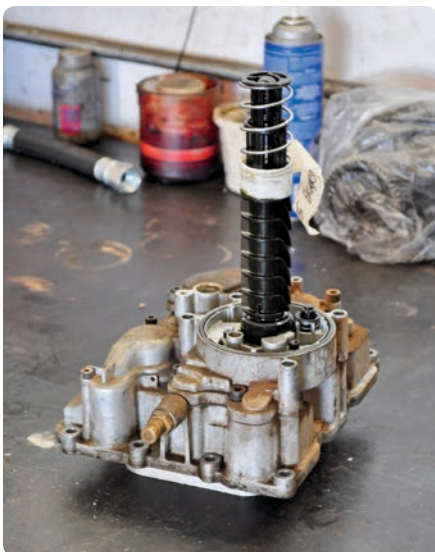
3 This manifold houses the factory oil cooler, a few sensors, and the factory oil filter. The black tube is what the factory drop-in filter surrounds and attaches to. Atop the tube is a bypass valve that is famous for breaking. When it does, oil completely bypasses the filter and sends contaminants straight to the high-pressure oil pump

(HPOP) and injectors. This is the last you'll see of this manifold. It will soon be replaced by a new Bulletproof Diesel part.

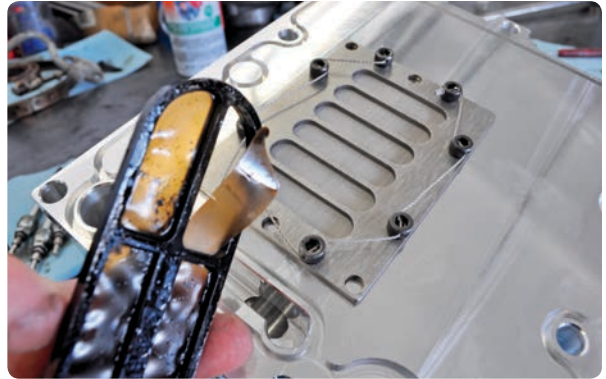
4 This screen is located below the oil cooler. It is there to stop contaminants from entering the injection system, potentially causing a no-start condition. They fail all the time like this one has. Bulletproof's new manifold uses a much more robust screen, which you can see in the background.

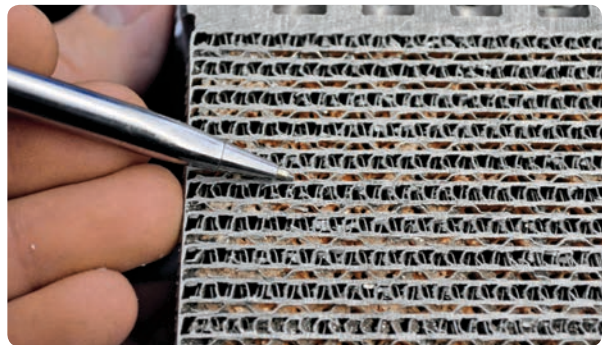
5 The factory oil cooler is a stacked plate heat-exchanger design. Coolant and oil flow through separate passageways stacked on top of each other. The problems with it are multifaceted. First, the coolant in this high-compression motor, like most, has contaminants from multiple sources, ranging from supplemental coolant additives and gasket material to leftover sand from the casting process. These contaminants clog up the passageways in the cooler and reduce its efficiency, thus creating hot, less-dense oil for everything down the line to use for lubrication. The turbo, injectors, and HPOP (high-pressure oil pump) all take a beating due to this, and failure eventually follows.

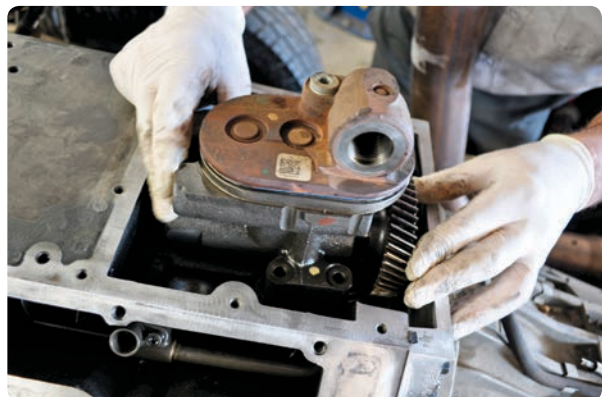
6 This is the HPOP or high-pressure oil pump. The motor's HEUI (hydraulically actuated electronically controlled unit injection) injectors use oil pressurized by this pump to inject fuel into the cylinders. Good, clean, and cool oil is extremely important to this power plant due to this HEUI system. Bulletproof removes and inspects the HPOP, if no problems are found, they replace all seals and reinstall it.

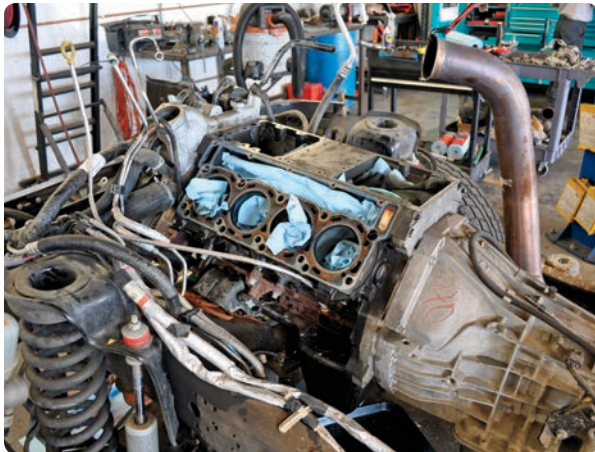
7 The valve seats in the heads tend to crack. So Del removed the heads and sent them out to be checked for straightness and to have the seats swapped out for hardened ones. Del then began to clean every nook and cranny of the disassembled engine until it was surgically clean.

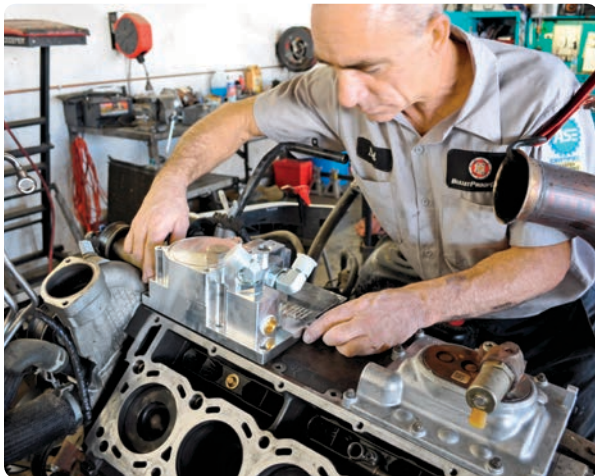
8 Here Del installs the new Bulletproof Diesel Transfer Block. The transfer block diverts engine oil down a hydraulic line to a new air-to-oil cooler and through a traditional spin-on filter, eliminating the problematic factory filter and cooler.

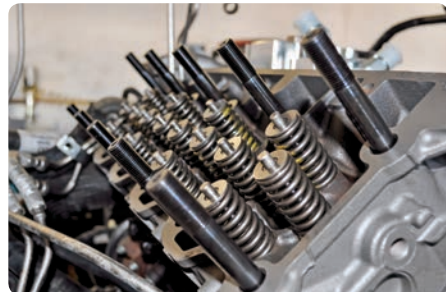
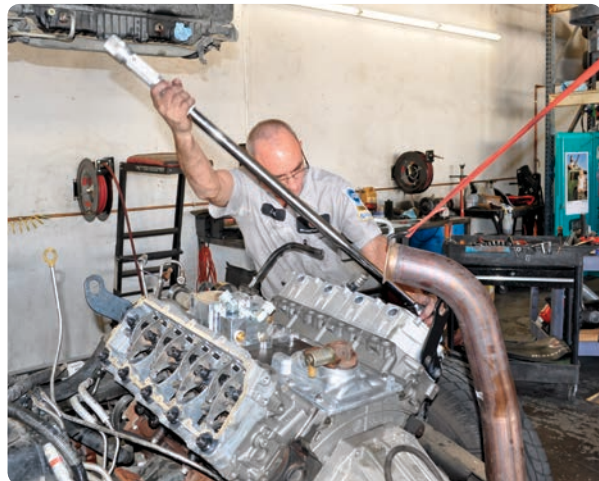
10 Head gasket failure is yet another common 6.0-liter Powerstroke problem. The fix is had with a new pair of gaskets and a set of ARP head studs.

11 The final torque of the studs, done with ARP's Ultra-Torque on the threads, should be 210 ft.-lbs. Factory head bolts take a much less 85 ft.-lbs. of torque (plus another three-quarter turn of the wrench).

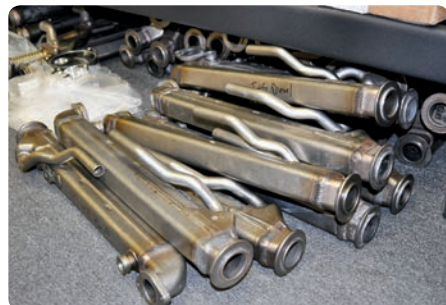
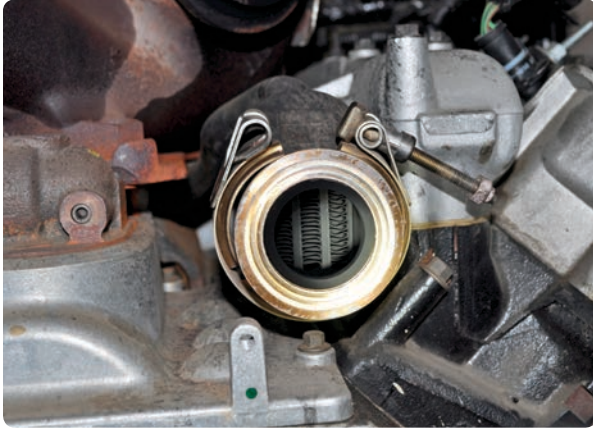
13 Here's the biggest problem the 6.0 has—the EGR cooler.

14 The EGR cooler uses coolant running through a set of passageways to cool the exhaust before reintroducing it into the engine. This process of recirculating exhaust air into the intake helps reduce tailpipe emissions. The factory EGR fails in two different ways and both generally stem from a failed oil cooler. The flow of coolant goes through the oil cooler, then directly to the EGR cooler. A clogged oil cooler means less and hotter coolant going to the EGR cooler, making it much less efficient. Generally, the EGR cooler will clog with soot or crack at the coolant passage, leaking coolant into the intake that could eventually lead to catastrophic engine failure.

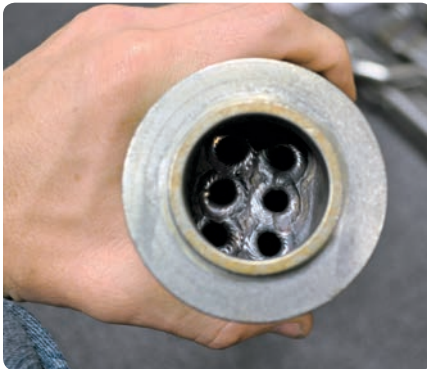
15 Here the new reworked Bulletproof EGR cooler, it's a much stronger unit consisting of six stainless steel tubes that allow less restriction in the exhaust and better coolant flow. The end result is cooler exhaust temperatures, better performance, less soot build up, and better emissions.

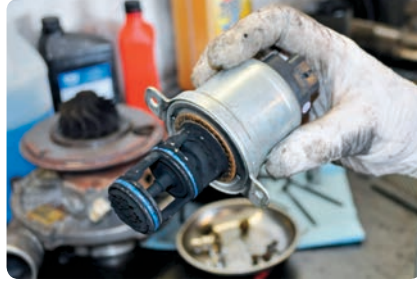
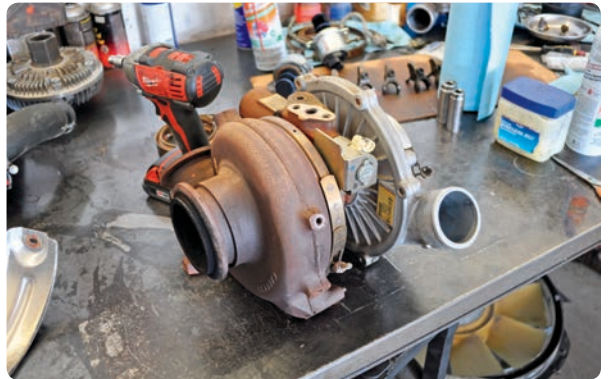
17 A common concern for any 6.0-liter owner is the EGR valve. They clog with soot constantly and need to be cleaned regularly. With the new Bulletproof Diesel EGR Cooler, carbon build up on this valve will be much less severe.

18 Next problem area: the variable geometry turbo (VGT).

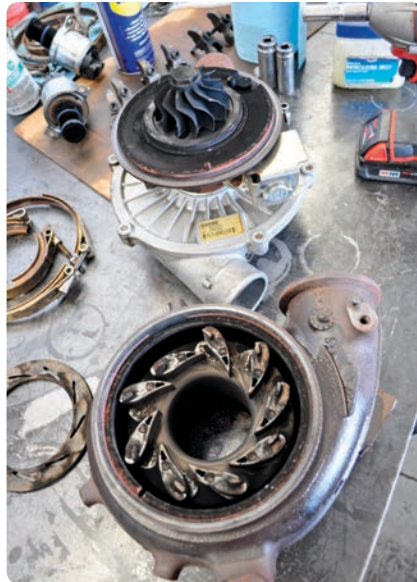
19 This VGT turbo uses a series of vanes to change the velocity at which the incoming exhaust air hits the exhaust turbine/wheel. To keep it simple, the end result is a turbo with almost zero spool up time that can give the engine a healthy and correct amount boost at any rpm. The problem occurs when the vanes become clogged with soot and freeze up.

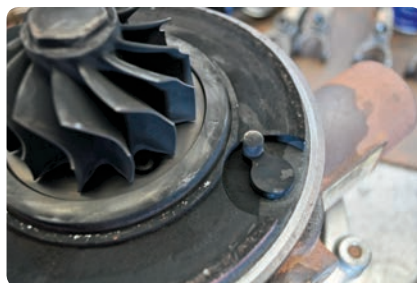
20 This pin/lever controls the direction of the turbo's vanes.

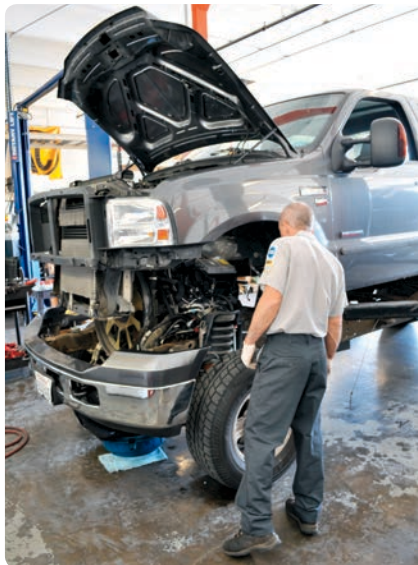
25 The factory power-steering cooler must be moved on this 2006 Superduty to allow room for the new oil cooler. It's a quick job as earlier Superdutys had their power-steering cooler mounted low, so the bolt holes are already there.

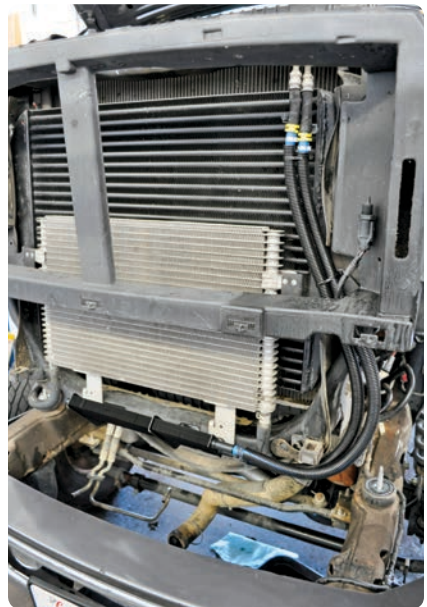
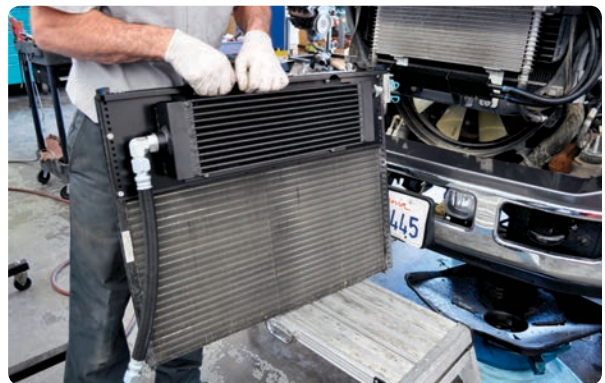
26 The new air-to-oil cooler mounts to the AC condenser with supplied bracket and hardware. Heavy-duty hydraulic lines connect the manifold in the engine's valley to the filter and new cooler. This air-to-oil cooler will keep the engine oil much cooler than the factory one. This means less deposit build up and better lubrication for the entire engine.

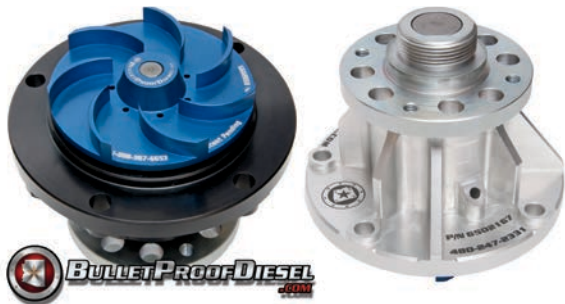
27 Another common failure is the Powerstroke's water pump. The factory pump has a plastic impeller that commonly cracks around the hub. The new Bulletproof pump uses a much stronger billet aluminum impeller, which helps prevent failures that could lead to overheating problems.

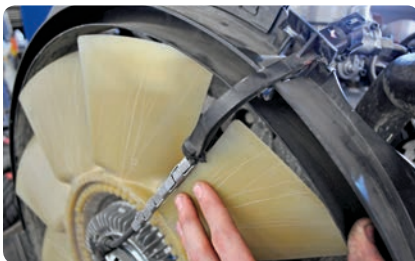
28 The Ford's radiator fan uses an electrically controlled clutch. The wires to this clutch always seem to get caught by the fan, and obviously, get ripped apart.

Further proving their vast knowledge of the 6.0-liter Powerstroke, Bulletproof has two fixes for this. First, seen here is a protective sheath for the wires. The second fix is an adaptor they've made that will allow a mechanical clutch from an earlier Powerstroke to be installed in the electric one's place, eliminating the wires altogether.

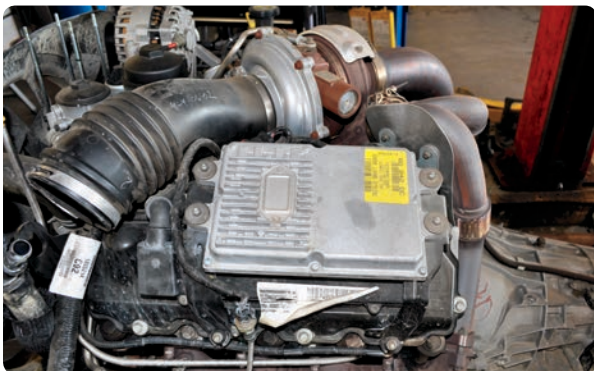
29 Last big problem: The fuel injection control module (FICM). It's the brain of the engine and lives its life in a very harsh environment. Mounted to the driver's side, valve cover vibration and high heat levels beat up on the FICM. A failed FICM will cause slow starts, poor cool-weather performance, poor performance, poor fuel economy and possibly a no-start situation.

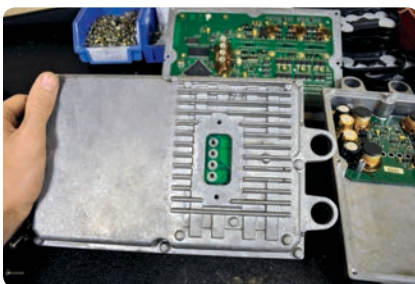
30 When FICMs fail, it's rarely the brain, but usually its power supply (on the right of the photo). Testing the FICM is easy. Simply measure the voltage output at the top pin (here it would be the bottom pin as the FICM is upside down in this photo). Anything less than 48 volts means the power supply has failed.

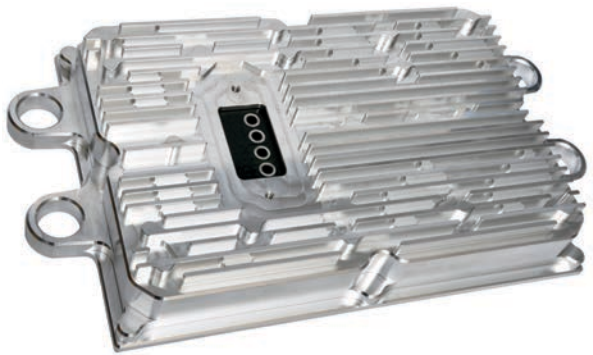
31 Bulletproof's new unit uses a much thicker, vibration-resistant circuit board, military-grade electrical components, and a full billet aluminum case with built in heat-sinks for optimal heat dissipation. An optional six-phase unit is available that features two extra redundant power circuits ready to take over in the rare event of a failure.

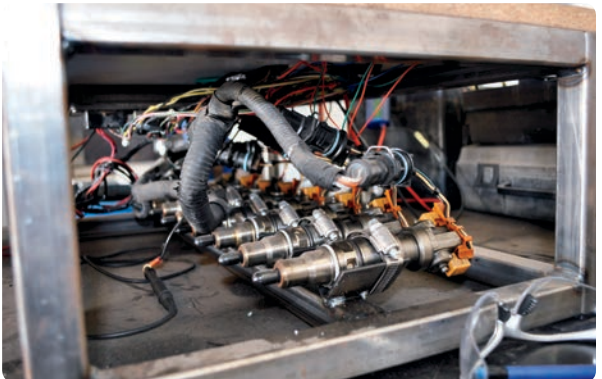
32 Ken Neal built this test bench where each FICM is plugged in to ensure there are zero problems before it goes out to the final user. The tester has all eight injectors set up to fool the FICM into thinking it's plugged into a running 6.0 liter.
