Journal section: Operative Dentistry and Endodontics
Publication Types: Case Report

doi:10.4317/jced.56585
https://doi.org/10.4317/jced.56585

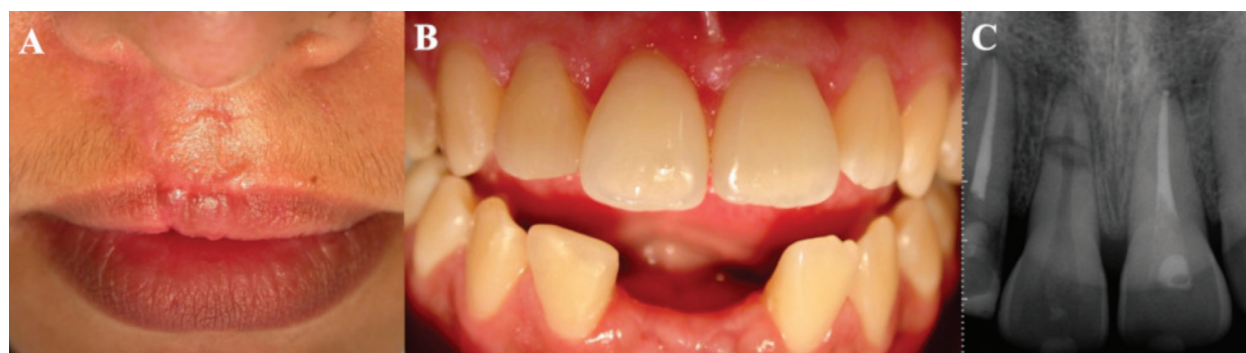
Fig. 1: A) Scar on the right upper lip due to trauma. B) Absence of teeth 31 and 41, avulsed. C) Initial x-ray suggestive of apical horizontal fracture.

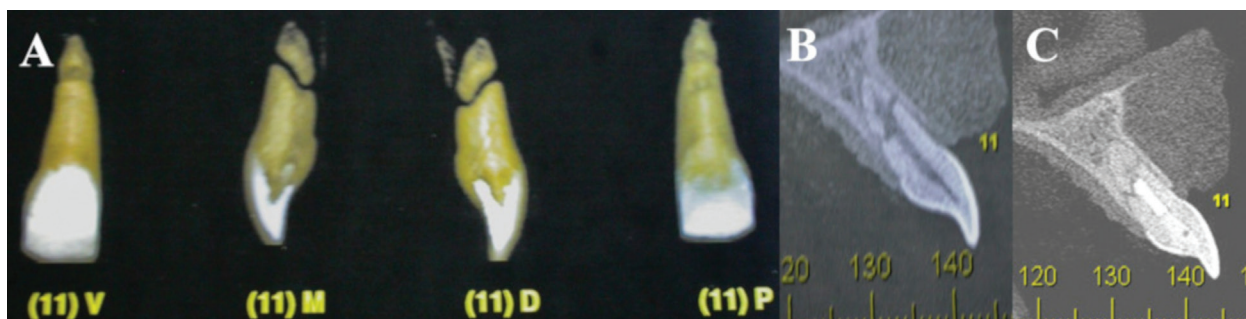
Fig. 2: A) Tomographic image of tooth 11, coronal and sagittal sections. B) Sagittal section demonstrating fracture extension, with fragment separation. C) 2-year preservation with fracture repair by mineralized tissue interposition, suggestive of bone deposition healing.

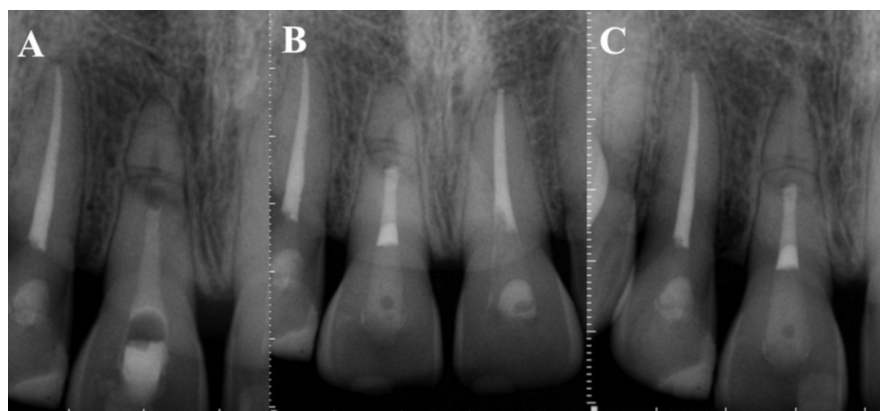
Fig. 3: A) Intracanal medication, B) Bioceramic obturation and 2 mm cervical obturation with thermoplastic gutta percha - 1 year control C) Preservation after 2 years.
