Seat Belt Anchorage Test Report

Report Reference No: 2007E

For an In-Vehicle Test To EC Directive 76/115/EEC As Amended By 2005/41/EC. & To ECE Regulation 14.07

Vehicle Type: Volkswagen T5 based Motor Caravan

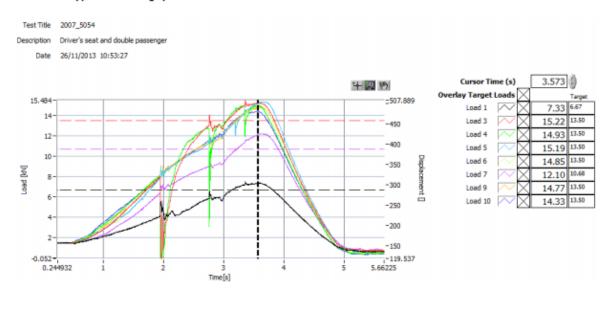
Appendix 2 - Load graphs

The loads held were as shown in the graphs found in Appendix 2:

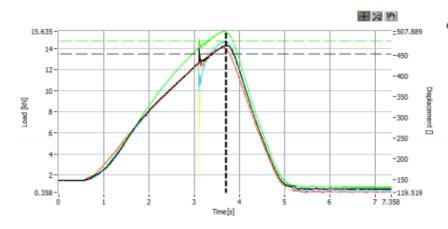
Test Title 2007_5055
Description Double RIBS seat
Date 26/11/2013 12:29:31

Cursor Tin	3.700	0		
Overlay Target I		Target		
Load 5	\sim	X	14.27	13.50
Load 6	\sim	X	13.99	13,50
Load 7	\sim	X	15.57	14.71
Load 9	\sim	X	14.59	13.50
Load 10	\sim	X	14.55	13.50

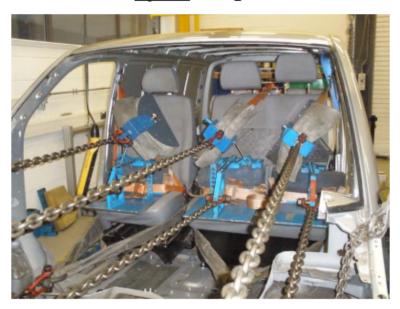
Figure 3.1 - 2007_4054

The vehicle first row driver's seat and anchorages were as per the original manufacturer. The first row double passenger seat was mounted on a Kiravan's swivel base, the anchorages were as per the original manufacturer.

Seat Vehicle	Position	RH	С	LH			
Vehicle row	1 0310011	Row 1					
Seat Manufac	turer	OE	OE	OE			
Seat name		Driver's seat	Front pass on	Front pass on			
		Driver's seat	Kiravan Swivel	Kiravan swivel			
Seat type		Single	Double				
Belt type		3 Point	3 Point	3 Point			
Anchorages on seat		LB	All	LB			
Configuration tested		Lowest rearmost with upper in highest postn	,	Upper in highest postn			
Seat weight (I	kg)	34.0	54.5	54.5			
Load	Lap	13.5	13.5	13.5			
applied	Diagonal	13.50	13.50	13.50			
(kN)	Seat C of G	6.7	10.	68			
Load	Lap	3	5	9			
Channel No	Diagonal	4	6	10			
Seat C of G		1	7				
		Pass To	Pass To	Pass To			
Test result		Regulation & Directive	Regulation & Directive	Regulation & Directive

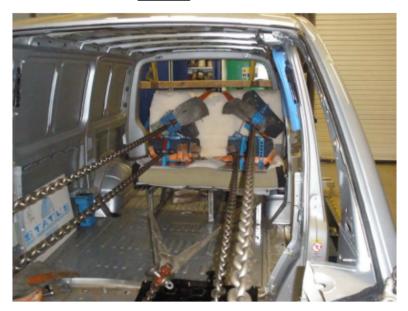
Figure 3.2 - 2007_4055

The rear row of seats comprised of a Scopema RIB double seat/bed,(Part No PCB CI 3P 2P 1D + ACA 64 R), adjustable in the fore/aft direction adjacent to the rear wheel arches. All anchorages were located on the seat. The seat was bolted through the floor into reinforcing brackets mounted underneath the vehicle.

Seat Vehicle Position		RH	LH			
Vehicle row		Row 2				
Seat Manufacture	er	Scopema	Scopema			
Seat name		RIBS PCB C1 3P2P	RIBS PCB C1 3P2P			
		1D+ACA 64 R AV	1D+ACA 64 R AV			
Seat type		Double	Double			
Belt type		3 Point	3 Point			
Anchorages on s	eat	All	All			
Configuration tes	ted	Slide in foremost position				
Seat weight (kg)		75.0	75.0			
Load applied	Lap	13.5	13.5			
(kN)	Diagonal	13.5	13.5			
	Seat C of G	7.4	7.4			
Load Channel	Lap	5	9			
No	Diagonal	6	10			
	Seat C of G	7				
Test result		Pass to Regulation and Directive	Pass to Regulation and Directive

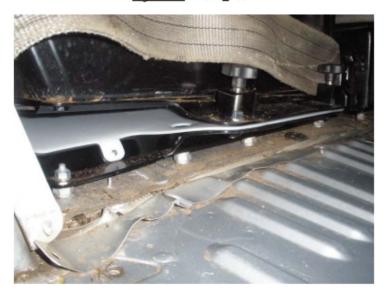
Figure 4.1 - 2007_4054

2007_4054 The Driver side upper disengaged and dropped to its

bottom position, dropping approximately 100mm - but still maintained its integrity. Swivel started to pull apart. Very slight deformation.

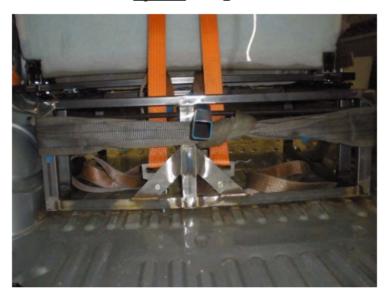
Figure 4.2 - 2007_4055

2007_4055 Vehicle floor pulled up at the rear (central region mainly) with front pushing down very slightly.
