Refurbishment considerations

2

3 different refurbishment projects:

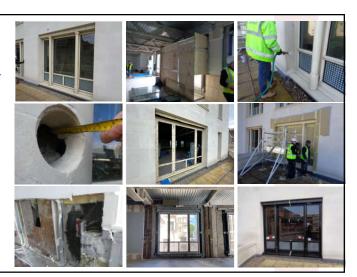
ALL PRIOR TO MAIN CONTRCATOR ENGAGEMENT TO INFORM DESIGN OPTIONS AND PERFORMANCE

- CORE HOLES EXTERNALLY
- · LOCAL OPENING UP INTERNALLY
- WATER AND AIR TESTING FULL WINDOW STRIP
- TRIAL SITE REPAINT
