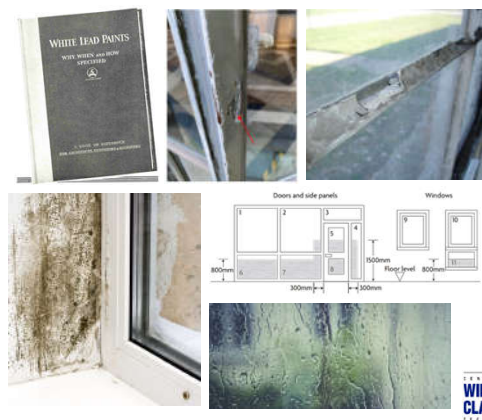
## Defects

### Leaks

### Condensation / mould growth

### Local comfort issues

### Solar control / overheating issues

### Interstitial condensation

### Poor ventilation

**Inappropriate materials** (e.g. cement mortar rather than lime)

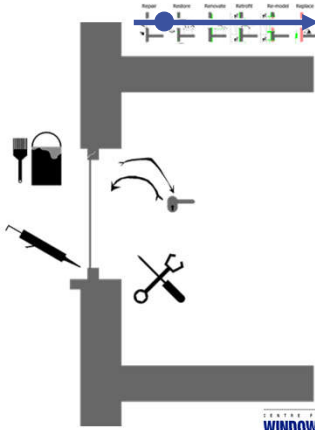
### Repair / Restore

**Strategy:** A full restoration to bring the existing window back to its original condition (or as close to it as possible). E.g. resealing small joints, reputting glass, replacing broken panes etc

- This will typically have little thermal benefit so U-values would remain **~5 – 6 W/m²K**
- Re-seal fixed joints which would **improve airtightness performance slightly**, although retrofitting weatherstripping to opening elements needs careful consideration and detailing
- Windows are still likely to **need replacement in 10 years** for safety reasons (corrosion etc)

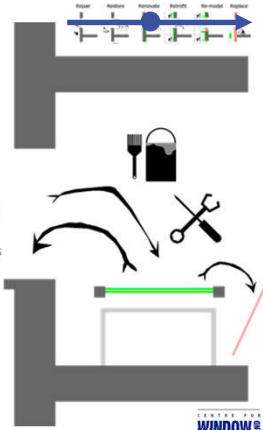
### Renovate

**Strategy:** Upgrading the existing system via:

- stripping paint and repainting
- add additional weatherstripping (to improve airtightness) if possible
- replace/refurbish ironmongery / actuation etc.
- replace glass units (with adapted bead profile where required) as such:

- Likely would need to remove window; feasibility of doing so without damage needs to be investigated
- Glass upgrade typically yields a **~30-50% thermal improvement** in heritage windows
- Good improved airtightness**
- Window life could be extended by (say) **30 years** until replacement

SGU Slimline DGU DGU TGU VIG

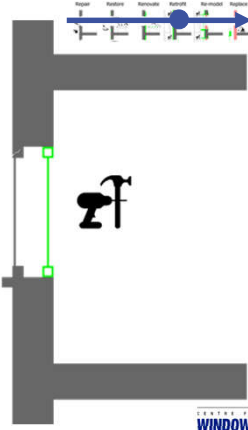
### Retrofit

**Strategy:** the addition of additional systems to compensate for the poor performance. E.g. Secondary glazing.

- Can **significantly reduce U-values**
- Need for **ventilation** makes secondary glazing difficult
- Cold bridging and **colder window frames / detailing** alongside potential for **trapped moisture** can lead to accelerated deterioration of existing windows
- Large windows can be difficult to secondary glaze sensitively

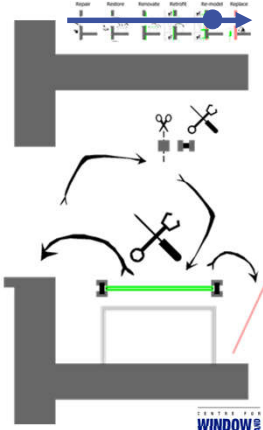
### Re-model

**Strategy:** consider removing window and look at options to improve / adapt the frame and glass.

E.g. Retrofit seals / thermal breaks to existing frames.

- Much more relevant to timber windows which are more adaptable
- Very difficult in metal windows
