# Armorlite JK 2DR- Rear Seat Clearance

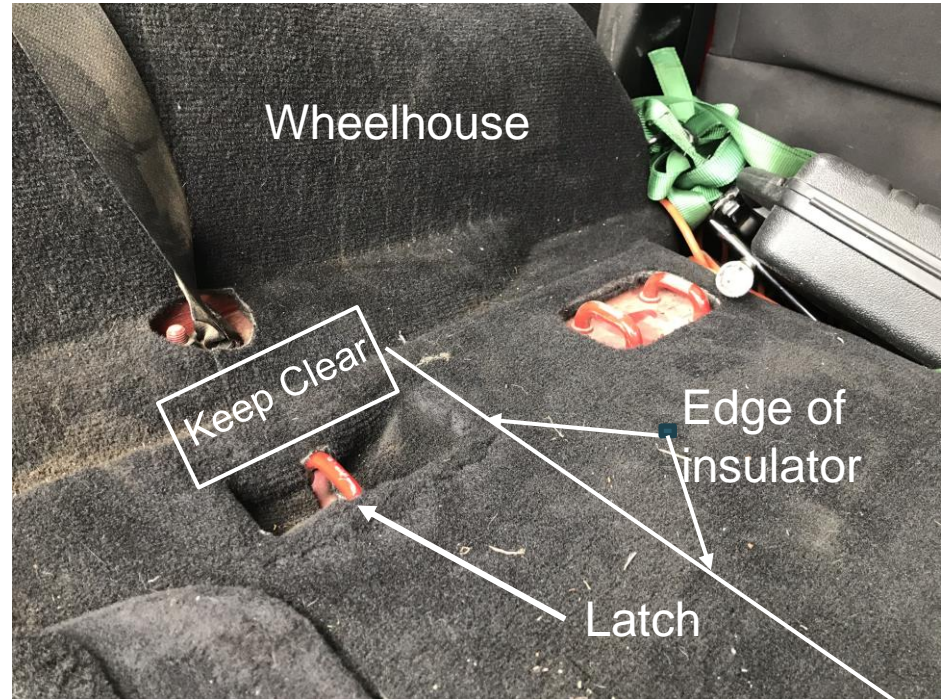
- Insure there is no debris in the areas between the latch and wheelhouse.
- Confirm that the insulation stops in front of the seat latch

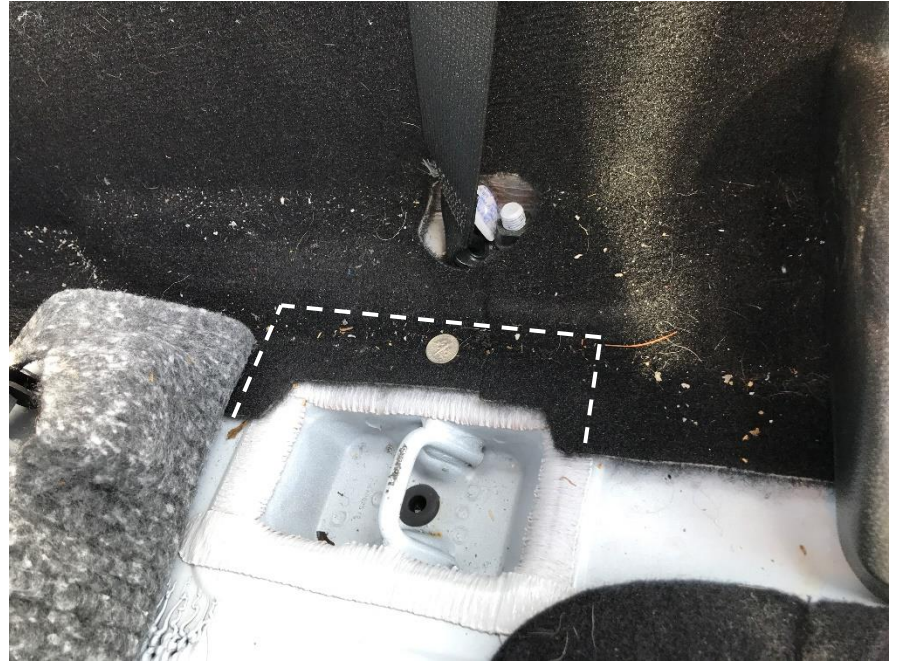
- If the area is clear of debris and the insulator, and the rear seat still does not engage, trim back the OE carpet at the white dashed line.
